Dealer Service Instructions for:

## **Safety Recall P08 / NHTSA 14V-101 Headlamp Wiring**

**2011 - 2012 (LD) Dodge Charger**

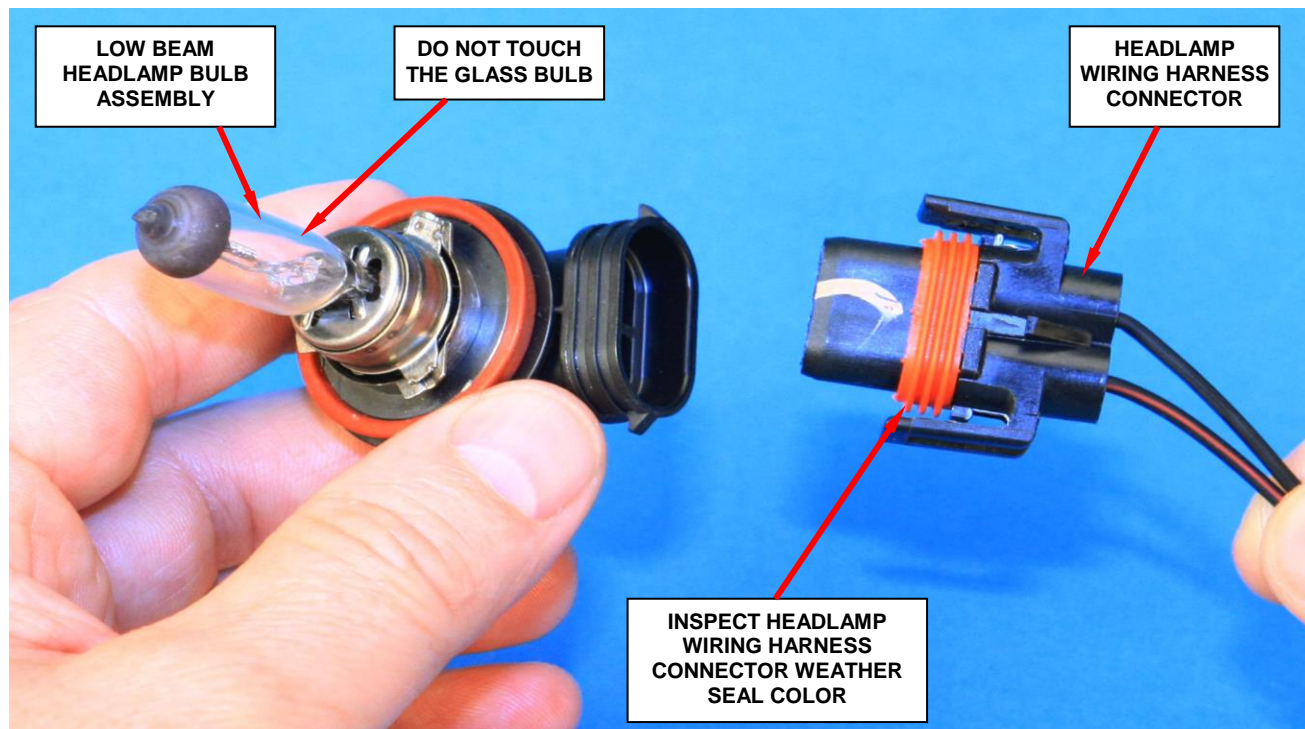
Figure 1 – Inspect the Headlamp Wiring Harness Connector Seal

- If both the right and left side weather seal on the headlamp wiring harness connectors are red, no further action is required. Assemble the headlamp assemblies and return the vehicle to the customer.
- If the right and/or left weather seal is black, and the headlamp assemblies are not damaged (melted), the headlamp wiring harnesses must be replaced. Continue with **Section B. Replace Headlamp Wiring Harness.**
- If the right and/or left weather seal is black, and one of the headlamp assemblies is damaged (melted), the undamaged headlamp wiring harness must be replaced. Continue with **Section B. Replace Headlamp Wiring Harness.**
- If both headlamp assemblies are damaged (melted) continue with **Section C. Replace Headlamp Assembly.**

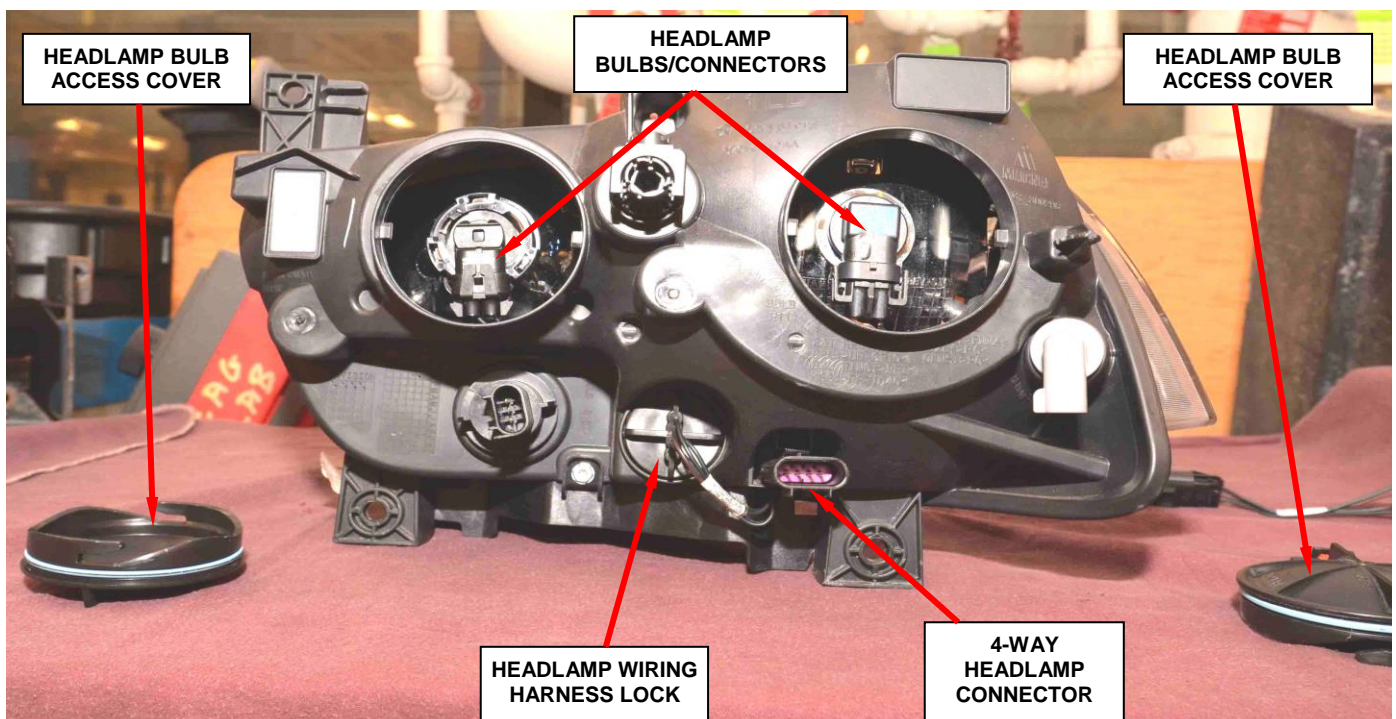
**Figure 2 – Headlamp Assembly Bulb Access Covers**

1. Open the trunk and disconnect the negative battery cable at the battery.
2. Disconnect the 4-way headlamp connector from the body harness (Figure 2).

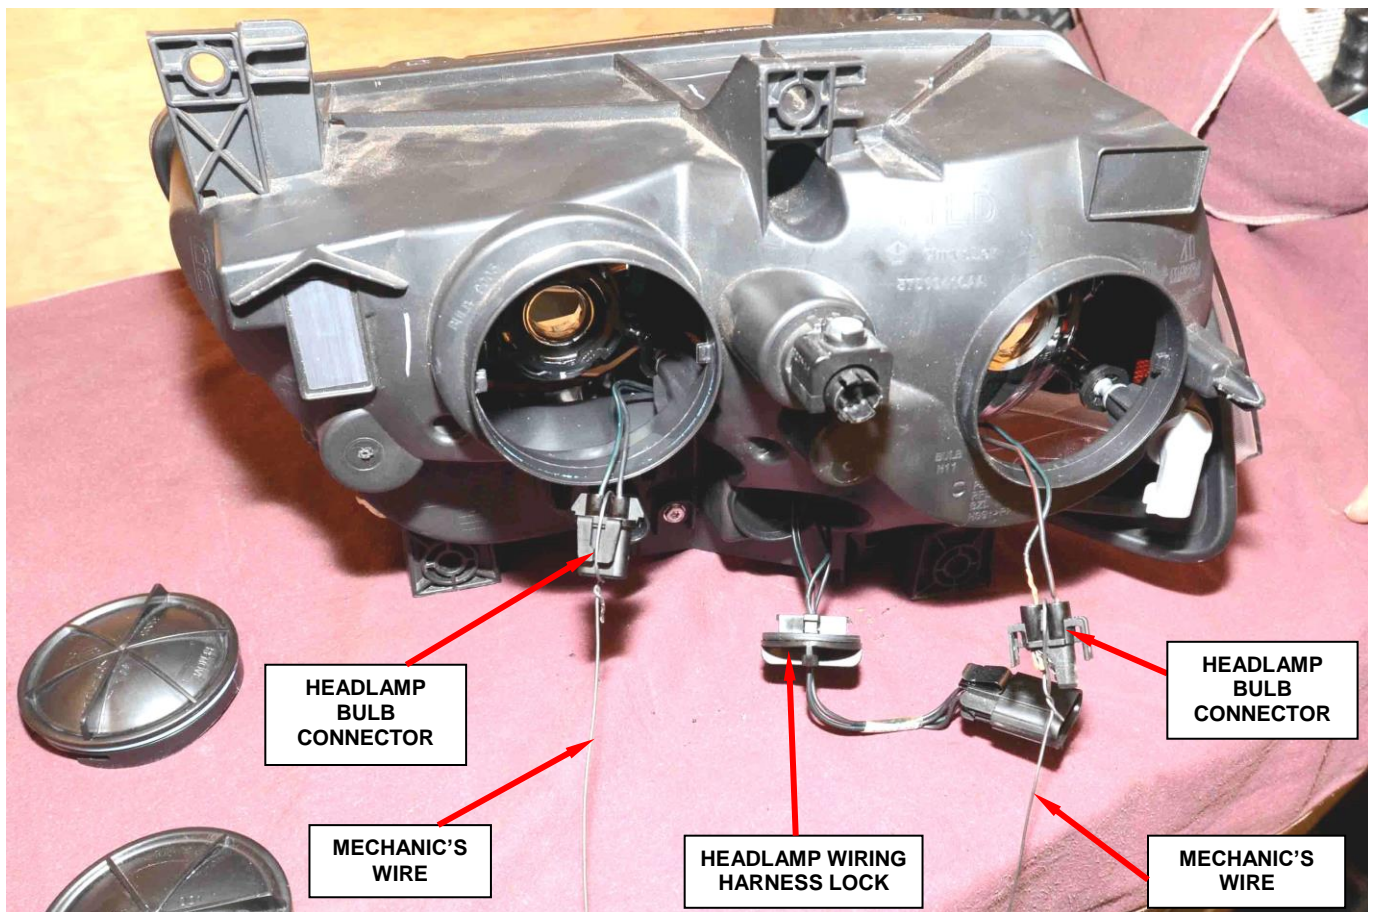
**Figure 3 – Attach Mechanic's Wire to Headlamp Bulb Connectors**

3. Using two 24 inch long pieces of mechanic's wire (or equivalent), connect one end of the mechanic's wire to each of the headlamp bulb connectors (Figure 3).
4. Unclip the 4-way connector from the back of the headlamp housing (Figure 3).
5. Disengage the headlamp harness lock on the headlamp housing by turning it ¼ turn counterclockwise (Figure 3).

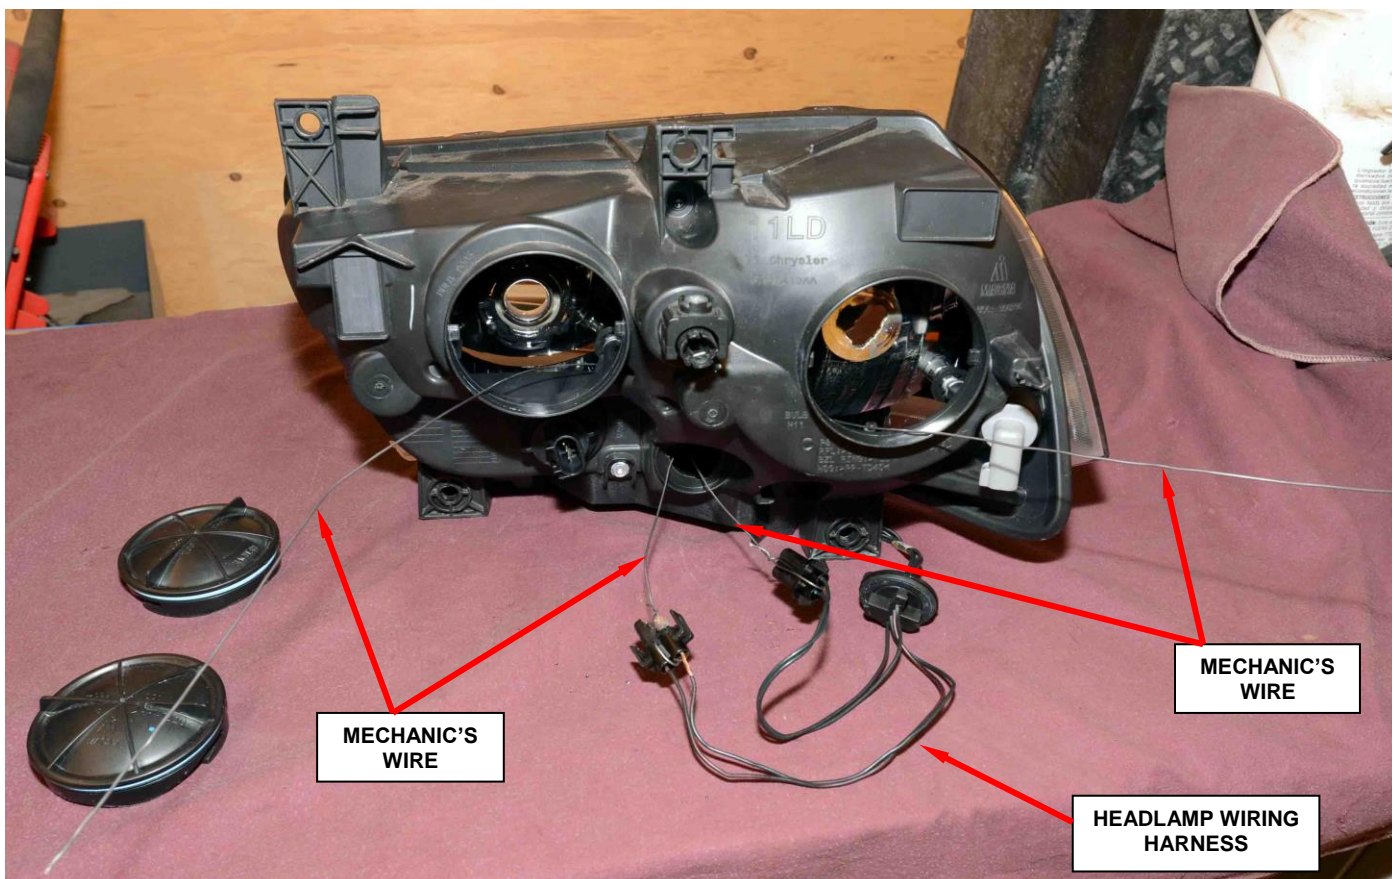
**Figure 4 – Remove Original Headlamp Wiring Harness from Headlamp Assembly**

6. Carefully guide the headlight bulb wiring harnesses out of the headlamp housing with the mechanic's wire attached (Figure 4).
7. Disconnect the mechanic's wire from the original headlamp bulb connectors.
8. Discard the original headlamp wiring harness.
9. Connect the new headlamp wiring harness to the mechanic's wire.

10. Using the mechanic's wire, pull the new headlamp wiring harness into position inside the headlamp housing (Figure 4).
11. Disconnect and save the mechanic's wire from each headlamp bulb connector.

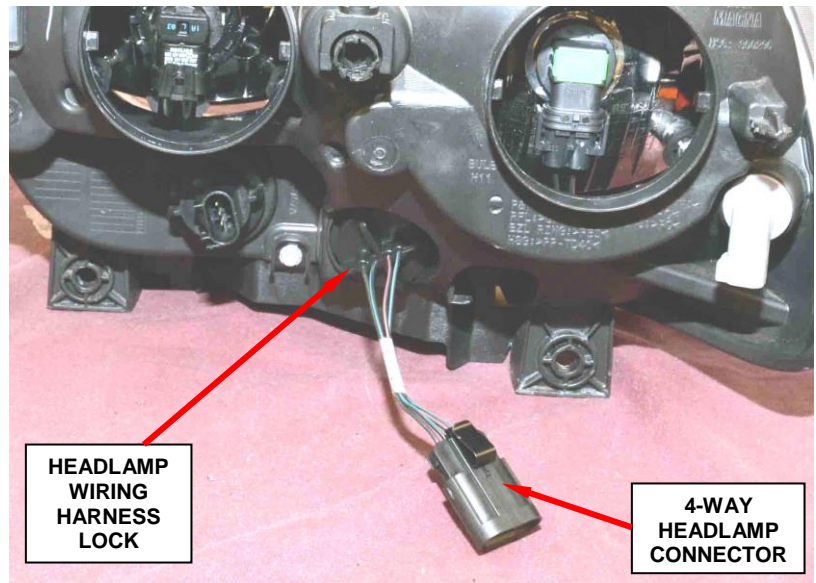
**Figure 5 – Headlamp Wiring Harness Lock**

12. Inspect both low beam bulbs for damage. Replace low beam headlamp bulb(s) if damage or corrosion is found.
13. Install the headlight bulbs into the headlamp harness connectors. Then install the bulb connectors into the headlamp housing.
14. Engage the wiring harness lock into the headlamp housing (Figure 5).
15. Clip the 4-way headlamp wiring harness connector to the headlamp housing (Figure 6).
16. Install the headlamp bulb access covers.
17. Connect the 4-way wire harness connector to the body wiring harness.
18. Repeat Steps 2 through 17 if the other headlamp assembly is undamaged or continue with **Section C. Replace Headlamp Assembly** if headlamp assembly replacement is required.
19. Install the air cleaner housing.
20. Return the vehicle to the customer.

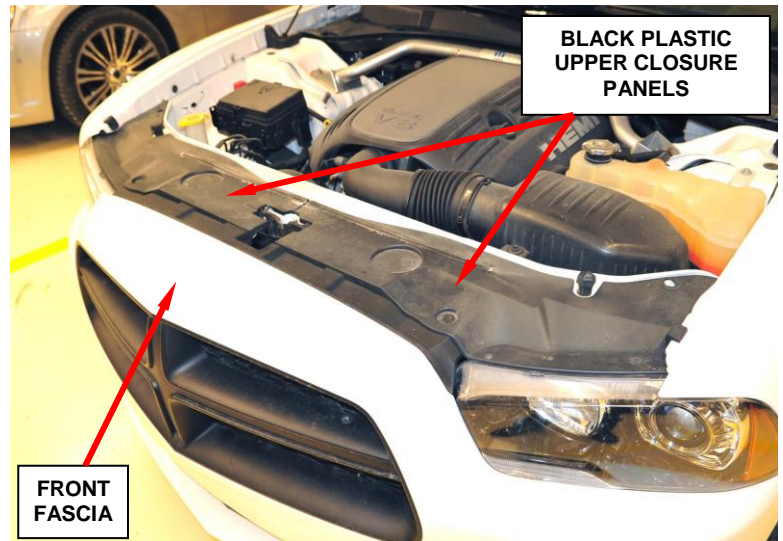
**Figure 7 – Plastic Upper Closure Panels**

1. Open the hood.
2. Disconnect the negative battery cable at the battery.
3. Remove and save the fascia black plastic upper closure panels (Figure 7).

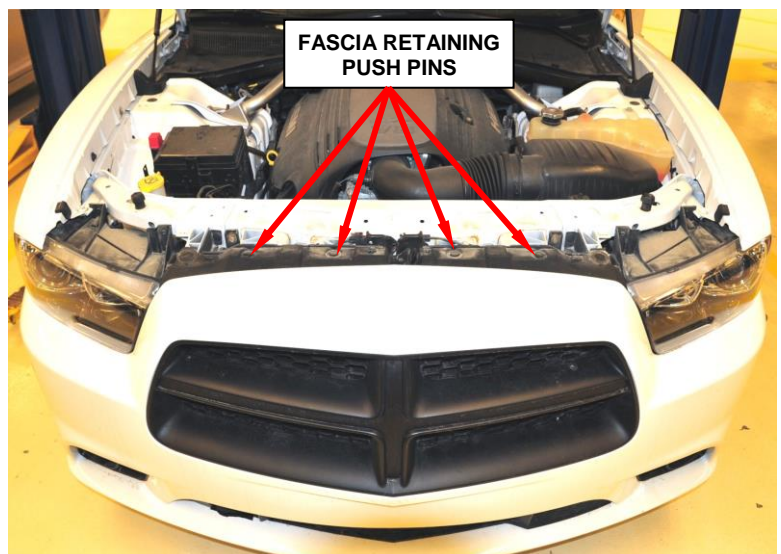
**Figure 8 –Fascia Retaining Push Pins**

4. Remove and save the four fascia retaining push pins (Figure 8).
5. Lift the vehicle on a hoist.
6. Remove and save the engine underbody splash shield.

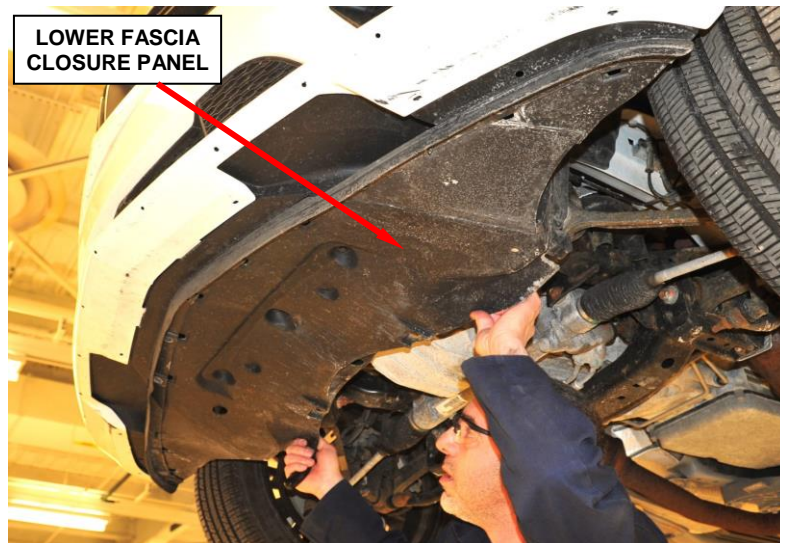
**Figure 9 – Lower Fascia Closure Panel**

7. Remove and save the lower fascia closure panel (Figure 9).

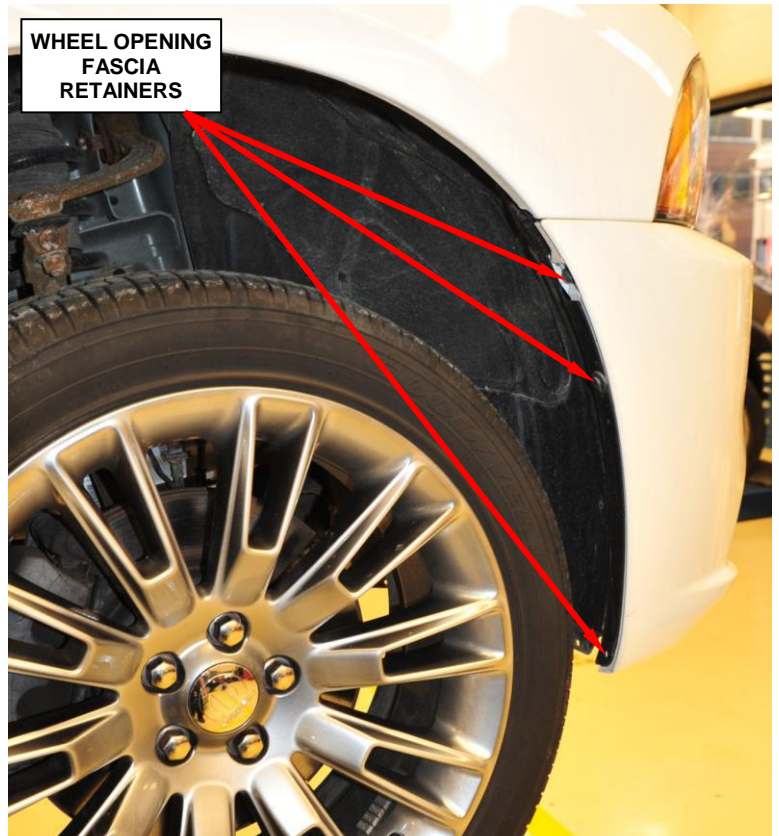
**Figure 10 – Wheel Opening Fascia Retainers**

10. Remove and save the right and left side fascia retainers located at the edge of the wheel openings (Figure 10).

17. Install new front right and left side fascia retainer clips (Figure 12).
18. Install the original front fascia into position.
19. Install the right and left side fascia retainers located at the edge of the wheel openings (Figure 10).
20. Lift the vehicle on the hoist.
21. Connect the fog lamp electrical connectors.
22. Install the lower fascia closure panel (Figure 9).
23. Install the engine underbody splash shield.
24. Lower the vehicle.
25. Install the four fascia retaining push pins (Figure 8).
26. Install the fascia black plastic upper closure panels (Figure 7).
27. If removed, install the air cleaner assembly.
28. Connect the negative battery cable to the negative battery post.
29. Return the vehicle to the customer.

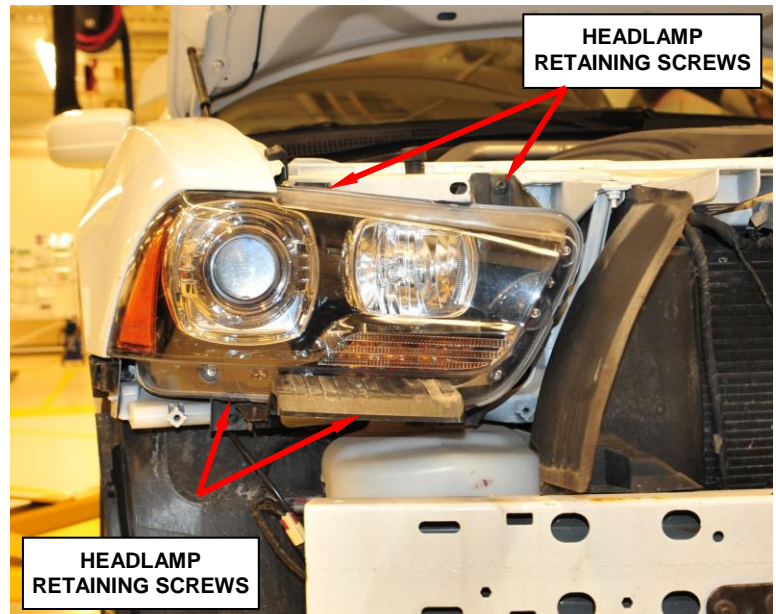
**Figure 11 – Headlamp Retaining Screws**

12. Remove and save the four headlamp retaining screws (Figure 11).
13. Disconnect the headlamp body wire harness electrical connectors and discard the original headlamp assembly.
14. Connect the headlamp body wire harness electrical connectors to the new headlamp.
15. Place the headlamp into position and install the four headlamp retaining screws (Figure 11).

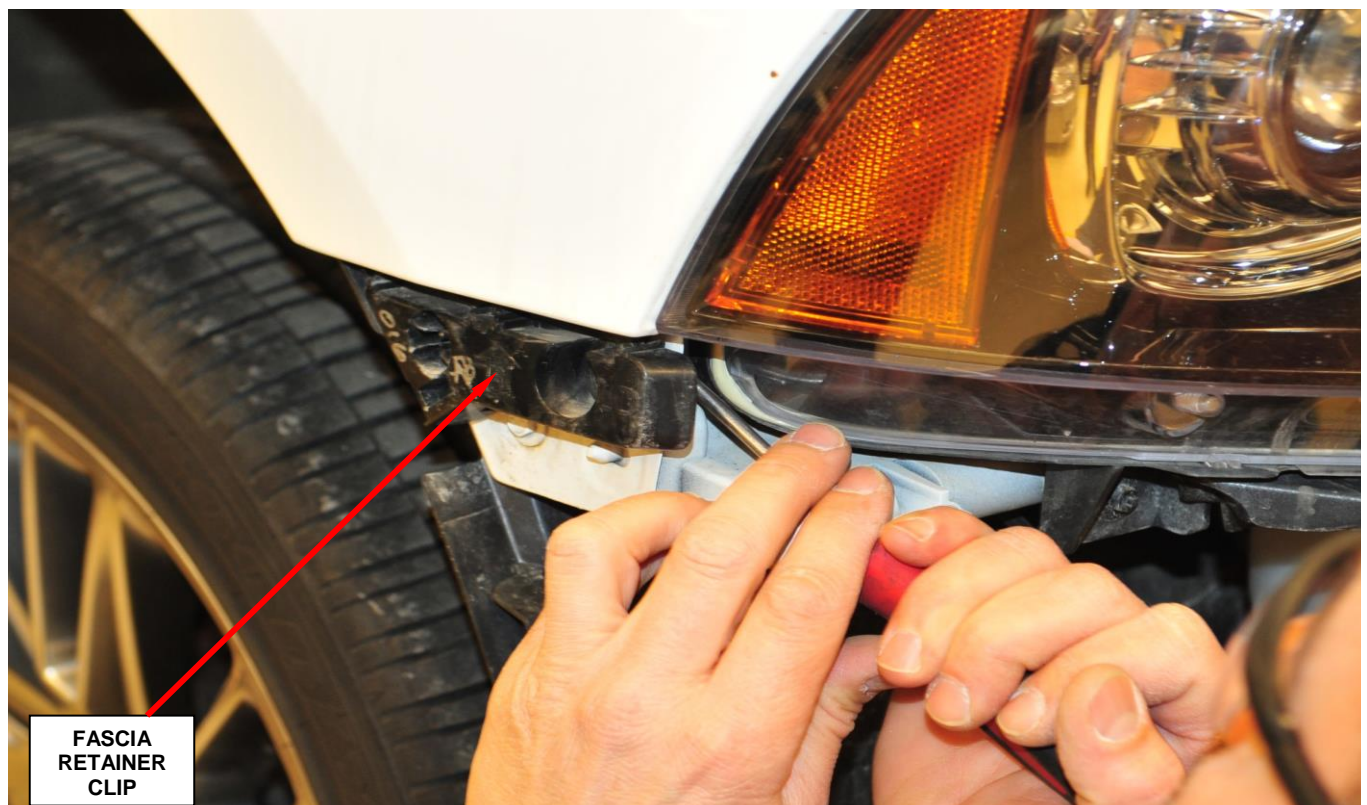
**Figure 12 – Fascia Retaining Clip (right side shown)**

16. Remove and discard the right and left side front fascia retainer clips (Figure 12).
