If there are questions regarding the work procedure:

Section A - Check for Previous Repair

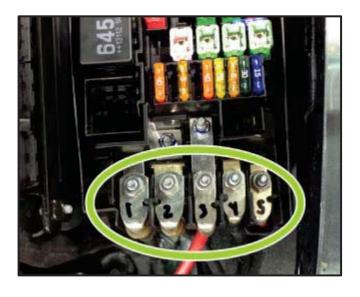
Disconnect battery terminal clamp of Ground (GND) wire <1> from battery Ground (GND) terminal.

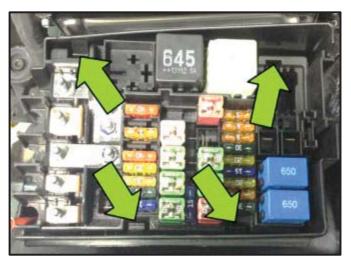
Tip: Using a permanent marker, label the position of the connections as shown <circle> so that they are installed correctly during reassembly.

Loosen and remove the threaded connections <circle> on the E-box.

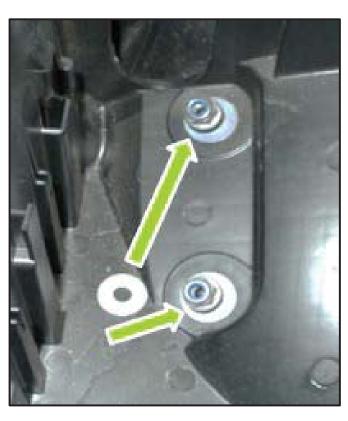
← Remove the two nuts <arrows>.

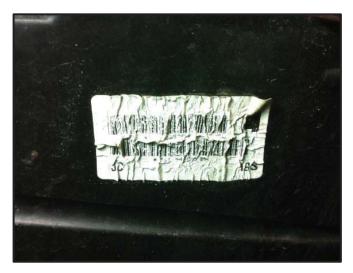
If the Generation Number for both headlights is 24S or higher as shown <circle>, Work Complete, Proceed to Section – Hood Bumper Replacement.

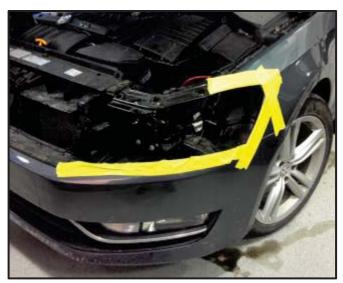
Carefully remove the headlight assembly from the vehicle.

Tip: It may be necessary to pivot the headlight assembly to remove it from the vehicle.

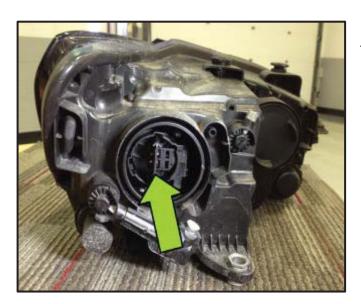
Remove low-beam cover <arrow.

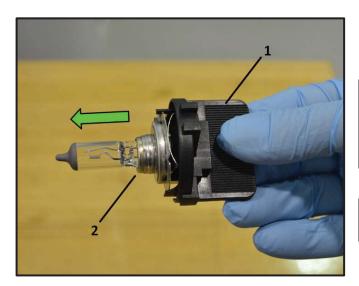
← Remove the low beam headlight bulb retainer <arrow> by turning the retainer to its "keyed" position and sliding outward.

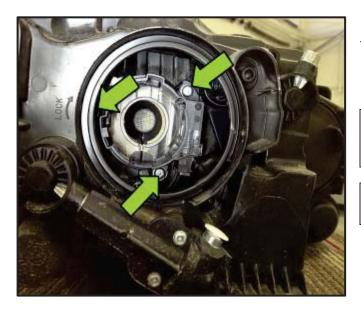
pulling the direction of arrow.

Note: Do not touch the glass of the bulb. Fingers will leave traces of grease on the glass which, when the light is switched on, will evaporate and cloud the glass.

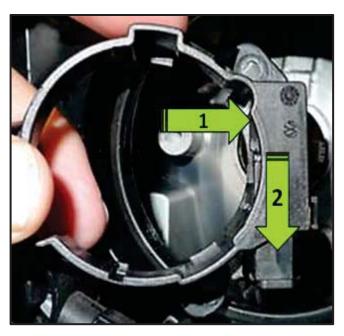
Using a magnetized #1 Phillips screwdriver, remove the three screws <arrows> for the Headlight Socket Retaining Ring and remove ring from headlight housing.

Tip: For better access to the screws, the headlight reflector adjustment can be changed.

Note: DO NOT ALTER LOWER ADJUSTMENT (white cap)!

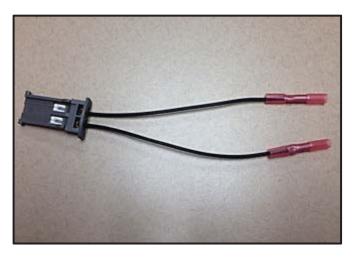
- ← Cut the repair harness from kit 561998109 in half <arrow>.
- Use -VAS 1978/3- wire stripper or equivalent to strip 6mm of insulation from the end of each wire.

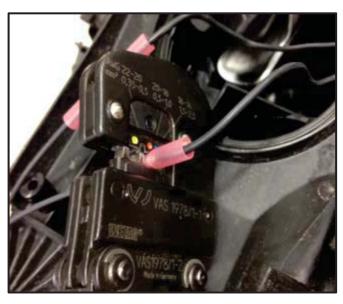
- ← Cut off 10cm of the black wiring harness with the -VAS 1978/3- or equivalent side cutting pliers <as shown>.
- Set the -VAS 1978/3- wire stripper to 6mm and strip insulation from the end of each wire.

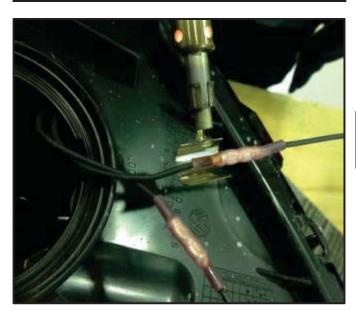
← Set up the UTI-100SI Ultratorch tool or equivalent from the -VAS 1978B- wire harness repair kit <as shown>.

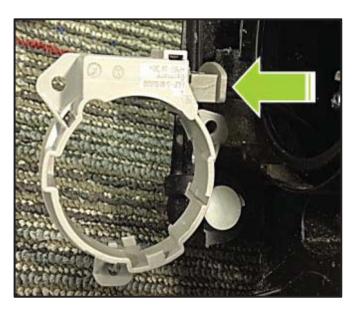
← Reinstall protective cover <arrow> and turn headlight over.

Note: Ensure proper seating of the cap to prevent water entry into the headlight.

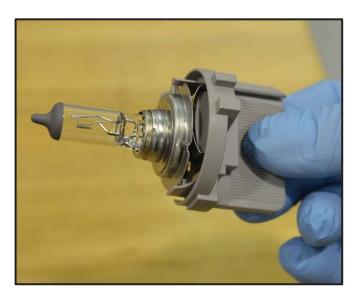
Install retaining ring into headlight and reinstall the three screws <arrows>.

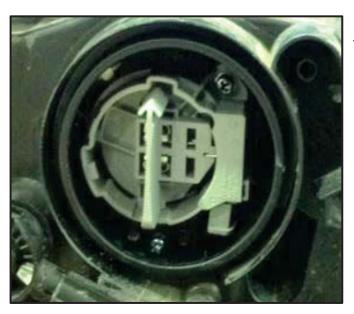
Reinstall the bulb onto the new retainer from kit 561998109 <as shown>.

Ensure that the bulb socket is properly seated and locked into the headlight housing.

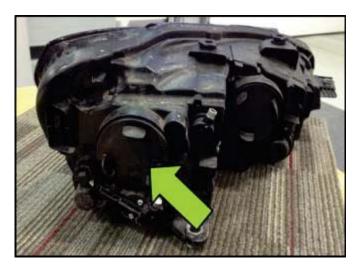
Install bulb retainer assembly into headlight by locking into position as shown <left>.

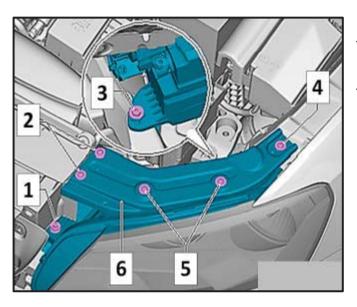
- Carefully reinsert the headlight assembly back into the vehicle.
- Loosely install all headlight mounting screws.
- Remove protective tape from body panel while headlight assembly is loose.
- Position the headlight to properly align with the bumper and fender <arrows>.

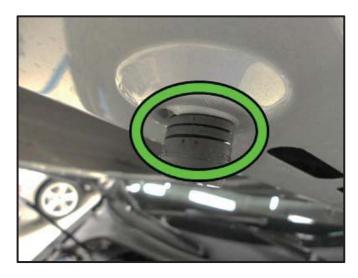
Remove the hood bumpers <arrows>.

Note: In the following step the two rearward mounted hood bumpers <arrows> are replaced and adjusted. The remaining hood bumpers <circles> remain untouched during this procedure.

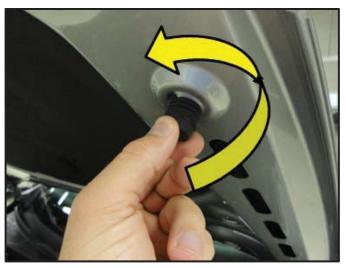
- Install replacement hood bumpers p/n 8T0 827 249.
- Adjust each new hood bumper so that 2 to 3 threads are visible <circle>.

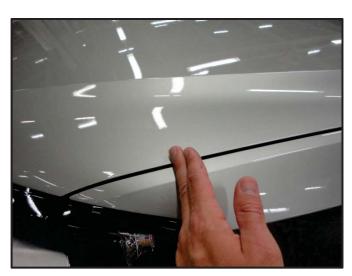
- Attempt to pull the paper out from under the hood bumper <arrow>.
- If the paper cannot be removed when pulled with low force, solid contact between the hood bumper and the contact point is made.
- If the paper slides out easily re-open the hood, adjust the bumper an additional ¼ turn out, then retest the adjustment using the paper.
 Repeat this step as necessary until proper contact is made.

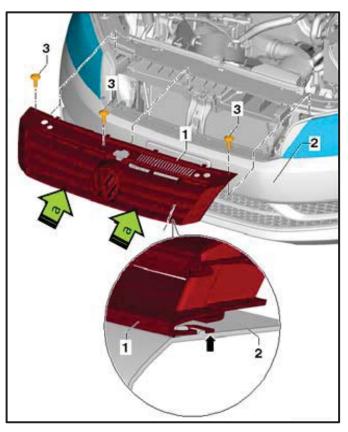
- ← Carefully reinsert the radiator grille <1> parallel into the retainers <arrow> on the front bumper cover <2> in <direction of arrow a>.
- ← Reinstall bolts <3>.
