ATB 51310 (1404)

Safety Recall: 2014 Odyssey Right (Passenger's) Side Curtain Airbag**AFFECTED VEHICLES**

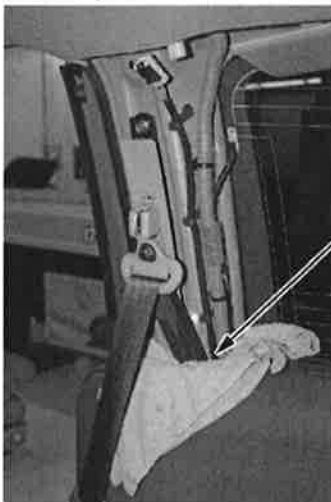
NOTE: If the terminal falls into the opening, **make sure that you retrieve it** by removing the rear trim panel. Do not leave the terminal in the vehicle where it may cause a rattle or fall into the seatbelt retractor.

Block this opening.

10. Before removing the shorting terminal, place clean shop towels in the opening at the top of the rear trim and C-pillar to prevent the shorting terminal from falling into the opening.

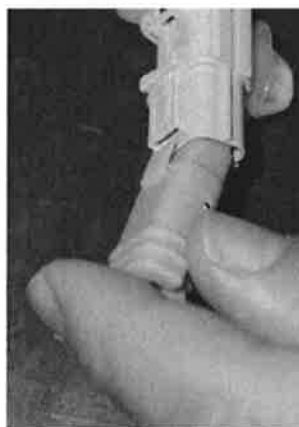
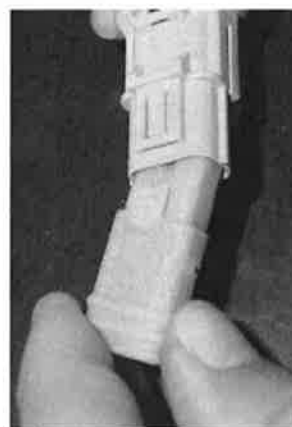
NO GOOD

- Use only the included removal tool to remove the terminal. Do not modify the tool or use any other shop tools to remove the shorting terminal.
- Make sure the tool goes in straight. Do not insert it at an angle.

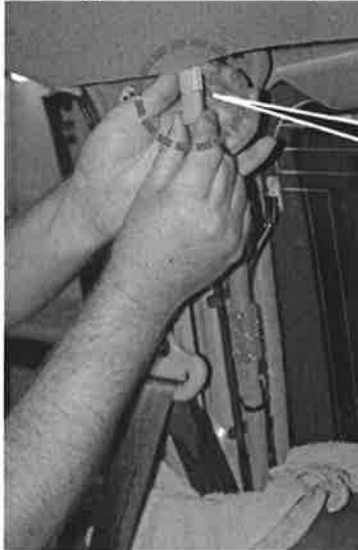
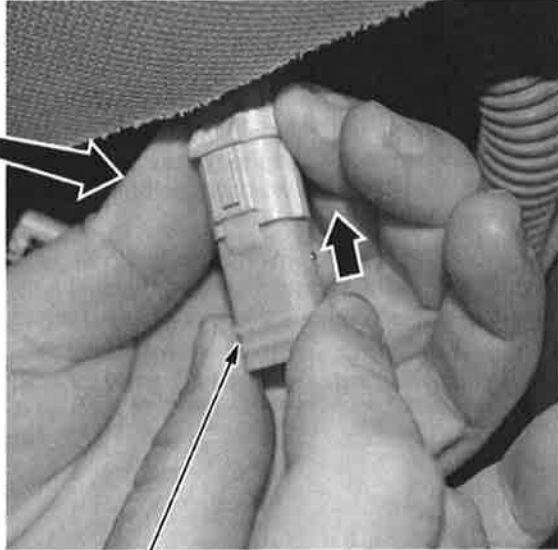
SHORTING TERMINAL REMOVAL TOOL

- Do not press or squeeze the button when inserting the tool.
- The tool does not “click” when it is properly inserted.
- The tool is designed to be used only once. Make sure you use a new tool for each vehicle repair.

Once the tool is inserted, press and hold the button, then pull the tool straight out of the connector.

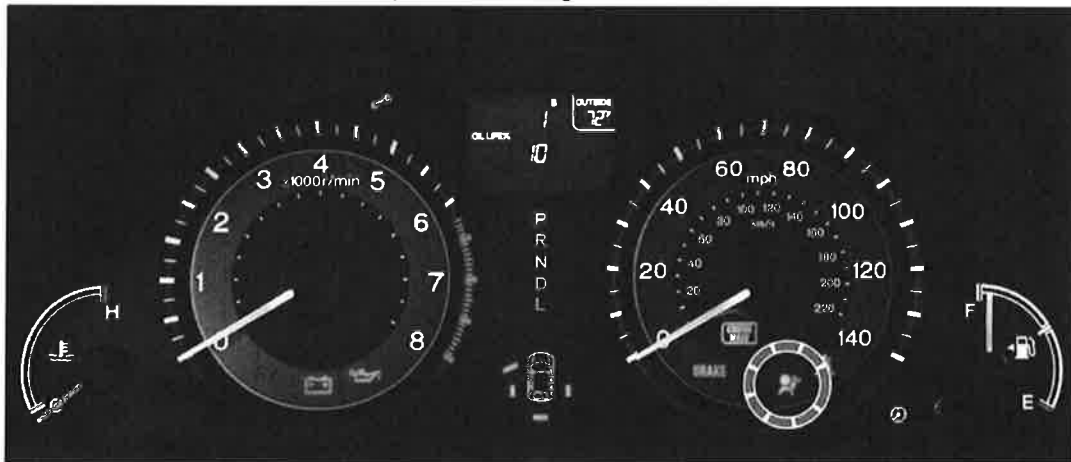
- If the SRS indicator comes on for about 6 seconds and then goes off, go to step 21.
- If the SRS indicator stays on, use the HDS to check for DTCs. If there are any DTCs related to the right side curtain airbag, install the service connector and replace the airbag.

20. Confirm that the SRS works properly by turning the vehicle to the ON mode, and making sure that the SRS indicator comes on for about 6 seconds and then goes off.
