April 4, 2014ATB 51310 (1404)

Safety Recall: 2014 Odyssey Right (Passenger's) Side Curtain Airbag

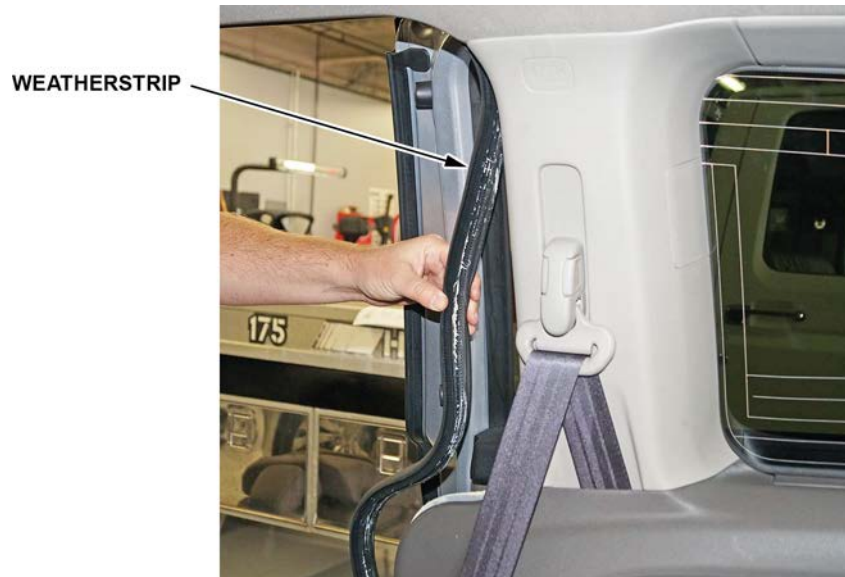
4. Remove the right sliding door weatherstrip as needed so that you can remove the C-pillar trim.

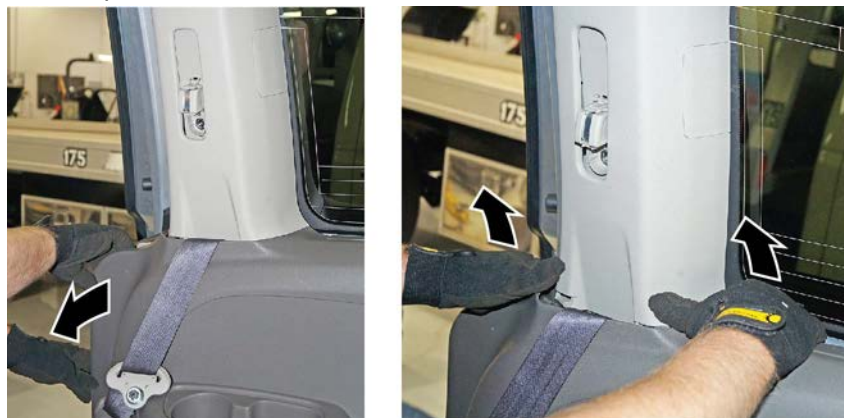
5. To release the hooks from the bottom of the C-pillar trim, pull out the front upper edge of the right rear panel by hand, and pull it back to release the clips.

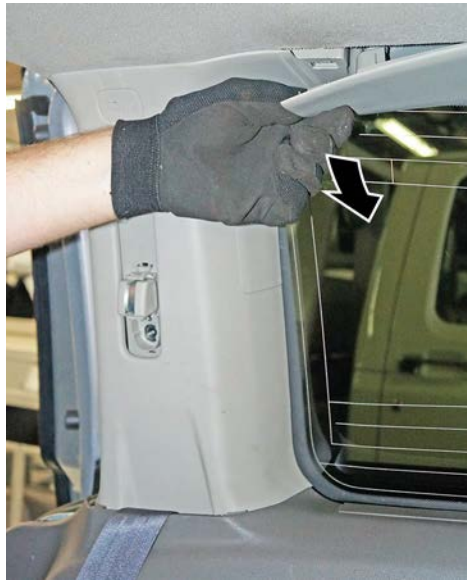
6. To release the top part of the C-pillar trim, pull down on the D-pillar trim until you can release the hooks and detach the clip.

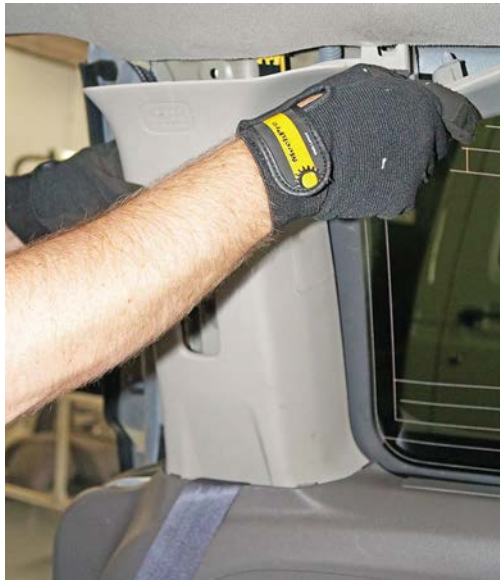
8. Pull back the C-pillar trim to detach the clip, then remove the trim.

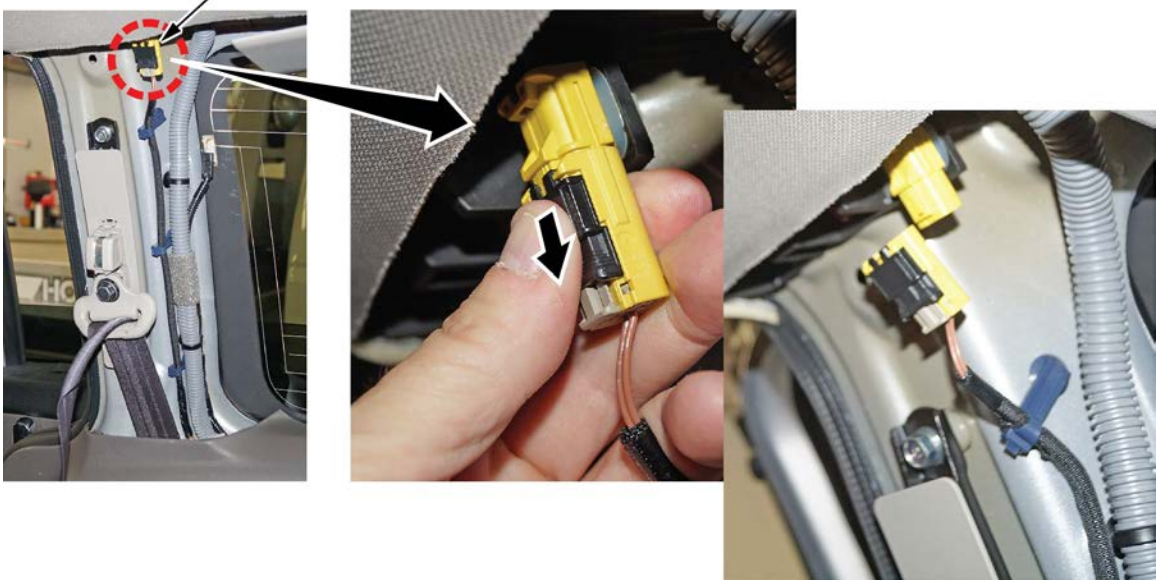
**SIDE CURTAIN AIRBAG
INFLATOR 2P CONNECTOR**

9. Disconnect the side curtain airbag inflator 2P connector. To do this, pull the spring-loaded lock all the way back while holding the opposite half of the connector, then pull the connector halves apart. Make sure to pull the lock all the way back, or the connector will be difficult to disconnect.

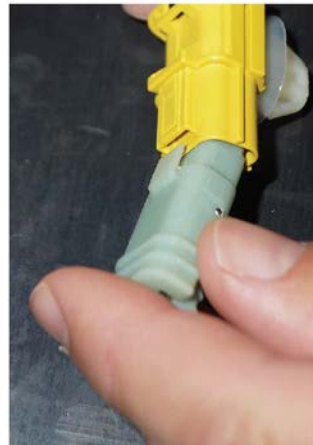
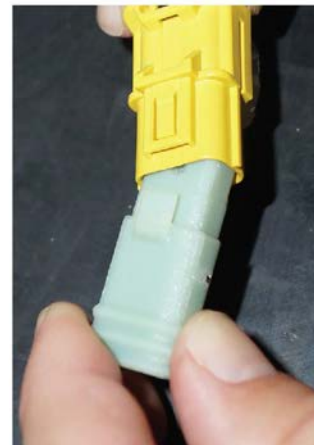
NO GOOD

- Use only the included removal tool to remove the terminal. Do not modify the tool or use any other shop tools to remove the shorting terminal.
- Make sure the tool goes in straight. Do not insert it at an angle.

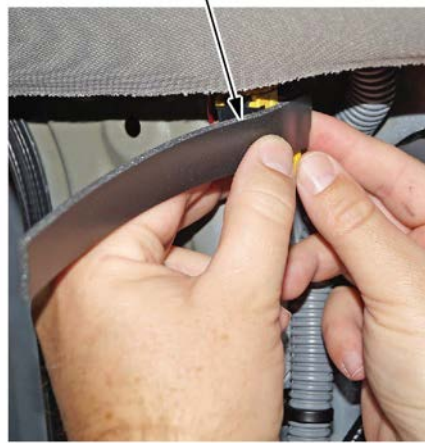
Wrap the two connectors with the provided cushion tape.

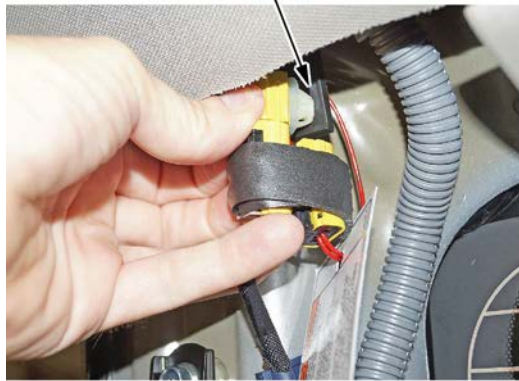
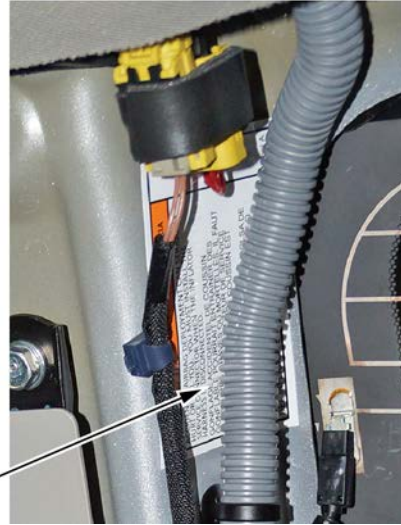
- Make sure the wire loop is beyond the mounting hole so that when you reinstall the airbag connector to the bracket, the service connector cannot fall off the bracket and become lost.
- Make sure the service connector and wire do not interfere or touch other components that may cause a rattle or other noise when the C-pillar trim is re-installed.
- Make sure the side of warning label with the writing on it faces away from the vehicle frame so that the information is easily visible if the right side curtain airbag is serviced in the future.

Reclip the assembly back into the bracket.

Position the label facing out.

18. Reinstall the right side curtain airbag connector clip to the mounting bracket.

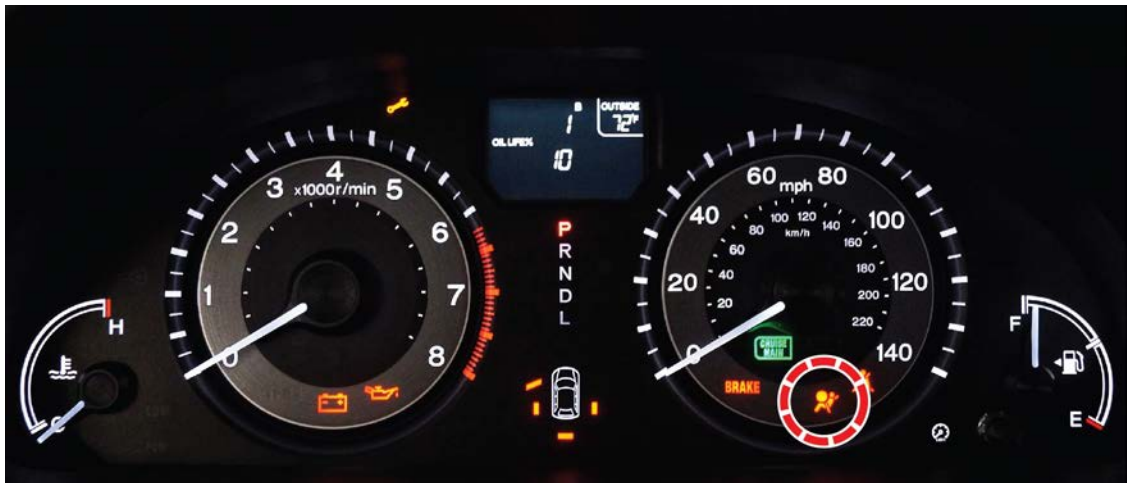
20. Confirm that the SRS works properly by turning the vehicle to the ON mode, and making sure that the SRS indicator comes on for about 6 seconds and then goes off.

- If the SRS indicator comes on for about 6 seconds and then goes off, go to step 21.
- If the SRS indicator stays on, use the HDS to check for DTCs. If there are any DTCs related to the right side curtain airbag, install the service connector and replace the airbag.

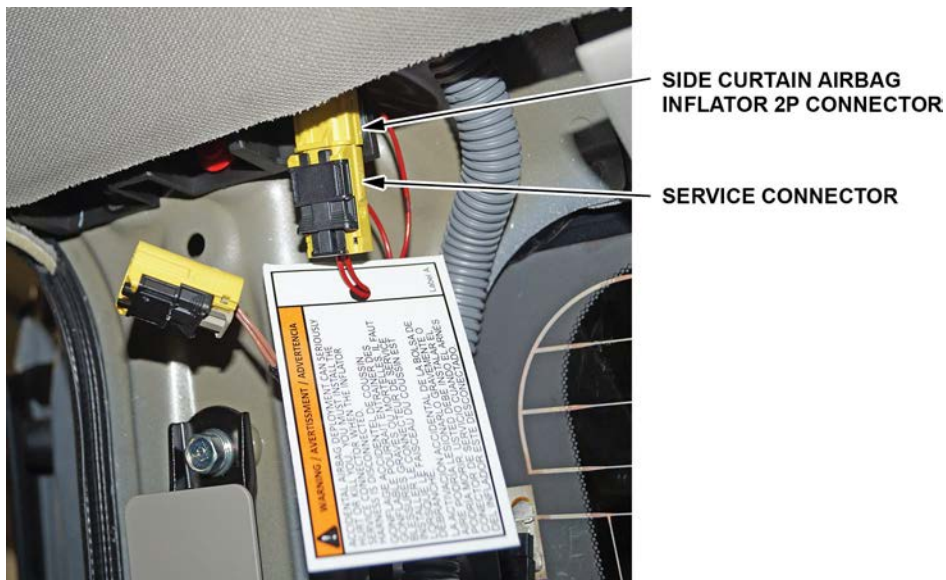
HOW TO USE THE SERVICE CONNECTOR

If you are working on a side curtain airbag and you see the warning label and the service connector attached to the airbag connector, make sure you install the service connector to the airbag side of the side curtain airbag connector after you disconnect it.

NOTE: Always install the service connector when working on the side curtain airbag to prevent it from inadvertently deploying. Not all Odyssey models will have a service connector installed; only vehicles affected by this campaign will have one.
