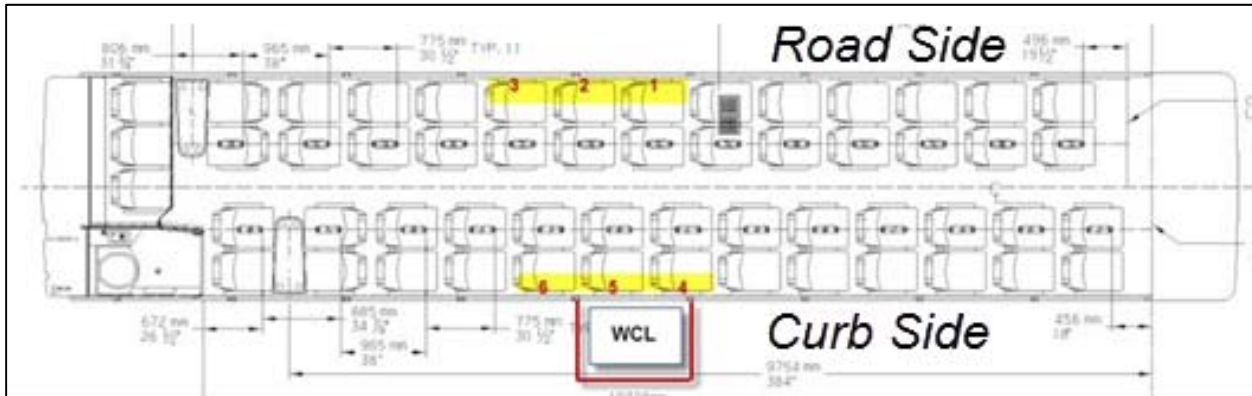
Figure 2

The outboard (wall side) seat belt anchor of all flip-up seats must be inspected for damage. (fig 2 & 3).

**Note:** the damage to the belt can sometimes be hard to see. Use a flash light, if necessary and expose the underside of the belt that is located in and around the anchor loop.

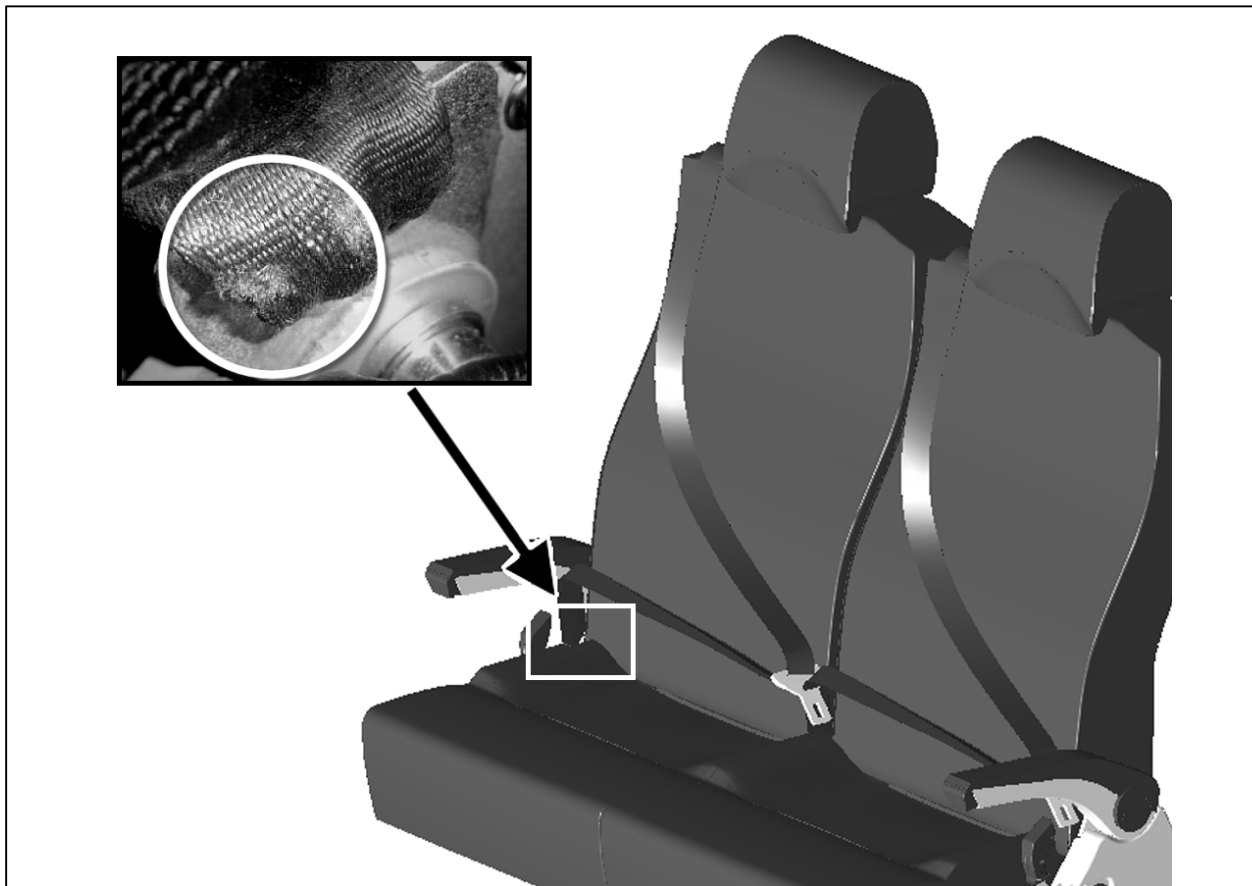
Figure 3: Typical belt damage (Curb side seat)

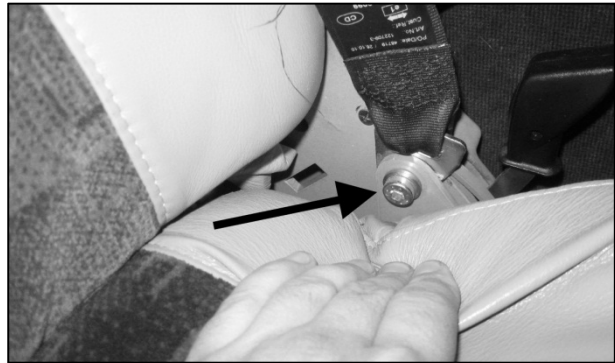
Two bolts, left and right. Remove wall side seat belt anchor (fig 4)

Figure 4 seat pivot and belt anchor (Road side)

12. Re-install cushion assembly.(Fig 4)

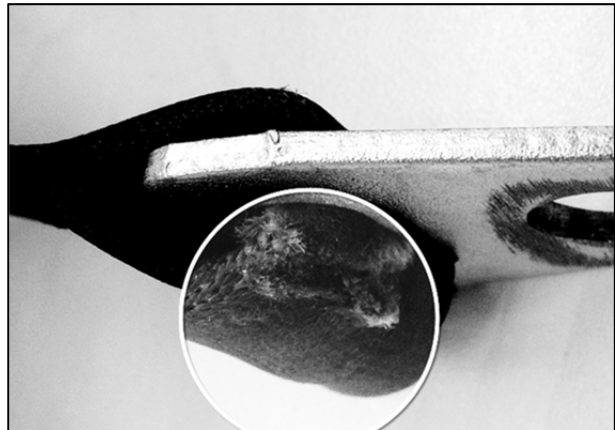
If it is damaged (Fig 5), replace with a new belt.

Figure 5: Typical Damaged belt

For Torino G models, order kit SR14-26-1.

For A210 models, order kit SR14-26-2.

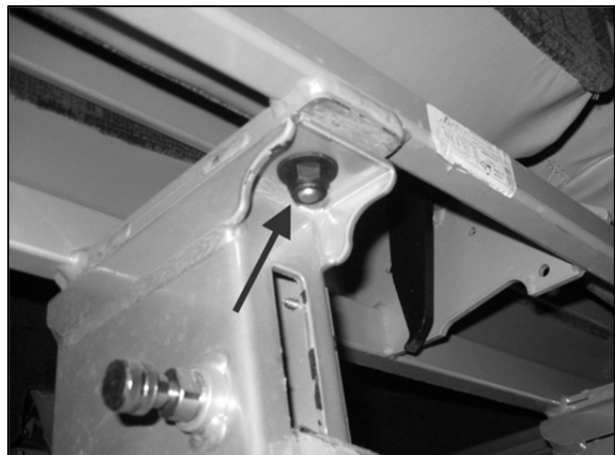
Front nuts are readily accessible.(Fig 6)

Figure 6 Front nuts.

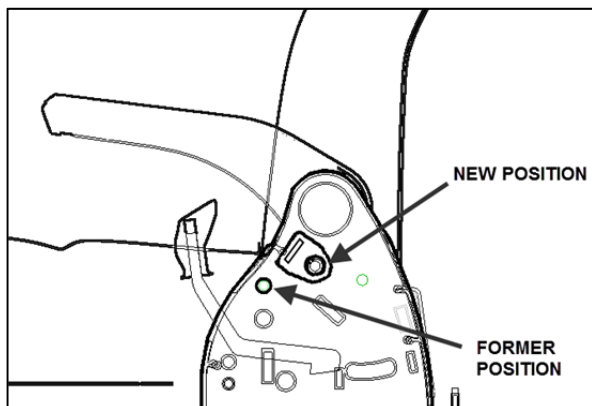
7. Re-install belt anchor in new location as shown, away from pivot. (Fig 10 & 11)

Figure 10: New position of belt anchor.

8. Belt anchor plate should be installed parallel to seat frame.

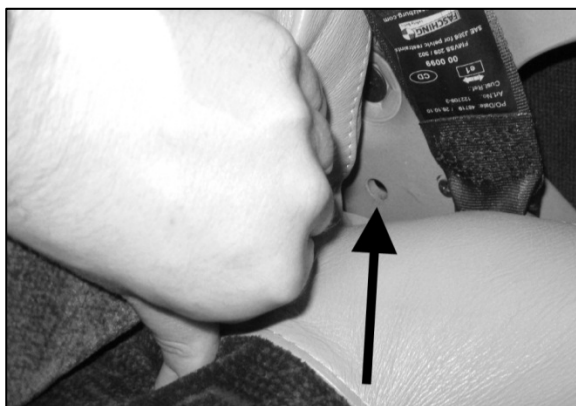
Figure 11: New position

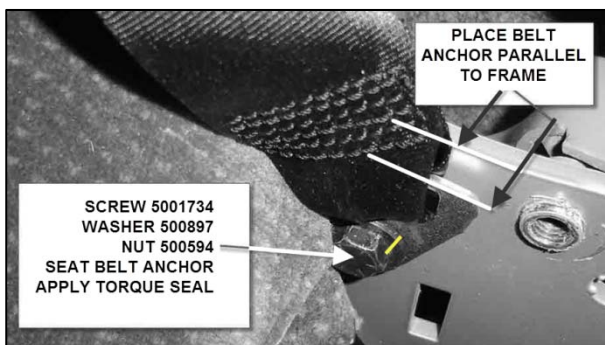
Apply torque seal mark to confirm belt relocation. (Fig 12)

Figure 12: New hardware and torque seal

Install with:  
5001734 Screw  
500897 Washer  
500594 Nut

**Tighten to:35 lbf-ft**

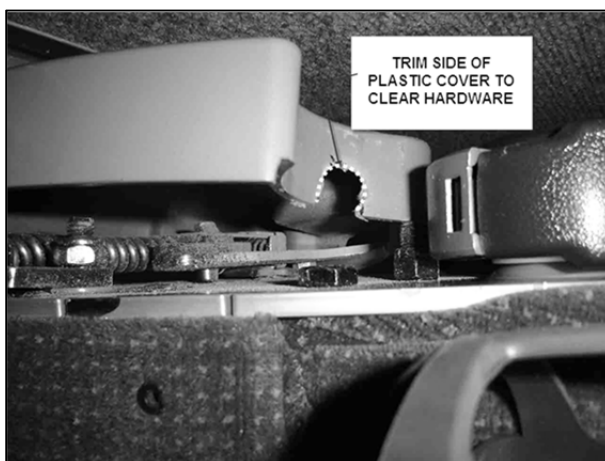
Figure 13

9. Plastic cover must be cut to provide clearance for new hardware.(Fig 13)
10. Re-install plastic cover
11. For road side seats: reinstall seats on pedestals
