## SERVICE PROCEDURE

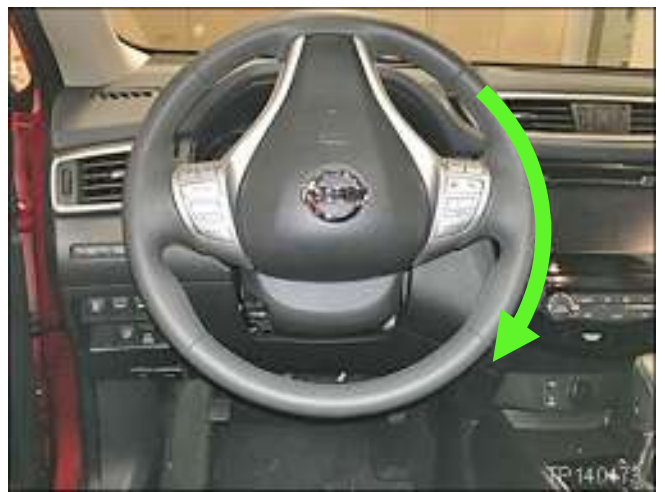
Figure 1

1. Place the vehicle in a level working area.
2. Turn the ignition OFF / not Ready.
3. Set the parking brake.
4. Rotate the steering wheel 180° from center (see Figure 1).

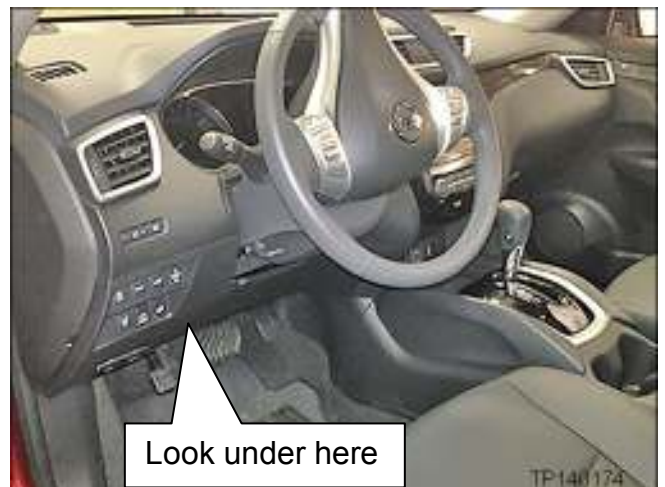
Figure 2

5. Locate the upper steering column bolt as follows:
  - a. Look directly UP from under the lower instrument panel LH (see Figure 2).

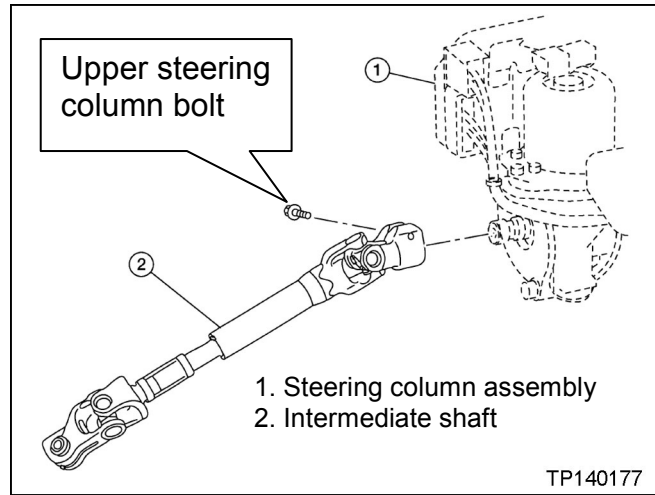
Figure 3

b. Locate the upper steering column bolt.

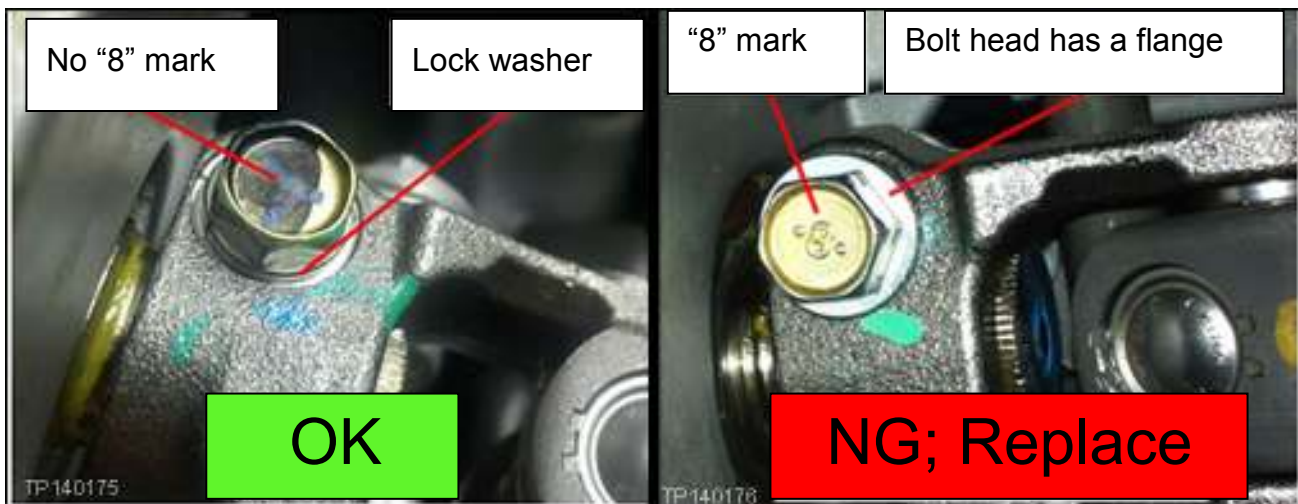
Figure 4

4. Inspect the upper steering column bolt; identify the bolt as **OK** or **NG** as shown in Figure 4.

**OK:** Procedure is complete.

**NG:** Replace the upper steering column bolt with the one listed in the Parts Information.

- Torque bolt to 31 N·m (3.2 kg-m, **23 ft-lb**)
