# Recall Bulletin

## F/CMVSS NONCOMPLIANCE RECALL

**SUBJECT:** Passenger Airbag Partial Deployment

**MODELS:** 2015 Cadillac Escalade, Escalade ESV

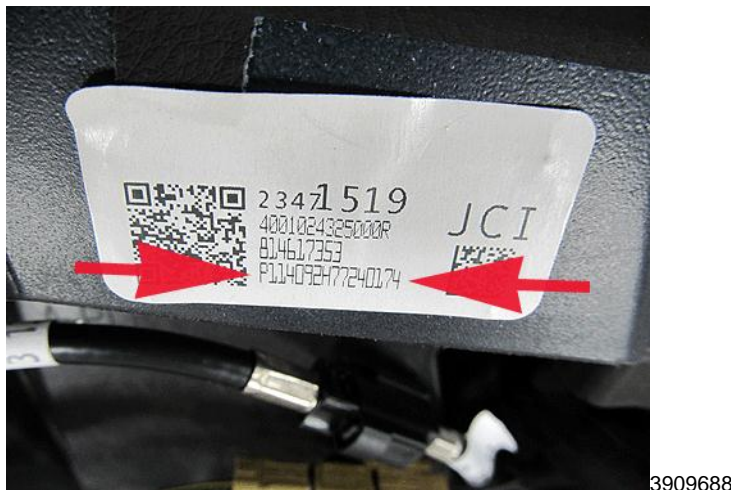
1. Locate the white paper tag on the instrument panel upper trim panel (there are two labels, it is the label toward the center of the vehicle).
2. Compare the last 9 numbers on the label to the Suspect Label Number Table below.
  - If the number does NOT appear on the list, the part is good and can be placed in inventory.
  - If the number IS on the list, DO NOT PLACE IN INVENTORY. Return the parts to GMCC&A using MR Code 7. If the part has been installed it would returned as a warranty return.

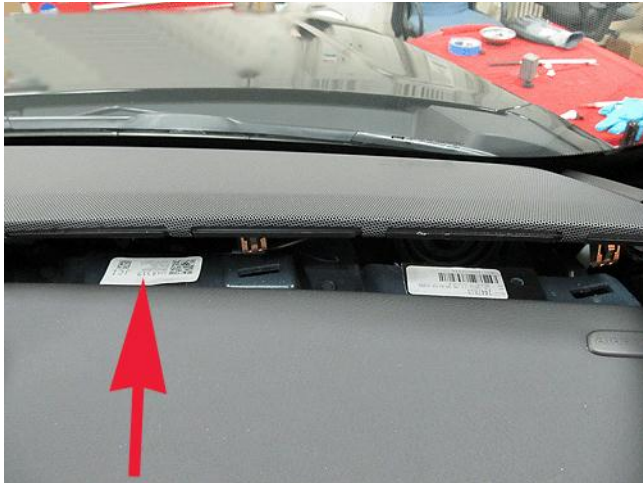
3909687

1. Remove the instrument panel extension. Refer to Instrument Panel Extension Replacement (Cadillac) in SI.

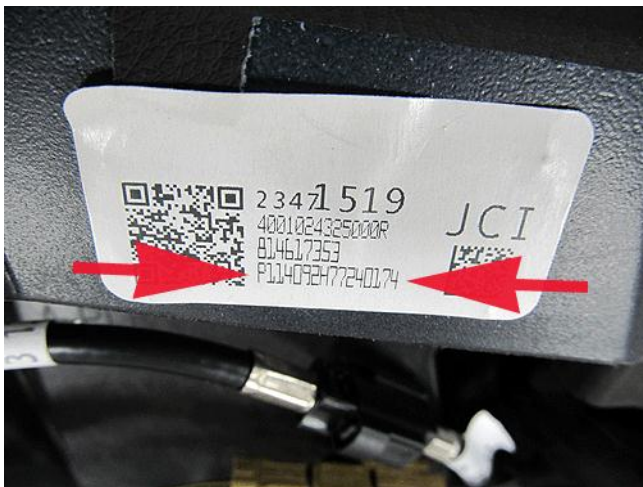
3909688

2. Locate the white paper tag on the instrument panel upper trim panel (there are two labels, it is the label toward the center of the vehicle).
3. Using a digital camera or the camera function on a cell phone, take a clear picture of the label.

4. Compare the last 9 numbers on the label to the Suspect Label Number Table below. The label will appear upside down in the photograph, rotate as required.
  - **If the number does NOT appear on the list**, no further action is required. Reinstall the instrument panel extension.
  - **If the number IS on the list**, return the part to GMCCA and proceed to the Replacement Procedure below.
