SAFETY RECALL E0S

SPARE TIRE CARRIER CABLE REPLACEMENT

2004 – 2011 SIENNA 2WD

UPDATED November 17, 2015

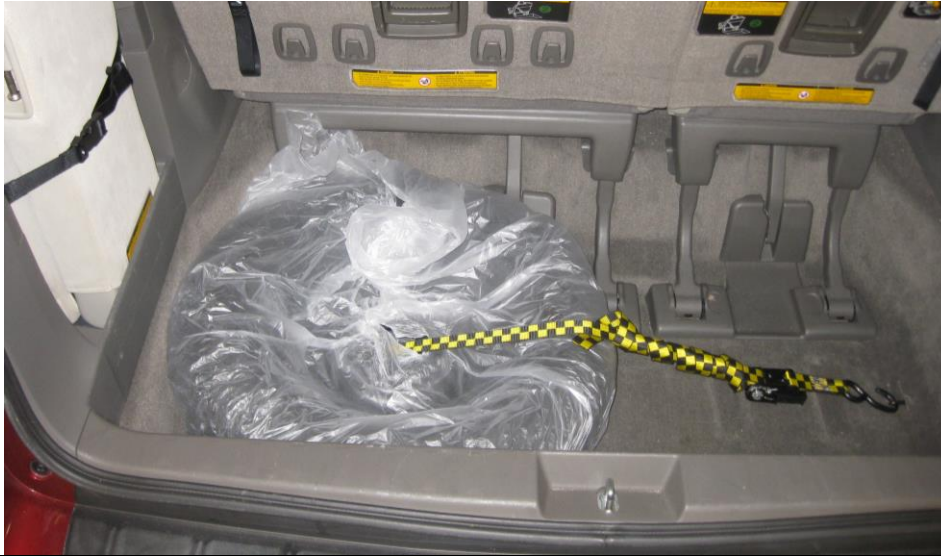
A. REMOVE THE RELOCATED SPARE TIRE

- Remove the ratcheting tie strap securing the spare tire and remove the tire from the cargo area.
- Neatly fold up the tie strap and offer it to the customer after the repair is complete.
- Continue to step V.F.1

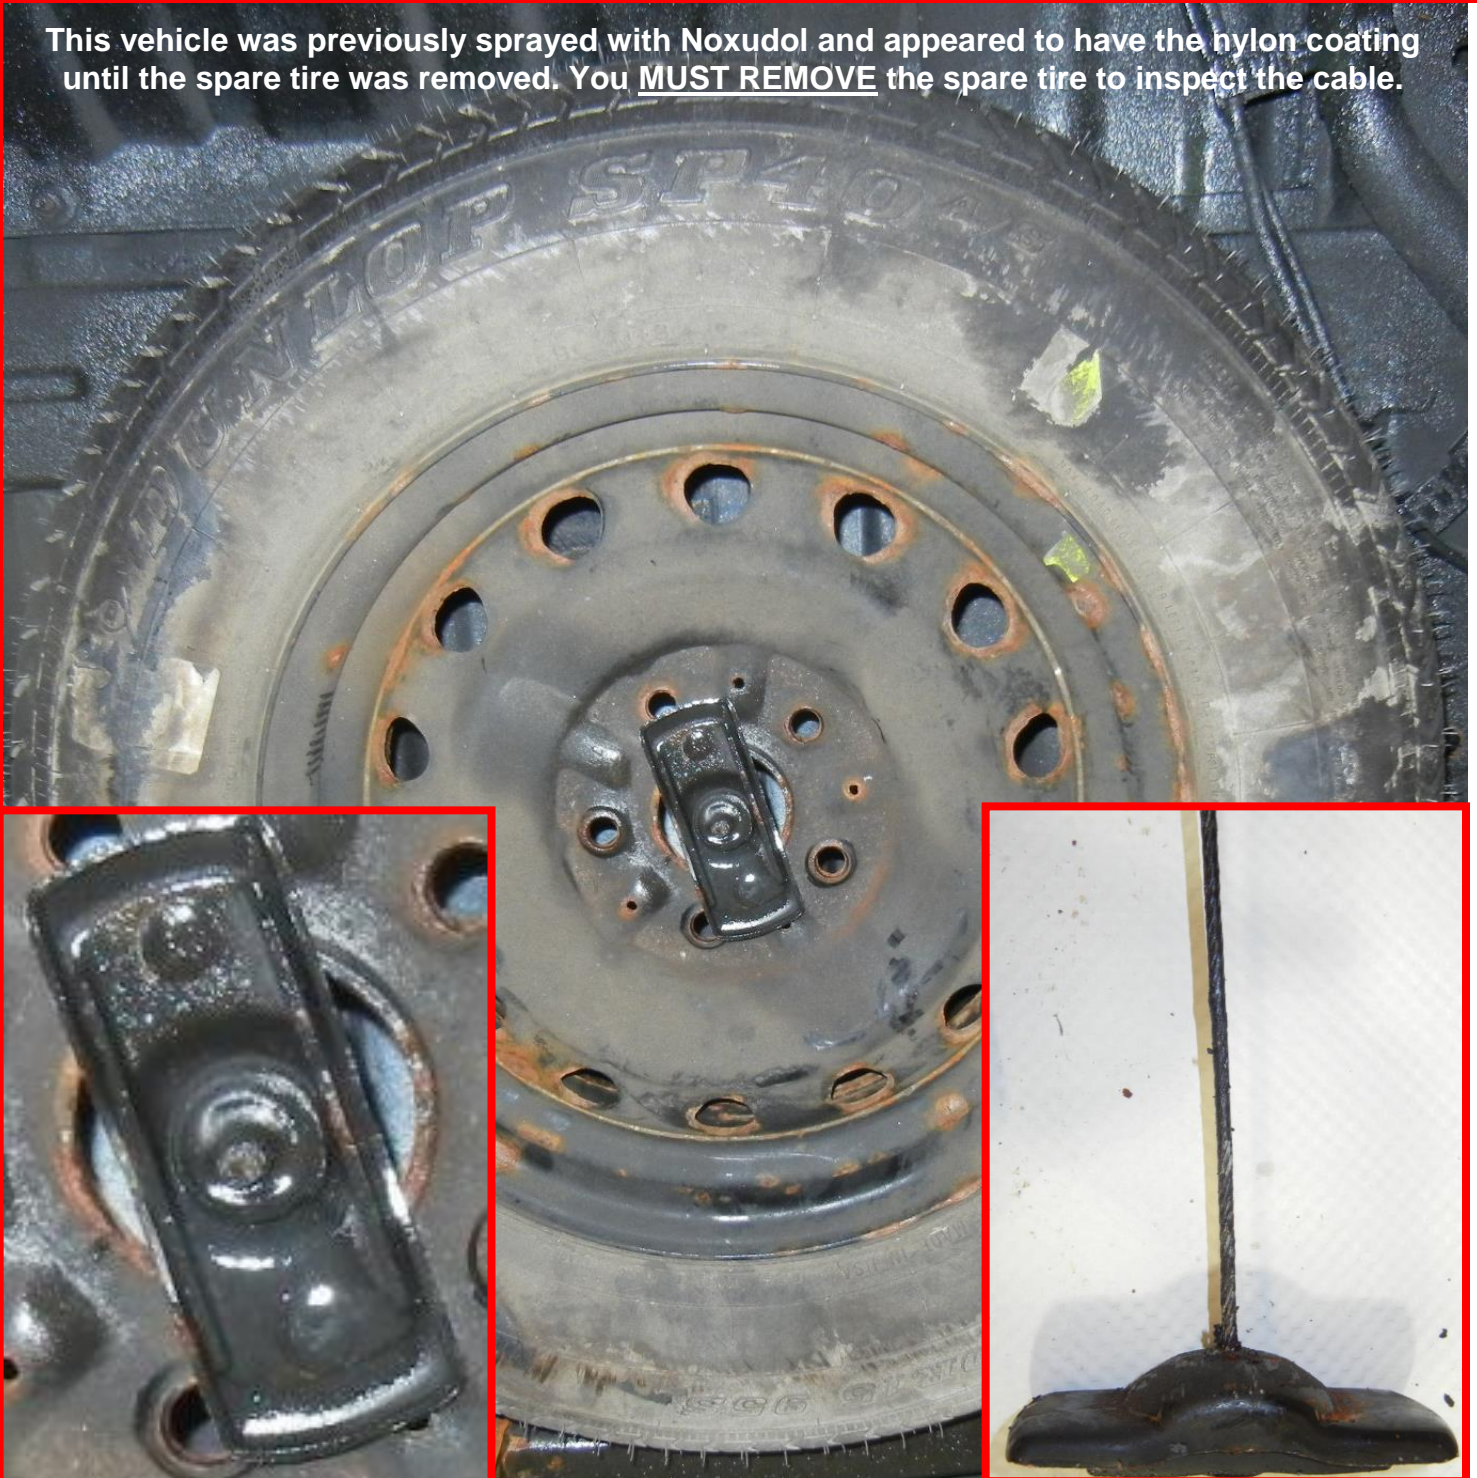
This vehicle was previously sprayed with Noxudol and appeared to have the nylon coating until the spare tire was removed. You **MUST REMOVE** the spare tire to inspect the cable.

- If you are unable to determine if the cable is nylon coated or was previously applied with Noxudol, replace the spare tire carrier.
- A low percentage of spare tire carriers were replaced under Safety Recall A9E, it is anticipated that the majority of spare tire carriers will need to be replaced.

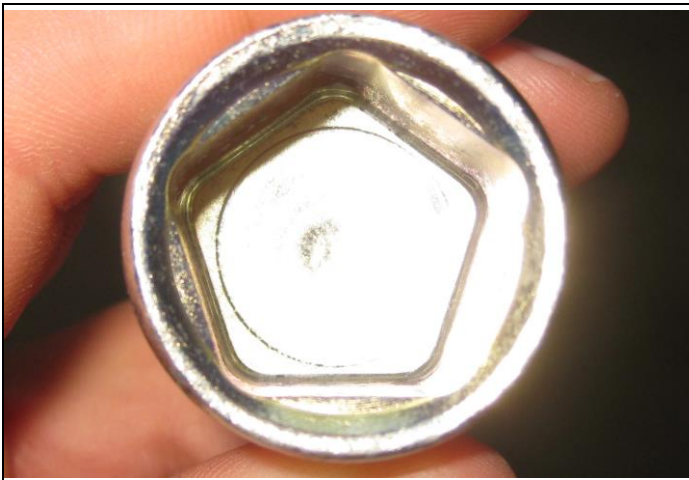
1. INSPECT THE SHAPE OF THE SPARE TIRE CARRIER DRIVE TOOL KIT.

Drive Design	Tool Kit Requirement
Pentagon (5-sided)	Current Tool Kit is Okay
Hexagon (6-sided)	NEW TOOL KIT REQUIRED

Note: The NEW spare tire carrier will come with a pentagon drive nut, so ensure the tool kit in the vehicle will be able to operate the new spare tire carrier.

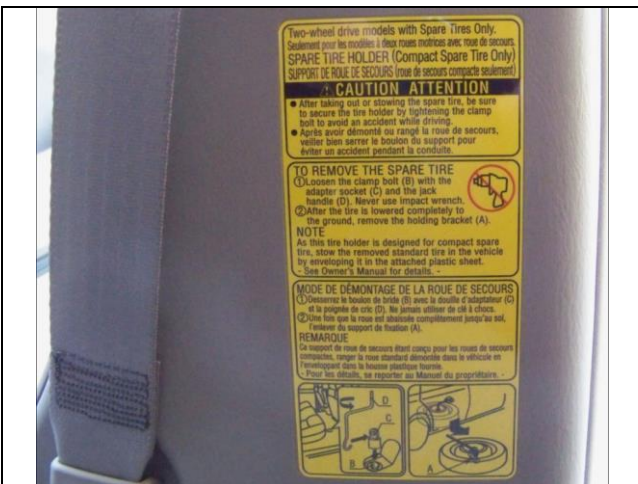
2. INSTALL THE NEW TIRE CARRIER NOTICE LABEL

- Install the new label over the existing label located on the RH "B" pillar.
