TECHNICAL INSTRUCTIONS

SPECIAL SERVICE CAMPAIGN E0R

2nd ROW PASSENGER SEAT FRAME LATCH

2014 MODEL YEAR HIGHLANDER

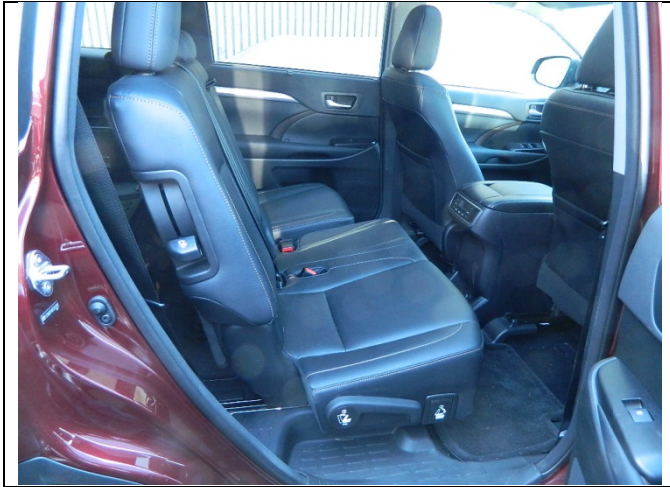
- a) Park the vehicle as follows:
 - Level paved ground
 - Engine off
- b) Slide the front passenger seat fully forward.

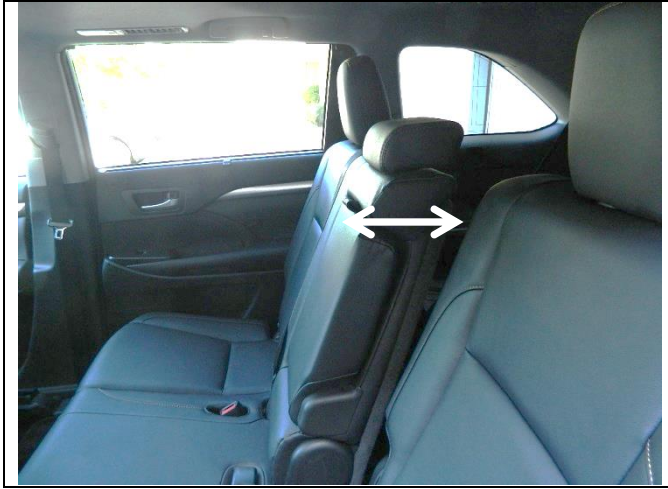
- h) From the right rear door. Using the tape or pencil mark as a reference, push the lower right seat cushion at the inner corner towards the rear until the seat latches.
- i) If the front inner corner of the right seat **MOVES** proceed to step 3.

If the front inner corner of the right seat **DOES NOT MOVE** proceed to step 4.
