PRODUCT CAMPAIGN BULLETIN

APPLICABILITY: 2005-2009 Subaru Legacy and Outback
 2009-2013 Subaru Forester
 2008-2011 Subaru Impreza, WRX, and STI
 2012-2014 Subaru WRX and STI

NUMBER: WQK-47R
DATE: July 2014
REVISED: 03/24/25
NHTSA ID: 14V-311

SUBJECT: Brake Line Corrosion

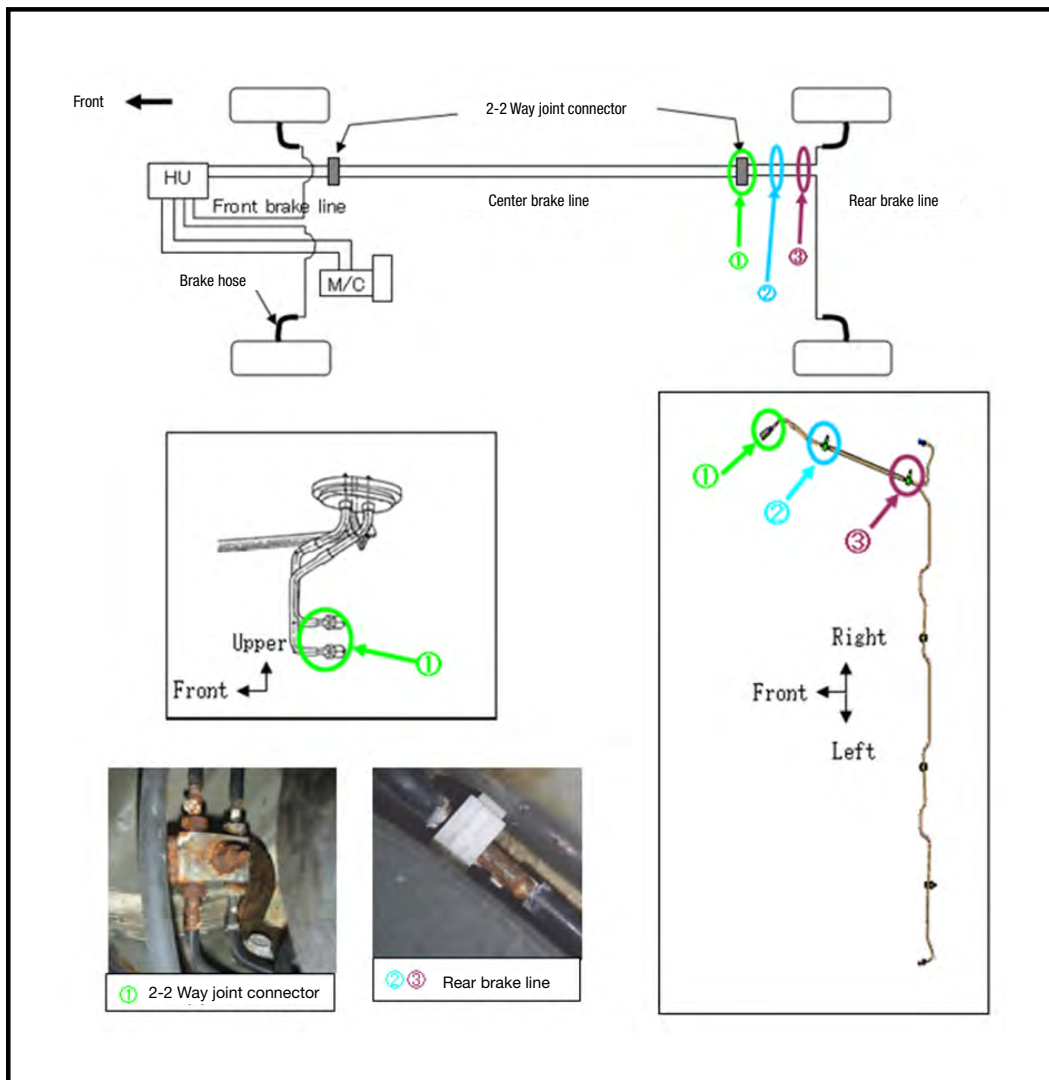
2005-2009 Legacy and Outback

This Campaign involves a close inspection of the steel brake pipes located in the fuel tank area of the vehicle. Corrosion may develop in areas of these brake pipes not protected by a resin cover and eventually perforate them causing brake fluid seepage. If seepage is verified during the inspection procedures, the affected brake piping must be replaced. If no seepage is verified, application of a protective rustproofing wax material to specific sections of the brake piping will be required to complete this Campaign. On Legacy and Outback models, the inspection and rustproofing procedures are all performed through the inspection cover opening on the right-hand (passenger side) of the plastic fuel tank cover. On Impreza and Forester models, the right-hand (passenger side) portion of the plastic fuel tank cover must be removed for access. The following illustrations provide an overview of the affected areas.

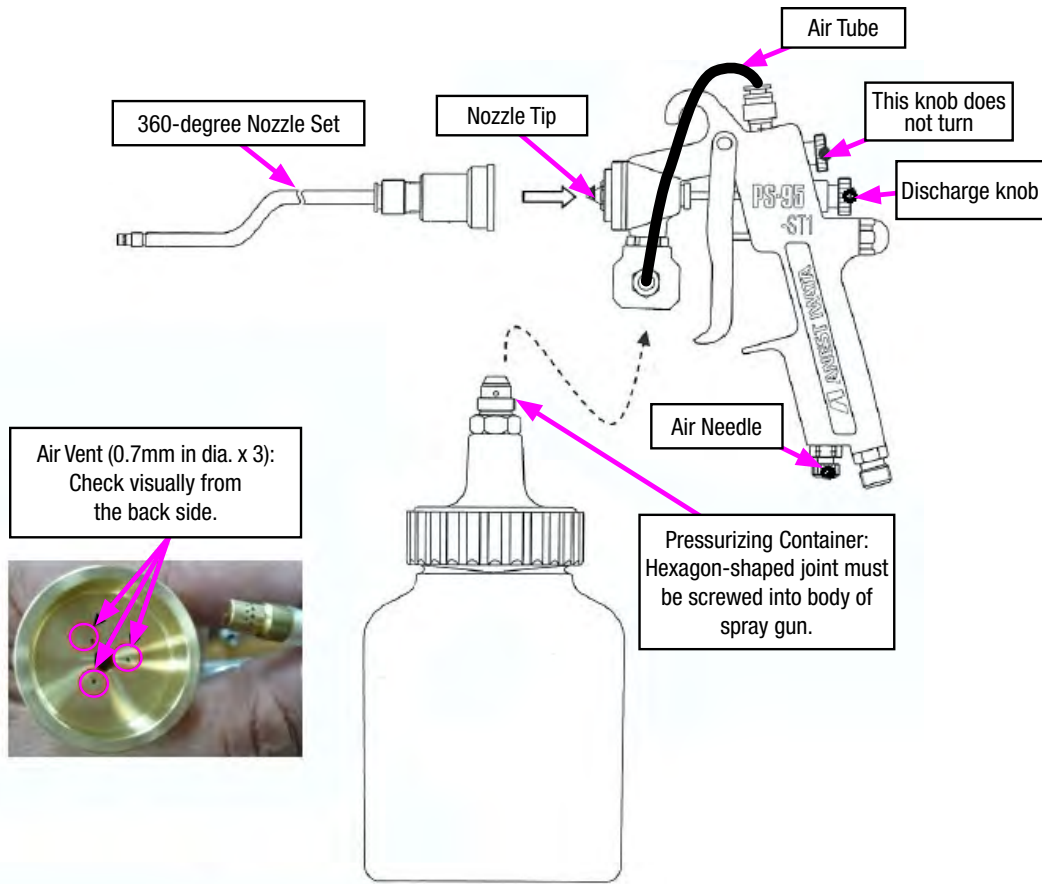
(2-1) Assembling of Spray Gun:

IMPORTANT: Be careful not to damage or deform the nozzle tip.

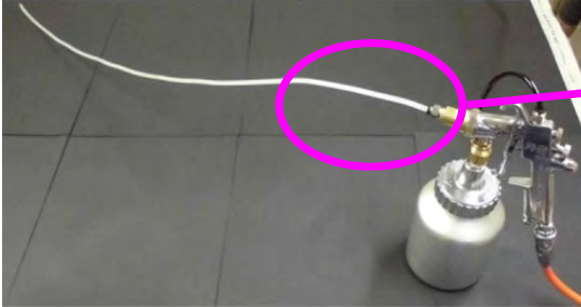
After operation

Close the discharge knob then clear the residual wax in nozzle with air pressure and wipe the tip clean.

Residual wax visible inside nozzle

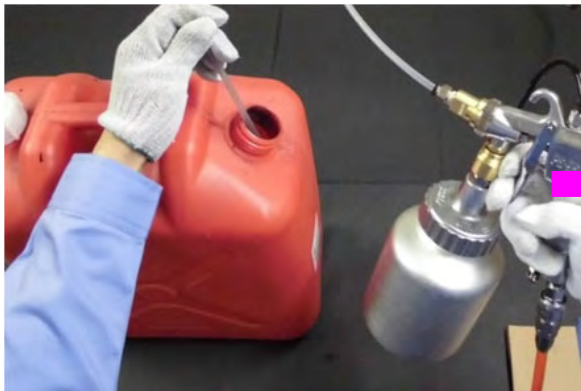
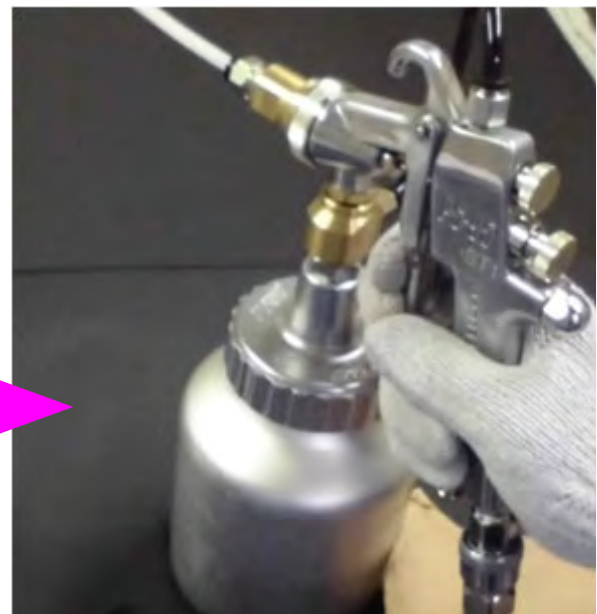
Pull the gun trigger half way and hold for about 20 seconds until the tip is clear.

Confirm the nozzle and tip are clear.

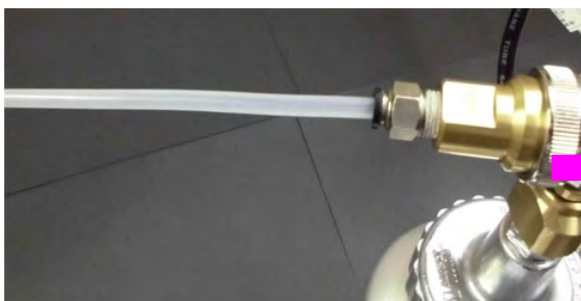
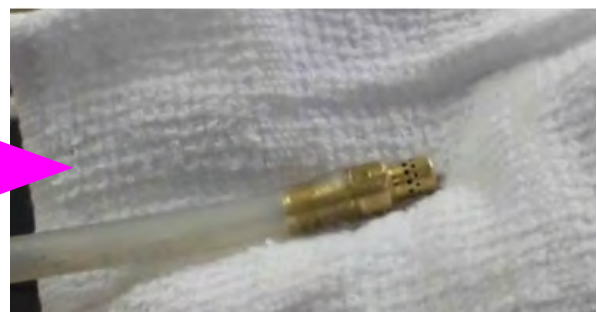
Wipe the tip with a clean cloth.

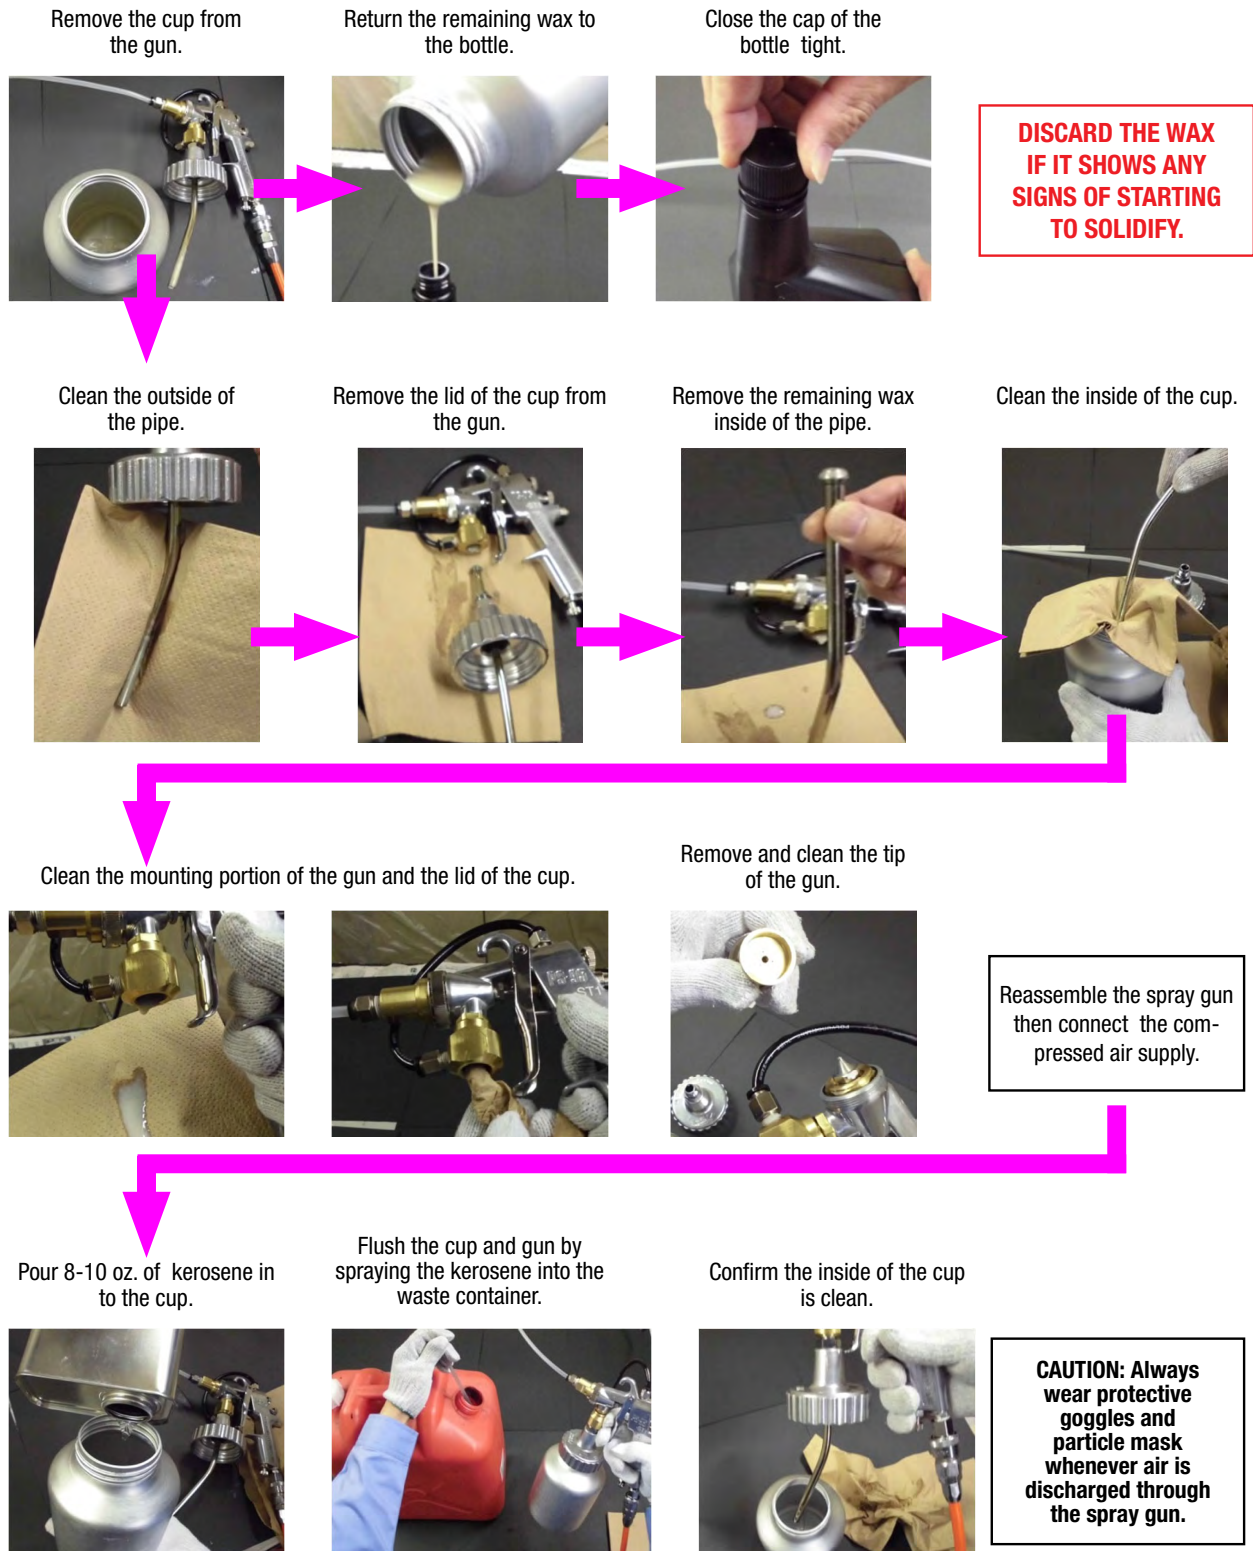
In this case, clean the complete spray gun.
Clean the nozzle, tip, gun and cup using kerosene.

REMINDER: This wax product does not dissolve in thinner.

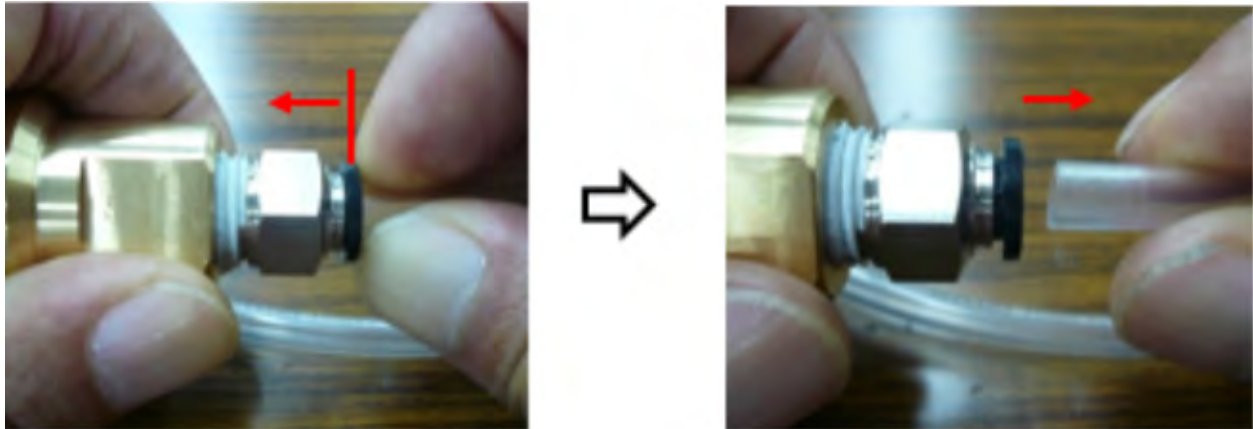
If the spray nozzle is not working properly (poor spray pattern), the tip may be partially clogged.

- Remove the tube / nozzle from the gun assembly and clean by applying compressed air.
- Release the plastic tube from the gun by pressing down on the black collar of the connector.
- Pull out the tube while holding the black collar portion down.

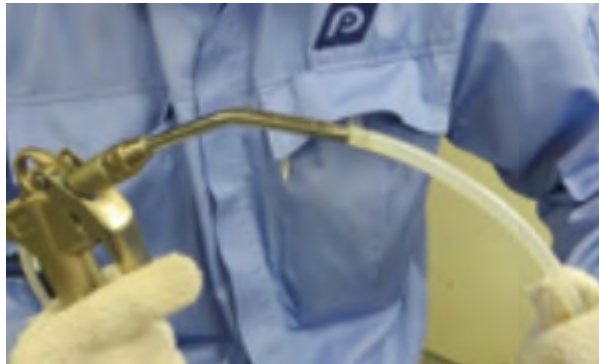
- **CAREFULLY** apply compressed (regulated, “shop”) air to the removed tube to clear the restriction from the tip.

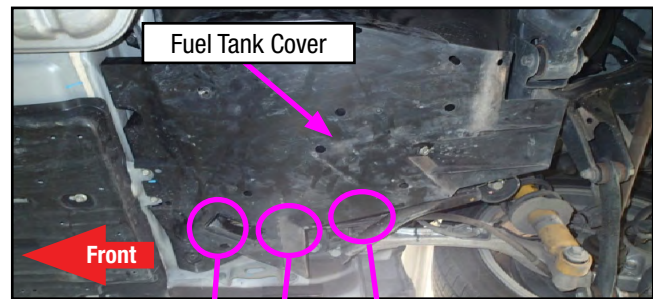
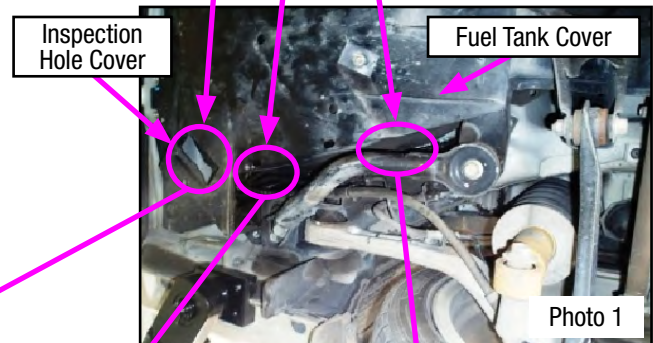
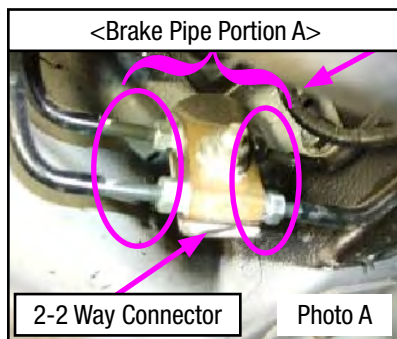
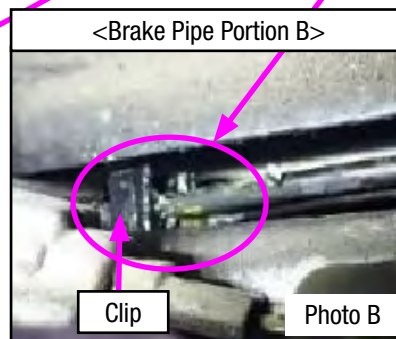
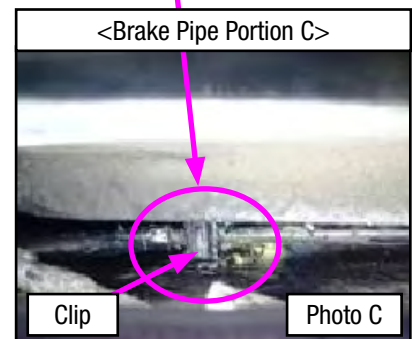
(2-2) Confirm the location of Brake Pipe Portion B and C through side gap of fuel tank cover. (Photo B and C)

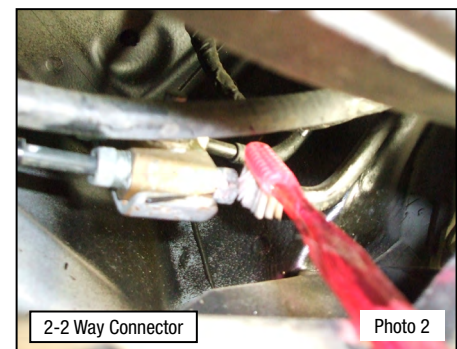
(3-2) For Brake Pipe Portion B and C, use compressed air to remove dust and dirt.

Be sure to **carefully** brush the brake piping to prevent damage.

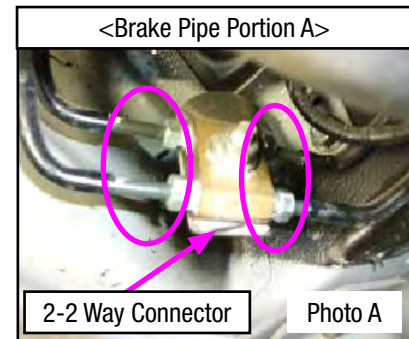
(4-1) Check for fluid leakage for Brake Pipe Portion A. (Photo A)

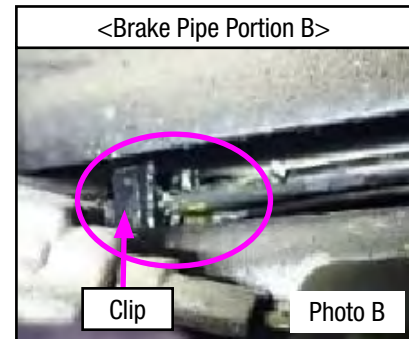
(4-2) Check for fluid leakage from Brake Pipe Portion B. (Photo B)

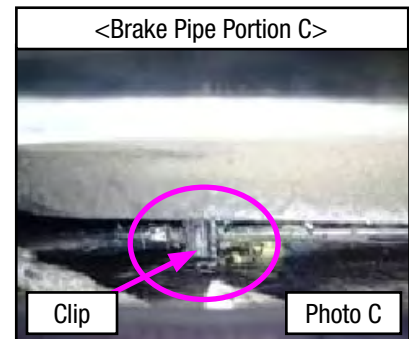
(4-3) Check for fluid leakage from Brake Pipe Portion C. (Photo C)

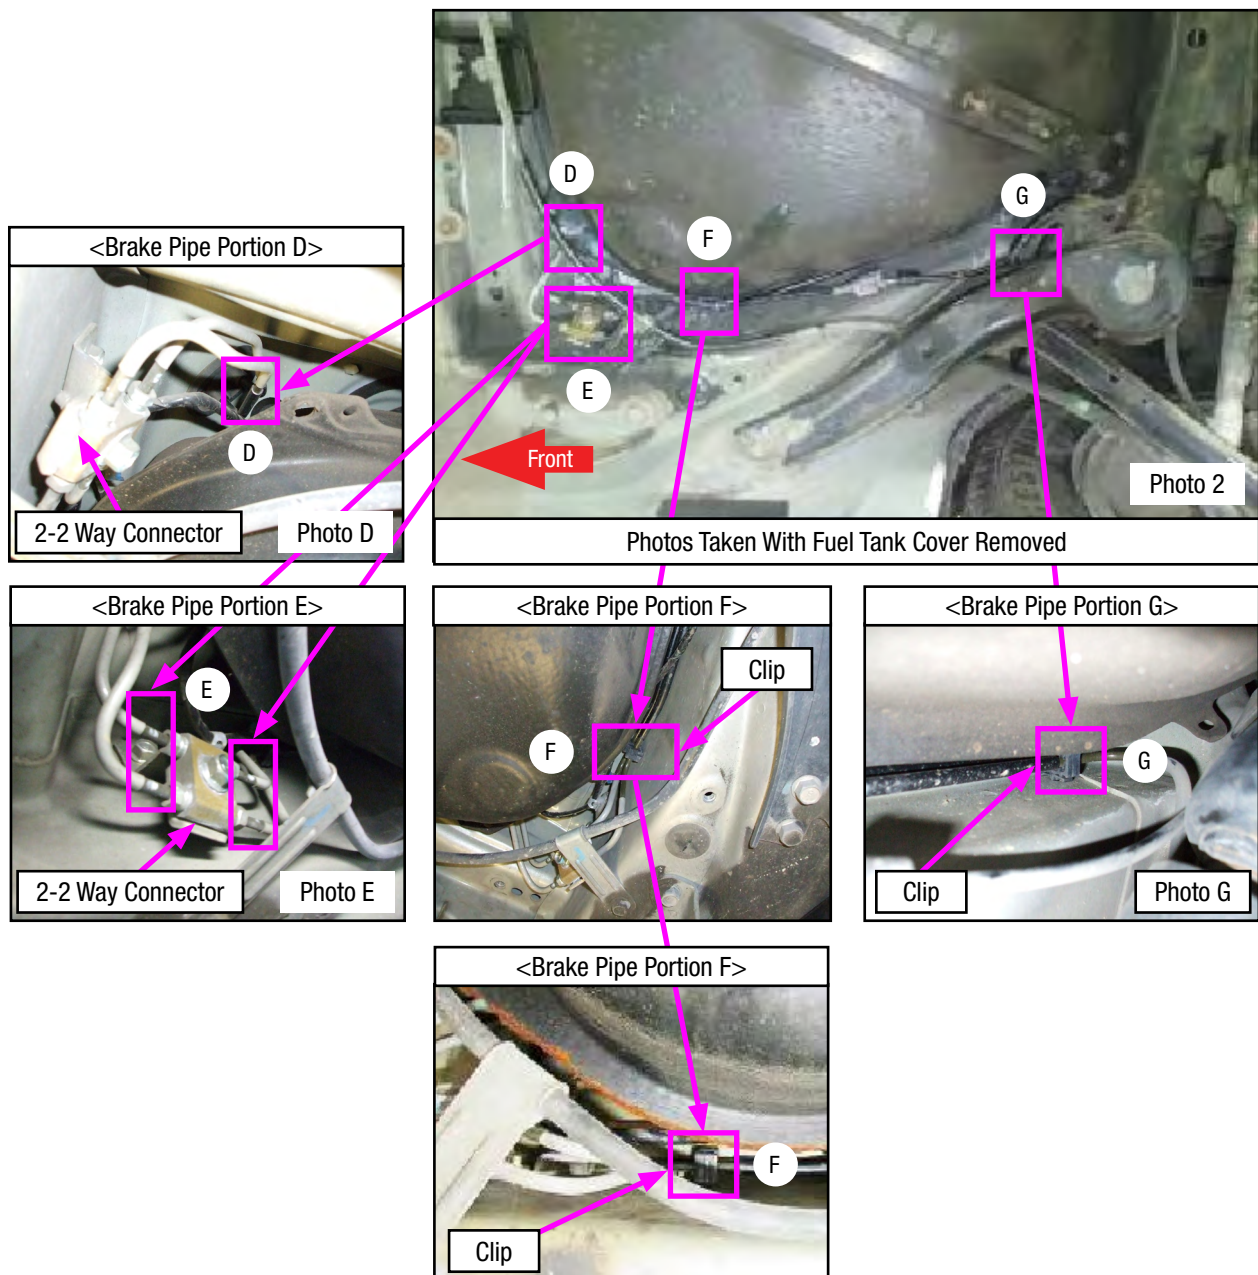
(2-4) Confirm the location of Brake Pipe Portion G through the side gap of fuel tank.
(Photo G)

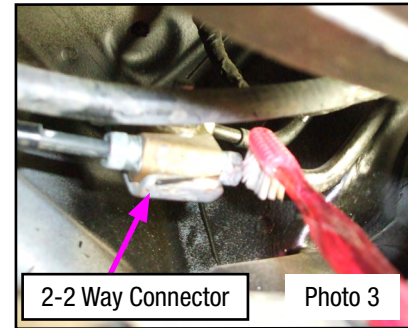
(3-1) For Brake Pipe Portion E, use a tooth brush and compressed air to remove dust and dirt.
(Photo 3)

Be sure to **carefully** brush the brake piping to prevent damage.

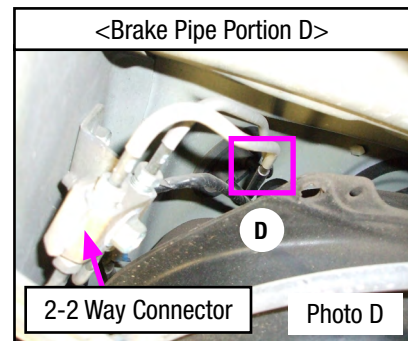
(4-1) Check for fluid leakage from Brake Pipe Portion D. (Photo D)

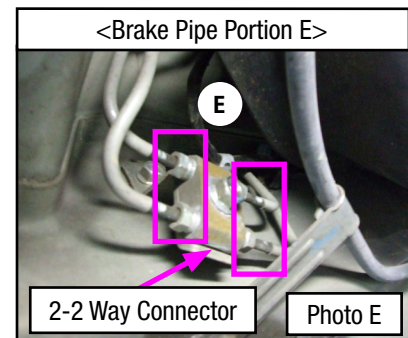
(4-2) Check for fluid leakage from Brake Pipe Portion E. (Photo E)

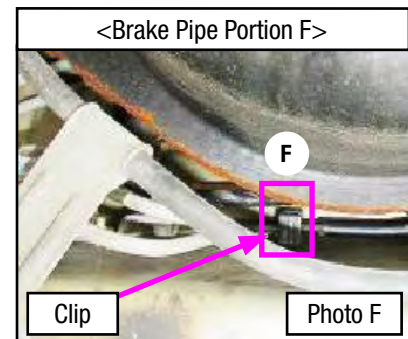
(4-2) Check for fluid leakage from Brake Pipe Portion F. (Photo F)

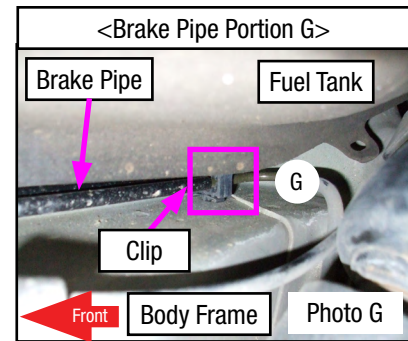
(4-3) Check for fluid leakage from Brake Pipe Portion G. (Photo G)

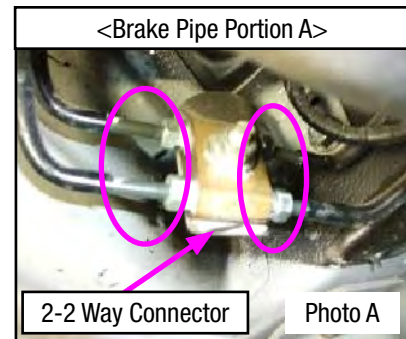
(3-1) Check on fluid leakage from Brake Pipe Portion A. (Photo A)

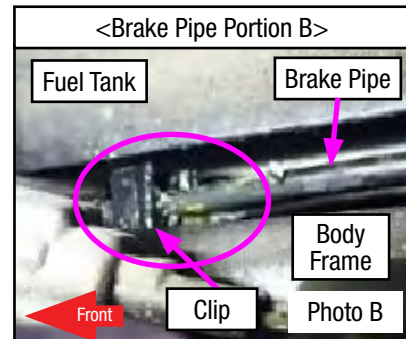
(3-2) Check for fluid leakage from Brake Pipe Portion B. (Photo B)

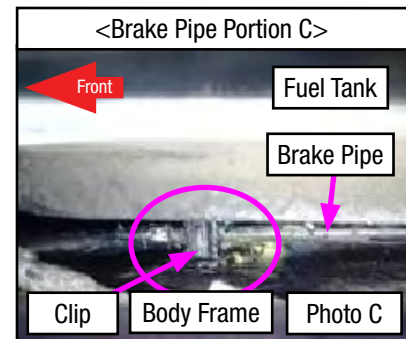
(3-3) Check for fluid leakage from Brake Pipe Portion C. (Photo C)

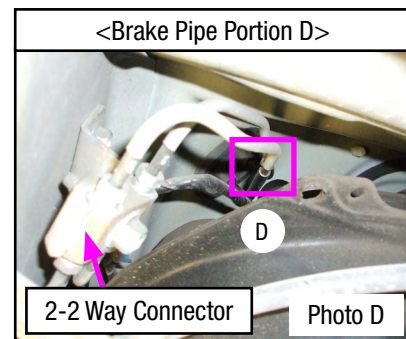
(3-1) Check for fluid leakage from Brake Pipe Portion D. (Photo D)

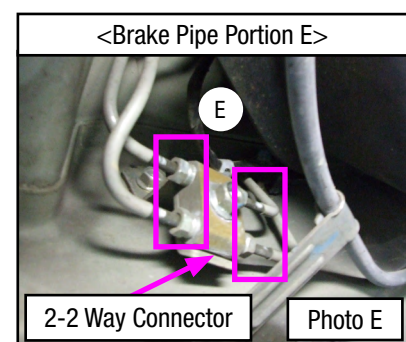
(3-2) Check for fluid leakage from Brake Pipe Portion E. (Photo E)

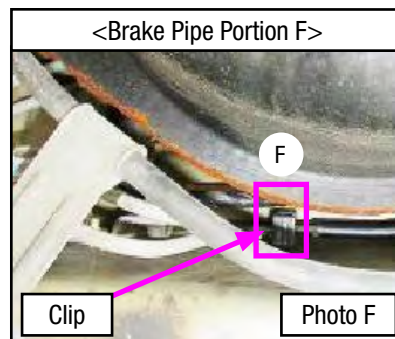
(3-3) Check for fluid leakage from Brake Pipe Portion F. (Photo F)

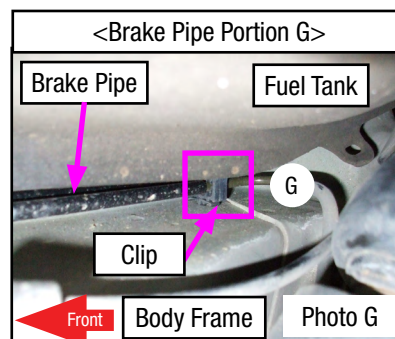
(3-4) Check for fluid leakage from Brake Pipe Portion G. (Photo G)

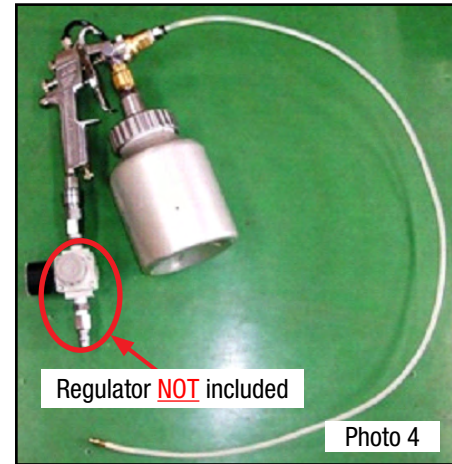
- (1-1) Assemble the spray gun and nozzle according to “2. Spray Gun: Assembly and Adjusting”.
- (1-2) Set zero-point of discharge knob and air needle of spray gun according to 2-2: Adjusting of Spray Gun: A: Zero-point Setting of Discharge Knob and Air Needle.

- (1-3) Fill the tank with anti-rust wax.
- (1-4) Adjust wax amount and air volume by setting the discharge knob, air needle, and compressor air pressure of spray gun according to 2-2: B: Adjustment of Wax Amount and Air Volume”.
- (1-5) Test-spray wax to confirm gun operates as intended.

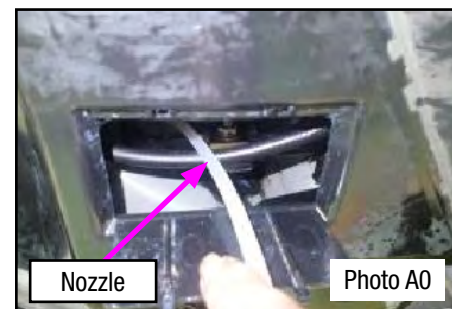
- (2-1) Spraying Brake Pipe Portion A:
 - (2-1-1) Open the inspection hole door in the fuel tank cover and insert the nozzle. (Photo A0)

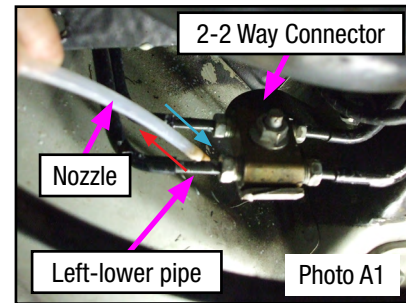
(2-1-2) Insert the nozzle over the left-lower pipe of the 2-2 Way Connector. Remove the nozzle while spraying for 3 seconds or more. (Photo A1)

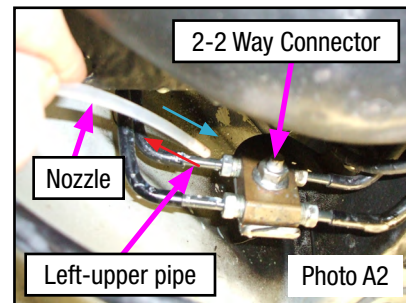
(2-1-3) Insert the nozzle over the left-upper pipe of the 2-2 Way Connector. Remove the nozzle while spraying for 3 seconds or more. (Photo A2)

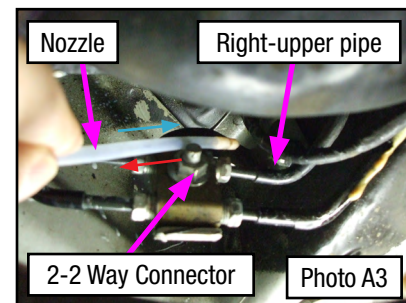
(2-1-4) Insert the nozzle over the right-upper pipe of the 2-2 Way Connector. Remove the nozzle while spraying for 3 seconds or more. (Photo A3)

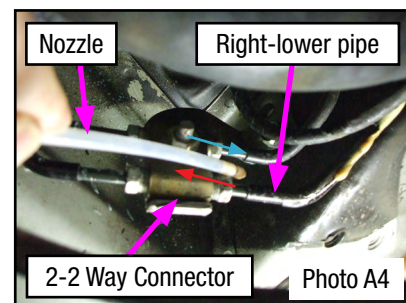
(2-1-5) Insert the nozzle over the right-lower pipe of the 2-2 Way Connector. Remove the nozzle while spraying for 3 seconds or more. (Photo A4)

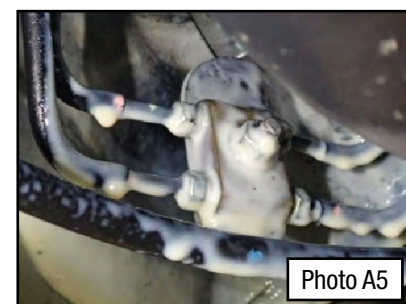
- Spray until the sprayed wax material drips. (Photo A5)
- To insure the proper amount of wax is applied, follow the steps listed above closely.

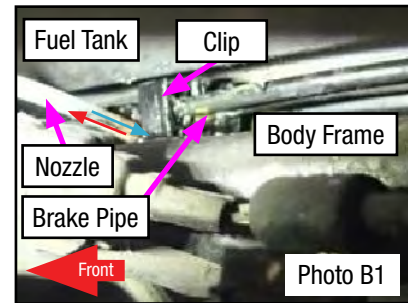
(2-2-1) Insert the nozzle between the brake pipe and the body frame in front of the clip until the nozzle touches the body frame. Remove the nozzle while spraying for 3 seconds or more. (Photo B1)

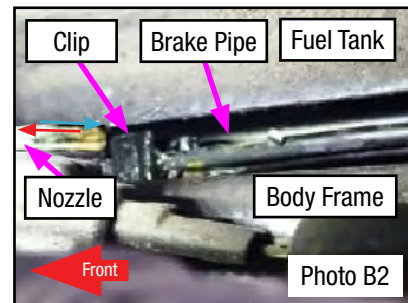
(2-2-2) Insert the nozzle between the brake pipe and the fuel tank in front of the clip until the nozzle touches the body frame. Remove the nozzle while spraying for 3 seconds or more. (Photo B2)

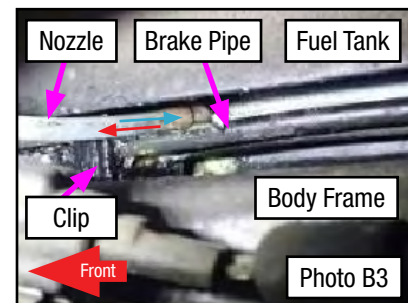
(2-2-3) Insert the nozzle between the brake pipe and the fuel tank at the rear of the clip until the nozzle touches the body frame. Remove the nozzle while spraying for 3 seconds or more. (Photo B3)

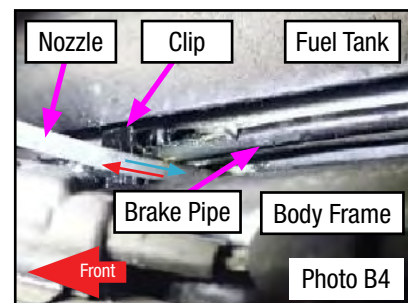
(2-2-4) Insert the nozzle between brake pipe and the body frame at the rear of the clip until the nozzle touches the body frame. Remove the nozzle while spraying for 3 seconds or more. (Photo B4)

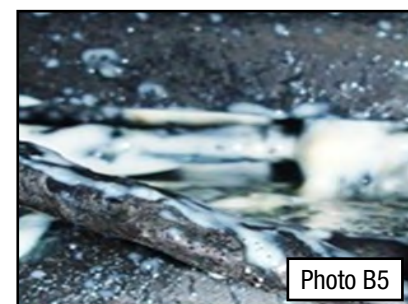
- Spray until the sprayed wax material drips. (Photo B5)
- To insure the proper amount of wax is applied, follow the steps listed above closely.

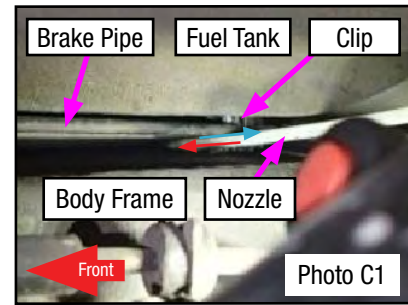
(2-3-1) Insert the nozzle between the brake pipe and the body frame in front of the clip as far as possible. Remove the nozzle while spraying for 3 seconds or more. (Photo C1)

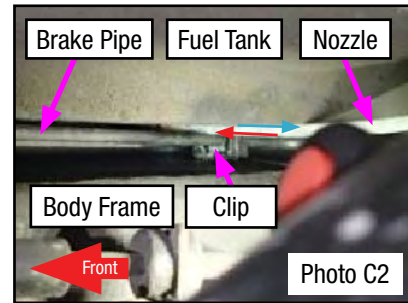
(2-3-2) Insert the nozzle between the brake pipe and the fuel tank in front of the clip as far as possible. Remove the nozzle while spraying for 3 seconds or more. (Photo C2)

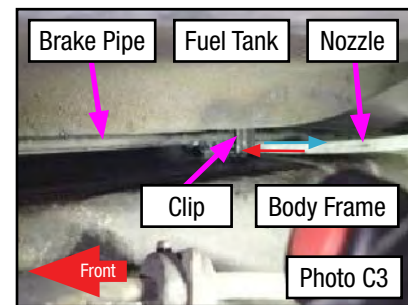
(2-3-3) Insert the nozzle between the brake pipe and the body frame at the rear of the clip as far as possible. Remove the nozzle while spraying for 3 seconds or more. (Photo C3)

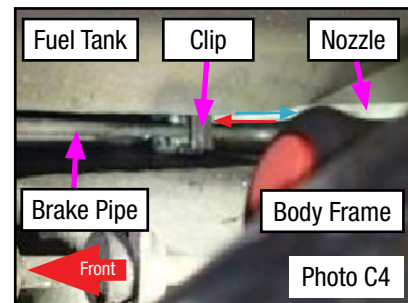
(2-3-4) Insert the nozzle between brake pipe and fuel tank at the rear of the clip as far as possible. Remove the nozzle while spraying for 3 seconds or more. (Photo C4)

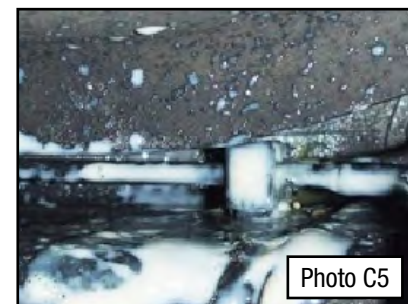
- Spray until the sprayed wax material drips. (Photo C5)
- To insure the proper amount of wax is applied, follow the steps listed above closely.

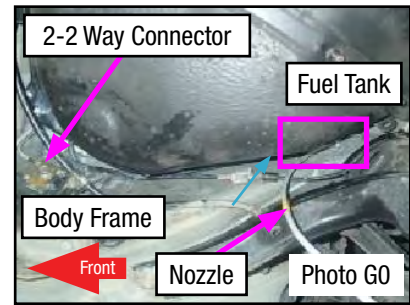
(2-1-1) Insert nozzle between the fuel tank and the body frame. (Photo G0)

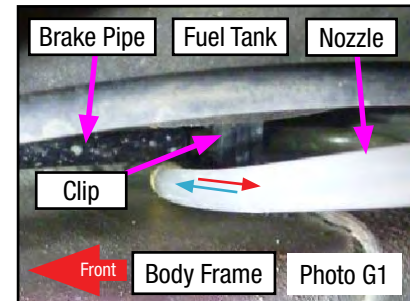
(2-1-2) Insert the nozzle in front of the clip between the brake pipe and body frame. Remove the nozzle while spraying for 3 seconds or more. (Photo G1)

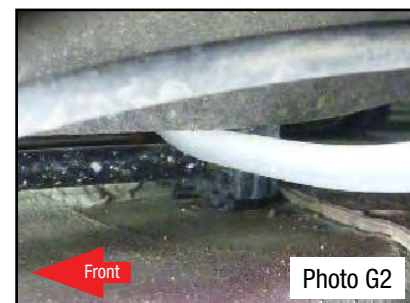
(2-1-3) Insert the nozzle in front of the clip between the brake pipe and the fuel tank. Remove the nozzle while spraying for 3 seconds or more. (Photo G2)

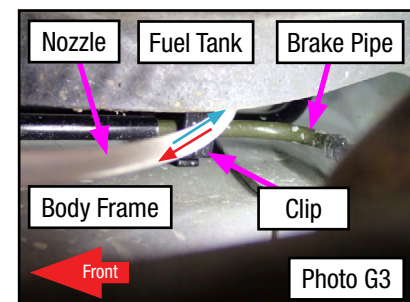
(2-1-4) Insert the nozzle in the rear of the clip between the brake pipe and fuel tank. Remove the nozzle while spraying for 3 seconds or more. (Photo G3)

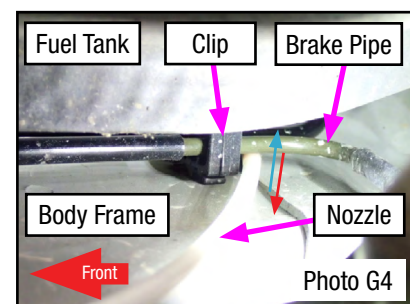
(2-1-5) Insert the nozzle in the rear of the clip between the brake pipe and body frame. Remove the nozzle while spraying for 3 seconds or more. (Photo G4)

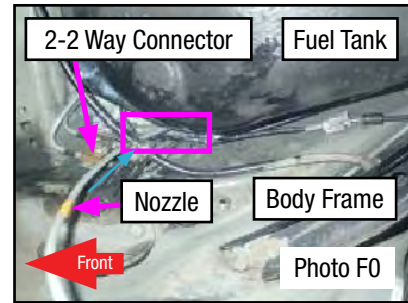
(2-2-1) Insert the nozzle through rear of 2-2 Way Connector between the fuel tank and the body frame. Remove the nozzle while spraying for 3 seconds or more. (Photo F0)

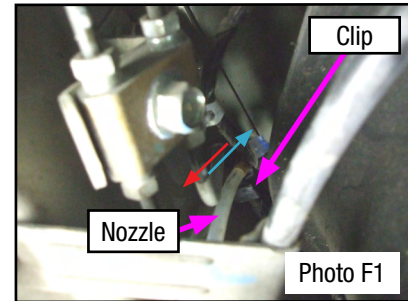
(2-2-2) Insert the nozzle in front of the clip until the nozzle touches body frame. Remove the nozzle while spraying for 3 seconds or more. (Photo F1)

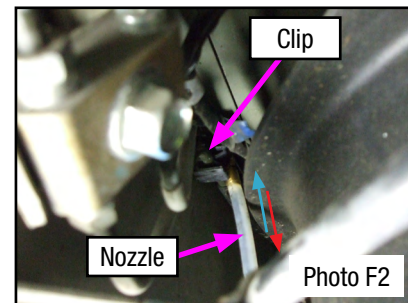
(2-2-3) Insert the nozzle in rear of the clip until nozzle touches the body frame. Remove the nozzle while spraying for 3 seconds or more. (Photo F2)

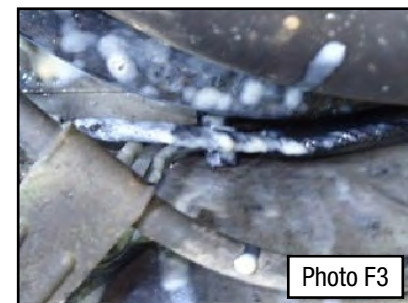
- Be sure to spray until sprayed wax material drips. (Photo F3)
- To insure the proper amount of wax material is applied, follow the steps listed above closely.

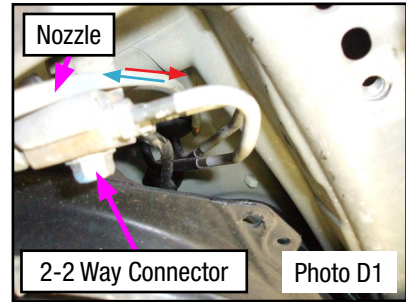
(2-3-1) Insert the nozzle to the left side of the 2-2 Way Connector. Remove the nozzle while spraying for 3 seconds or more. (Photo D1)

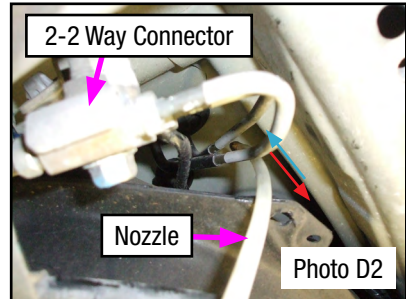
(2-3-2) Insert the nozzle to the right side of the 2-2 Way Connector. Remove the nozzle while spraying for 3 seconds or more. (Photo D2)

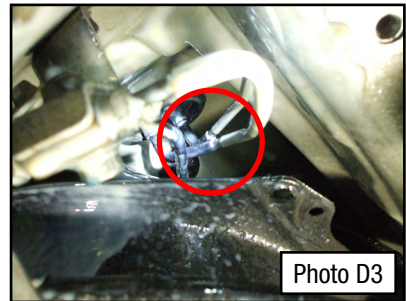
- Be sure to spray until sprayed wax material drips. (Photo D3)
- To insure the proper amount of wax is applied, follow the steps listed above closely.

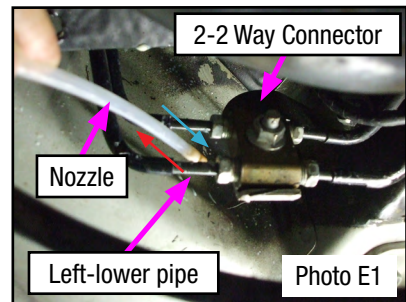
(2-4-1) Insert the nozzle over the left-lower pipe of the 2-2 Way Connector. Remove the nozzle while spraying for 3 seconds or more. (Photo E1)

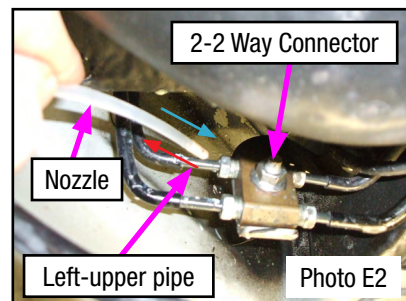
(2-4-2) Insert the nozzle over the left-upper pipe of the 2-2 Way Connector. Remove the nozzle while spraying for 3 seconds or more. (Photo E2)

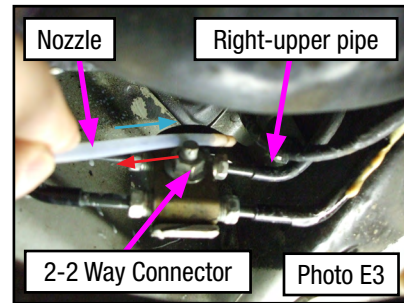
- (2-4-3) Insert the nozzle over the right-upper pipe of the 2-2 Way Connector. Remove the nozzle while spraying for 3 seconds or more. (Photo E3)

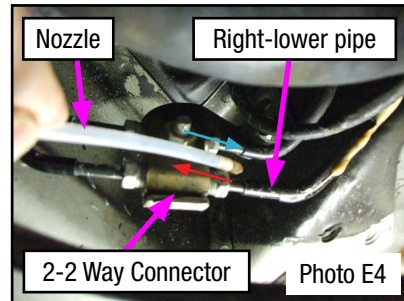
- (2-4-4) Insert the nozzle over the right-lower pipe of the 2-2 Way Connector. Remove the nozzle while spraying for 3 seconds or more. (Photo E4)

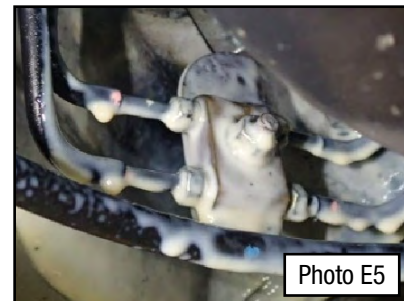
- Spray until the sprayed wax material drips. (Photo E5)
- To insure the proper amount of wax is applied, follow the steps listed above closely.
