PRODUCT CAMPAIGN BULLETIN

APPLICABILITY: 2005-2009 Subaru Legacy and Outback
 2009-2013 Subaru Forester
 2008-2011 Subaru Impreza, WRX, and STI
 2012-2014 Subaru WRX and STI

NUMBER: WQK-47
DATE: July 2014
NHTSA ID: 14V-311

SUBJECT: Brake Line Corrosion

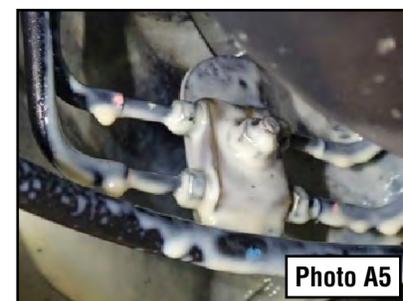
- Spray until the sprayed wax material drips. (Photo A5)
- To insure the proper amount of wax is applied, follow the steps listed above closely.

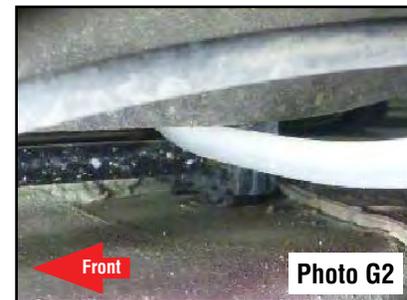
(2-1-3) Insert the nozzle in front of the clip between the brake pipe and the fuel tank. Remove the nozzle while spraying for 3 seconds or more. (Photo G2)
