**PRODUCT CAMPAIGN BULLETIN**

**APPLICABILITY:** 2005-2009 Subaru Legacy and Outback  
 2009-2013 Subaru Forester  
 2008-2011 Subaru Impreza, WRX, and STI  
 2012-2014 Subaru WRX and STI

**NUMBER:** WQK-47R  
**DATE:** July 2014  
**REVISED:** July 29, 2014  
**NHTSA ID:** 14V-311

**SUBJECT:** Brake Line Corrosion

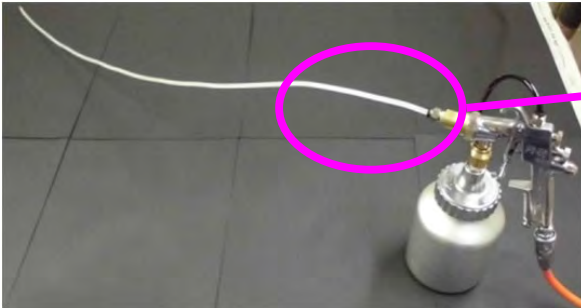
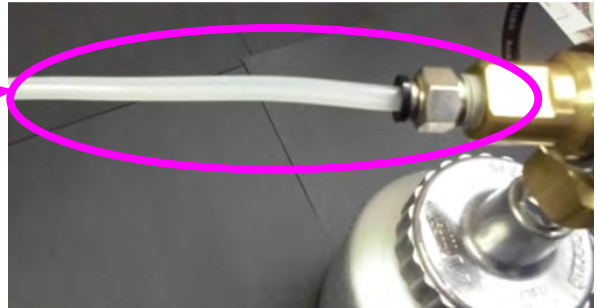
**After operation**

**Residual wax visible inside nozzle**

**Insert nozzle into waste container and close the discharge knob.**

**Pull the gun trigger half way and hold for about 20 seconds until the tip is clear.**

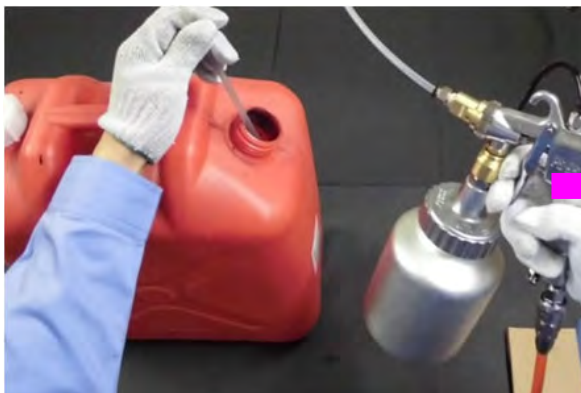
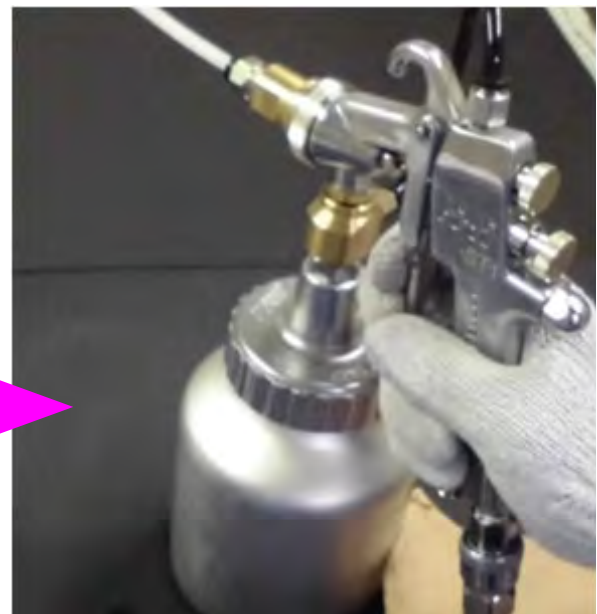
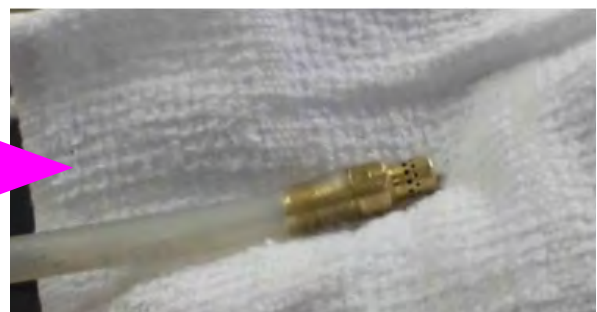
**Confirm the nozzle and tip are clear.**

**Wipe the tip with a clean cloth.**

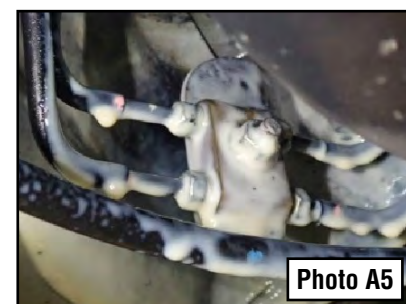
- Spray until the sprayed wax material drips. (Photo A5)
- To insure the proper amount of wax is applied, follow the steps listed above closely.

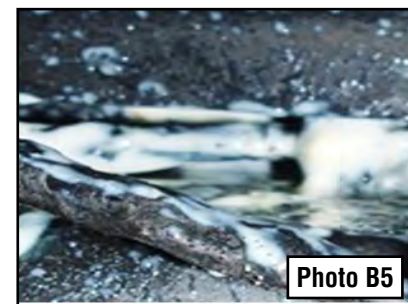
- Spray until the sprayed wax material drips. (Photo B5)
- To insure the proper amount of wax is applied, follow the steps listed above closely.

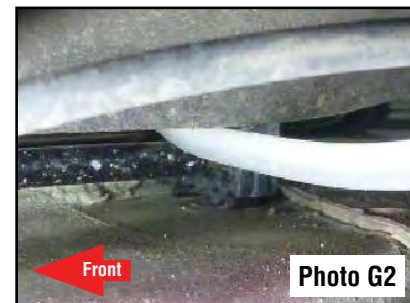
(2-1-3) Insert the nozzle in front of the clip between the brake pipe and the fuel tank. Remove the nozzle while spraying for 3 seconds or more. (Photo G2)

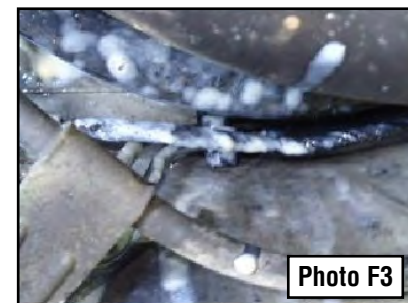
- Be sure to spray until sprayed wax material drips. (Photo F3)
- To insure the proper amount of wax material is applied, follow the steps listed above closely.
