BMW Motorrad USA Service Information Bulletin

****Notice of Recall 14V-320****

Subject: Replacing Rear Spring Strut

Model: R 1200 RT (K52, 0A03/0A13) with Dynamic ESA as optional extra (option code 0191 or 0233)

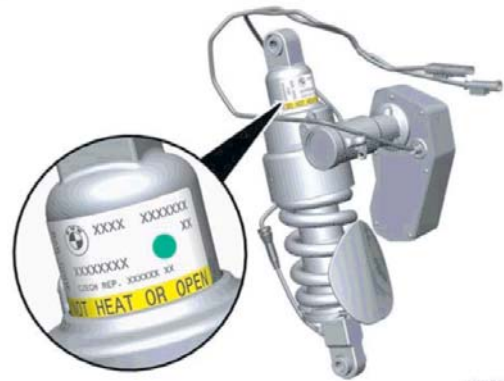
The green spot is the identifying mark for the new, improved Dynamic ESA spring strut.

Aftersales Solution: All vehicles affected by this issue must have the Dynamic ESA rear spring strut or the dummy spring strut removed and a new, improved Dynamic ESA spring strut installed (see attached work item 00 60 296 for a description of the procedure).

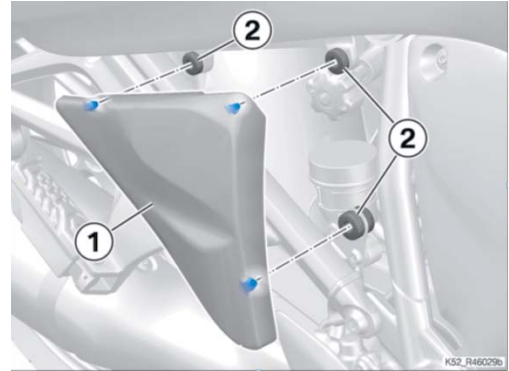
2 Removing right cover for spring strut

Ease cover (1) out of grommets (2) and remove.

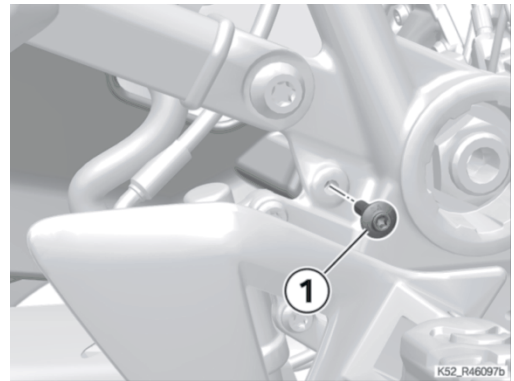
3 Removing front rear-wheel cover

Remove screw (1).

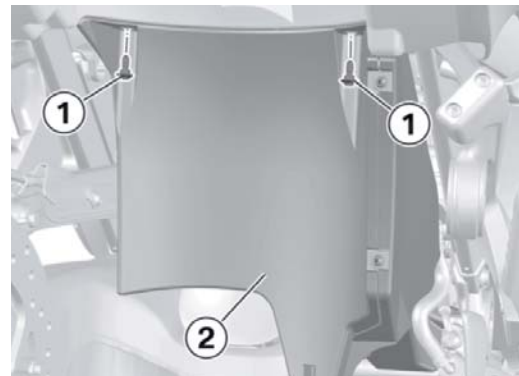
Remove screws (1).
Remove front rear-wheel cover (2).

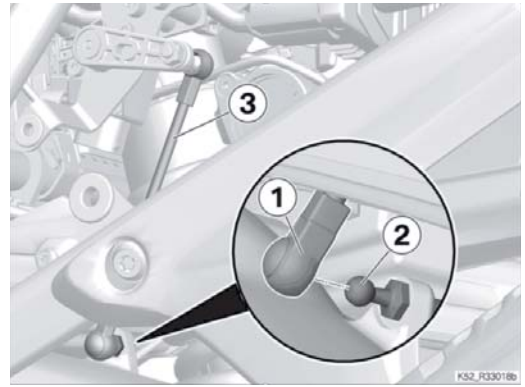
- 4 Unclip ball socket (1) from ball head (2).
Pivot actuator rod (3) up.

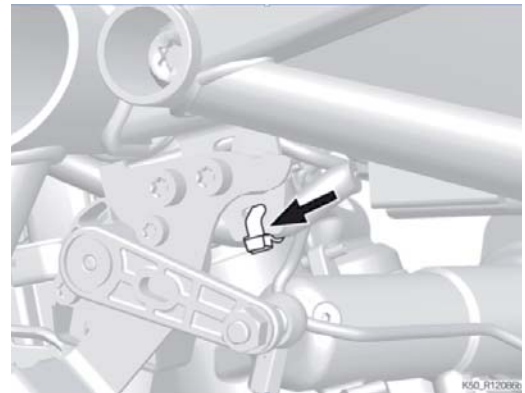
- 5 **Releasing voltage regulator**
Remove cable tie (arrow).

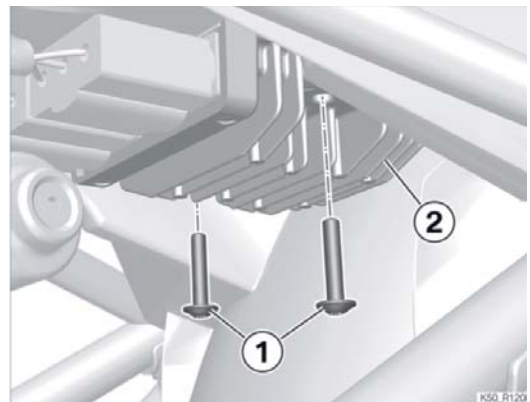
Remove screws (1).
Allow voltage regulator (2) to dangle to one side.

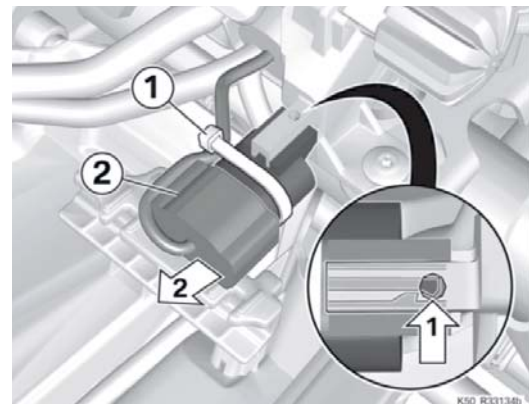
- 6 **Disengage the engine control unit**
Remove cable tie (1).
Disengage fuse carrier (2) by working through the hole (detail) and remove.

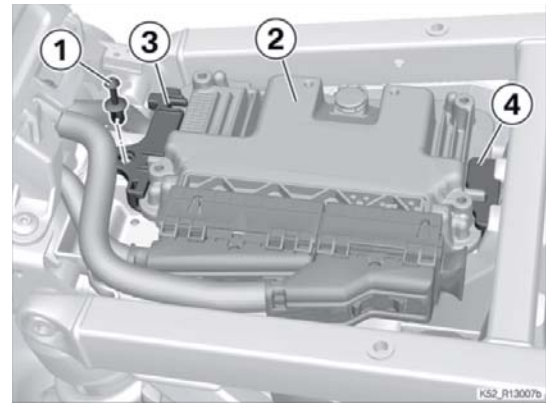
Remove body-bound rivet (1).
Remove engine control unit (2) with rubber holders (3) and (4).
Allow engine control unit (2) to dangle to one side.

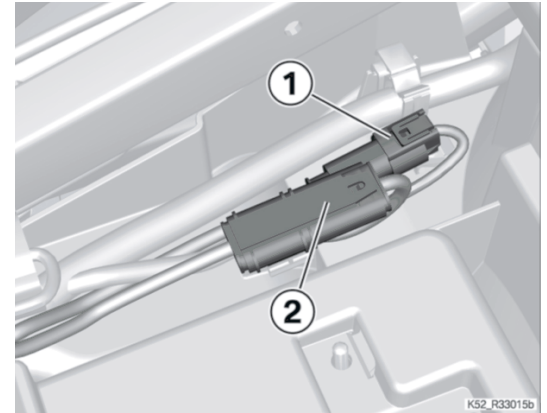
7 Disengaging cable for ESA spring strut
Disconnect plugs (1) and (2) for the ESA spring strut and remove.

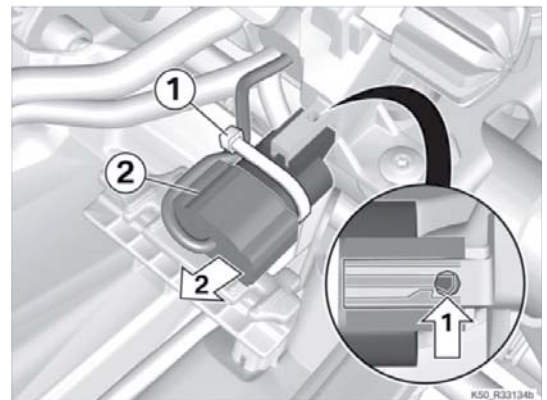
Remove cable tie (1).
Disengage fuse carrier (2) by working through the hole (detail) and remove.

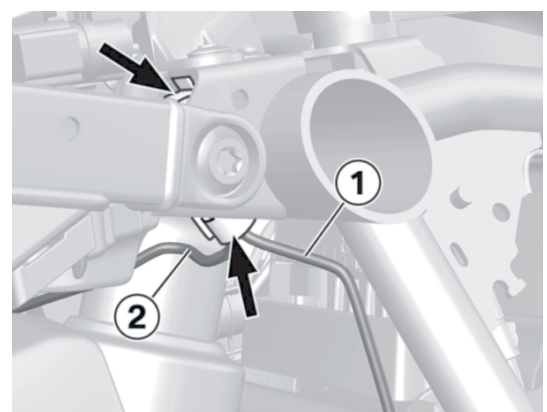
Disengage cables (1) and (2) for the ESA spring strut from the holders (arrows).

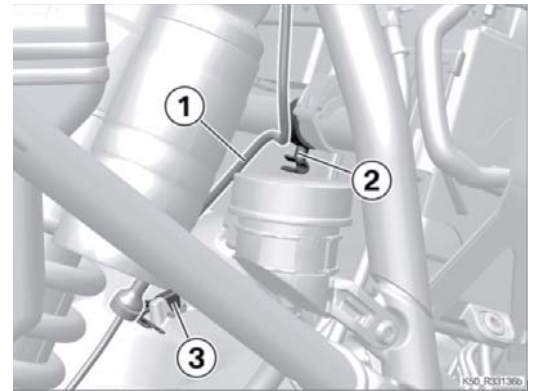
Work item continued: Disengage cable (1) for ESA spring strut from holders (2) and (3).

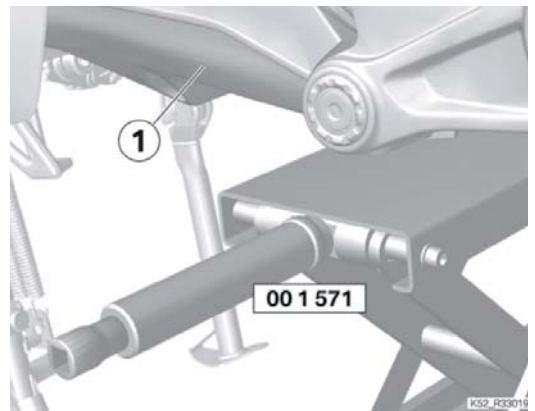
8 Removing rear spring strut

Attention: Risk of hard or sharp-edged objects damaging components. Take care not to scratch components; cover or mask as necessary.
Support swingarm (1) with scissor jack (00 1 571).

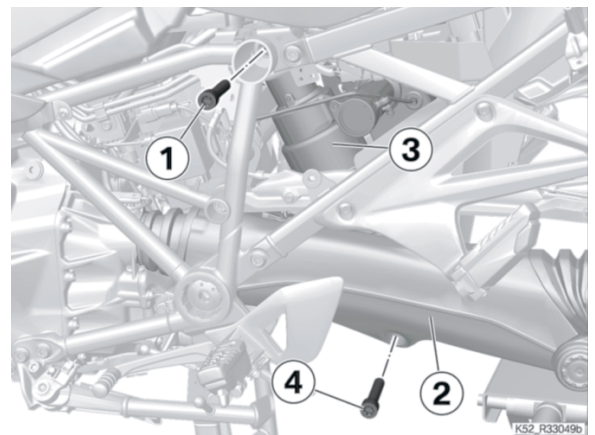
Remove screw (1), if necessary lifting or lowering swingarm (2) slightly to take the strain off spring strut (3).
Fully lower swingarm (2).
Remove screw (4).
Remove spring strut (3).

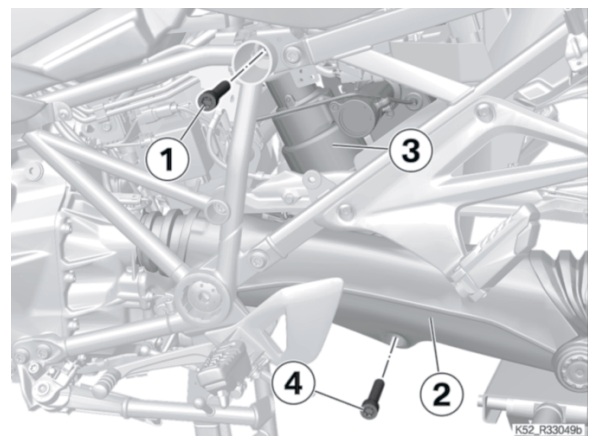
9 Installing rear spring strut

Clean the threads.
Install spring strut (3).
Insert original screw (1).
Slightly raise swingarm (2).
Install original screw (4) and tighten screw (1).

Tightening torques	
Spring Strut to Frame	
M12 x 1.5 x 60 Thread-locking compound (Loctite 2701,High strength)	100 Nm
Spring Strut to Swingarm	
M12 x 75 - 10.9 Thread-locking compound (Loctite 2701,High strength)	100 Nm
