BTB 51769-51809 (1406) REV1

Safety Recall: ILX Headlights

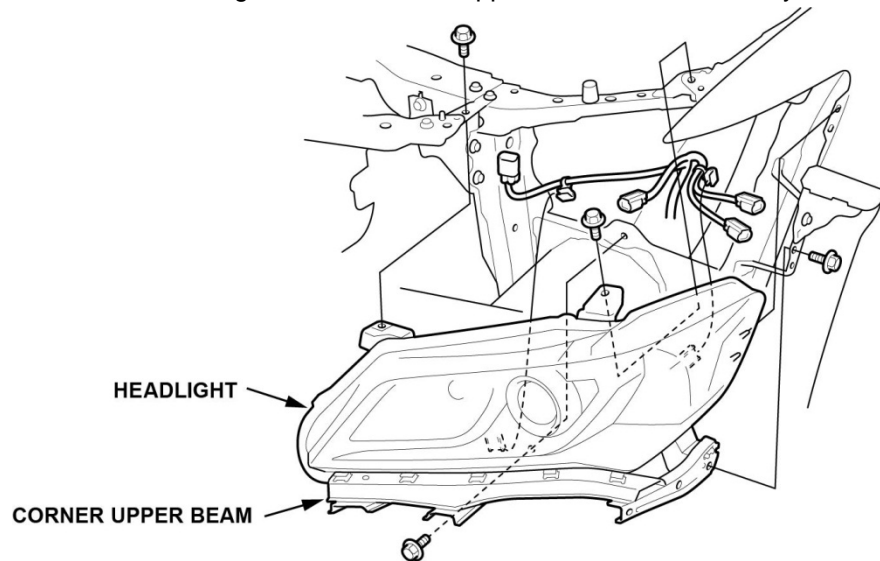
1. Remove the front bumper.
2. Remove the headlight with the corner upper beam as an assembly and disconnect the connectors.

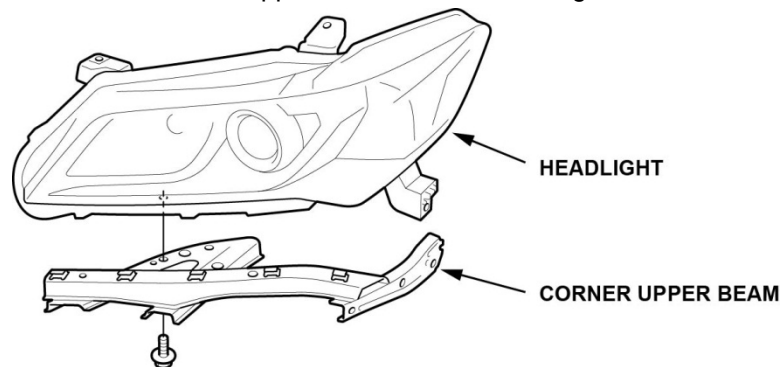
3. Remove the corner upper beam from the headlight.

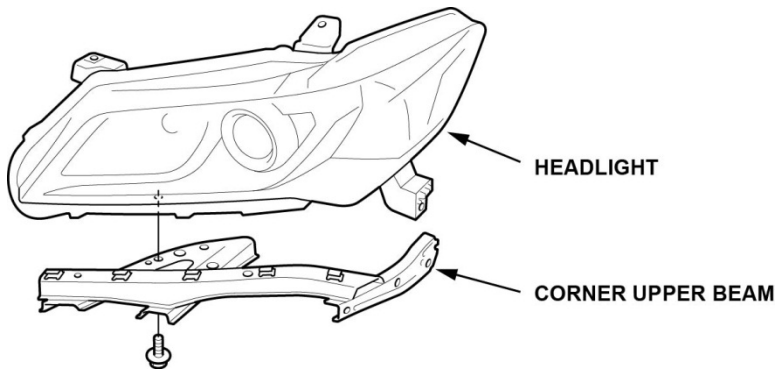
4. Install the corner upper beam to the new headlight and tighten the bolt to **9.3 N-m (6.9 lb-ft)**.

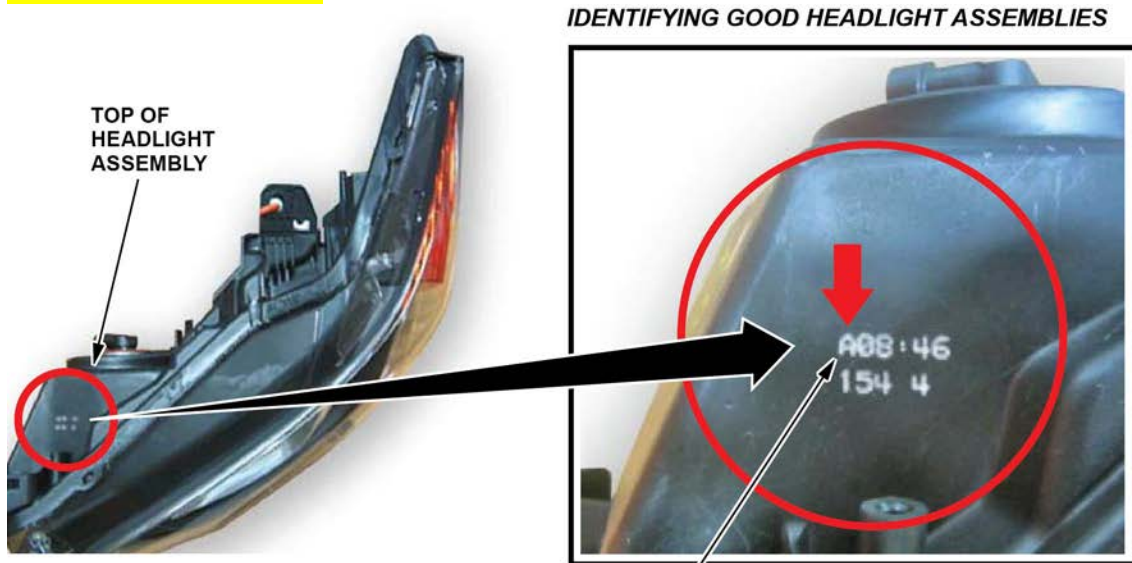
REVISED ILLUSTRATION

NOTE: Just in case the headlight assemblies get mixed up on your work bench, the improved head light assemblies have the letter (A) in front of the date code.

IDENTIFYING GOOD HEADLIGHT ASSEMBLIES

Look for an "A" in front of the date code.

In step 4 under NOTE, the illustration was changed.

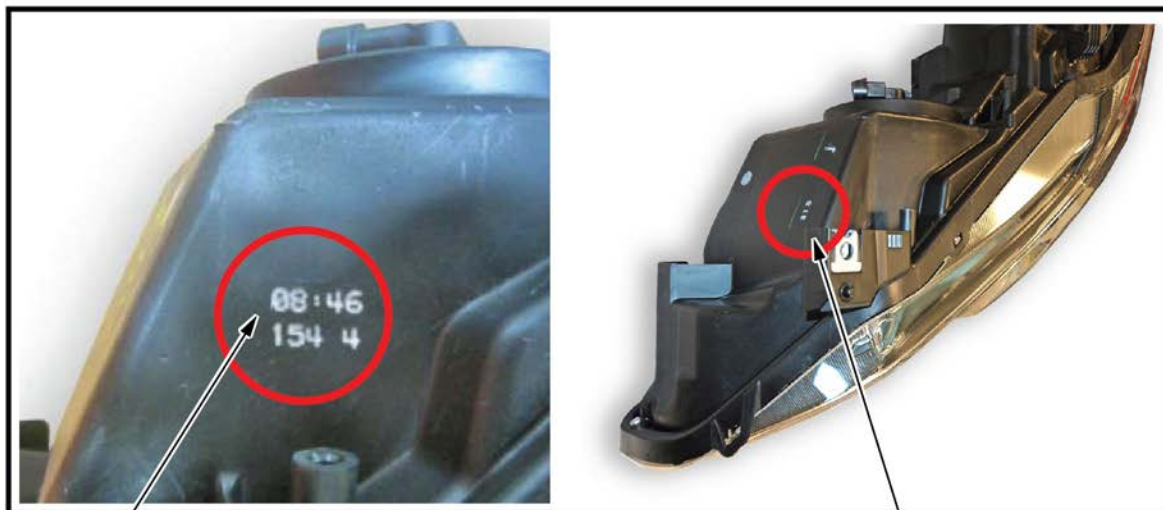
IDENTIFYING HEADLIGHT ASSEMBLIES TO BE REPLACED

FACTORY ORIGINAL HEADLIGHT ASSEMBLIES
No "A" in front of date code.

NO-GOOD SERVICE PARTS
Date code is on the side of the assembly.

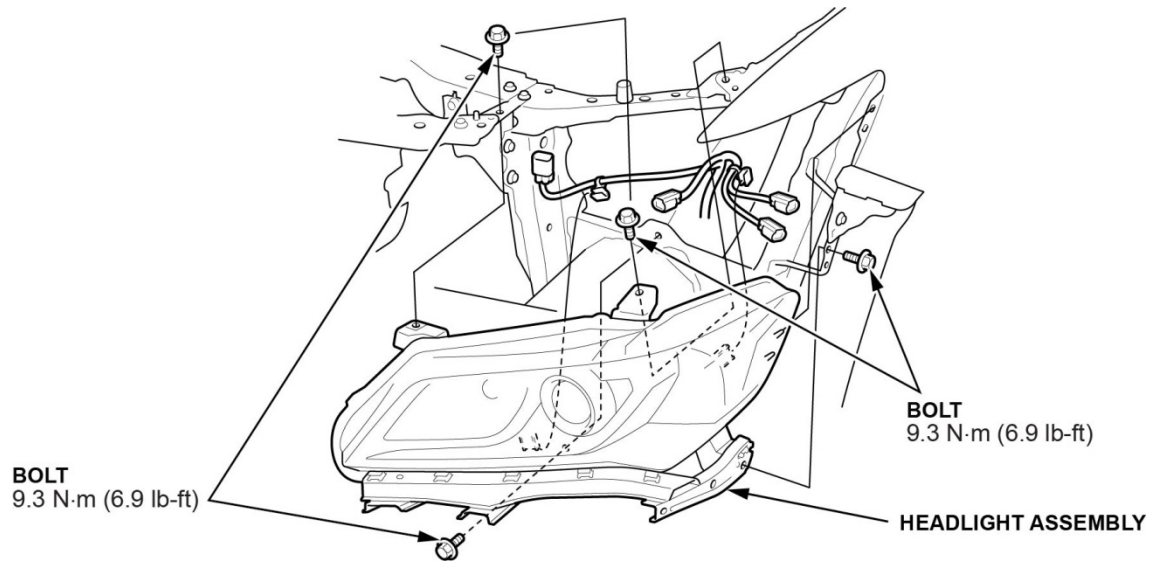
5. Install the new headlight, tighten the bolts to **9.3 N·m (6.9 lb-ft)** and reconnect the connectors. Then make sure the headlight bulbs are set into the headlight assembly.

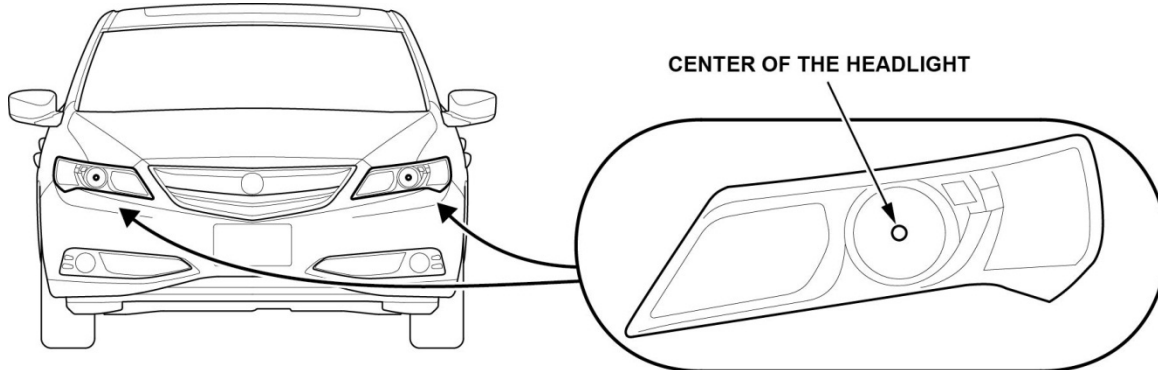
6. Repeat steps 2 through 5 on the other side.
7. Drill a ½" hole in the lens of the old headlight assemblies to render them useless.
8. Before adjusting the headlights, do this:
- Unload the vehicle.
 - Make sure the tire pressures are correct.
 - The driver or someone who weighs the same should sit in the driver's seat (or use an equivalent weight).
9. Make sure the outer lens is clean so that you can see the center of the headlights.

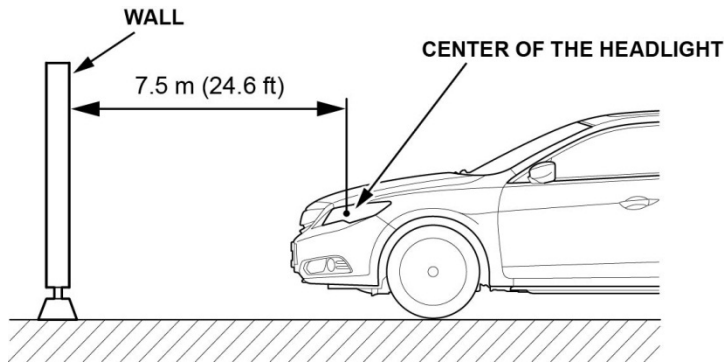
10. Park the vehicle on a level surface so that the center mark of the headlight is **7.5 m (24.6 ft)** away from a wall or screen.

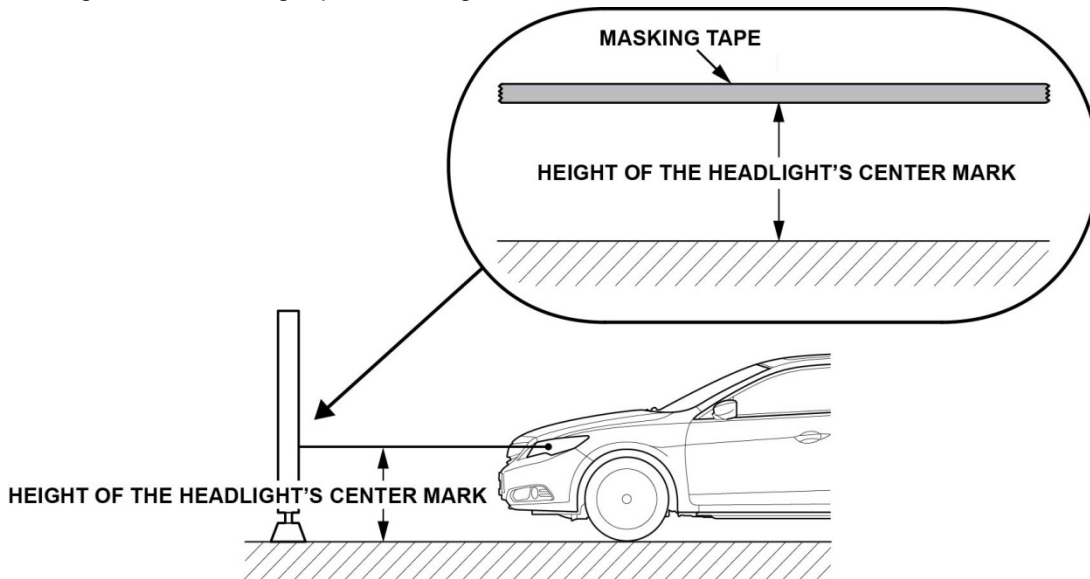
11. Measure the height of the headlight's center mark, then on the wall or screen, mark the same height of the headlights with masking tape in a straight line.

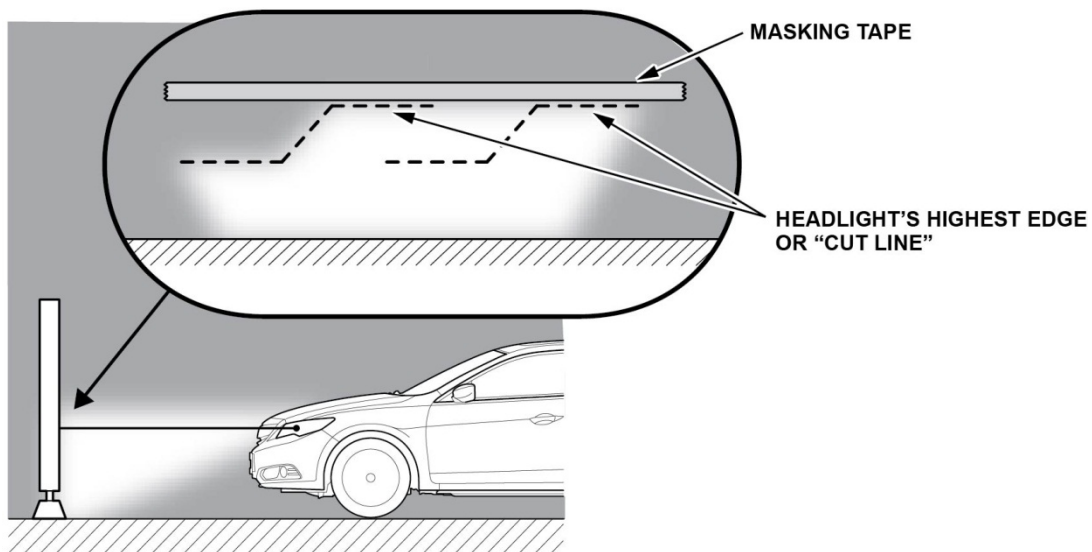
12. Turn on the low beam headlights.

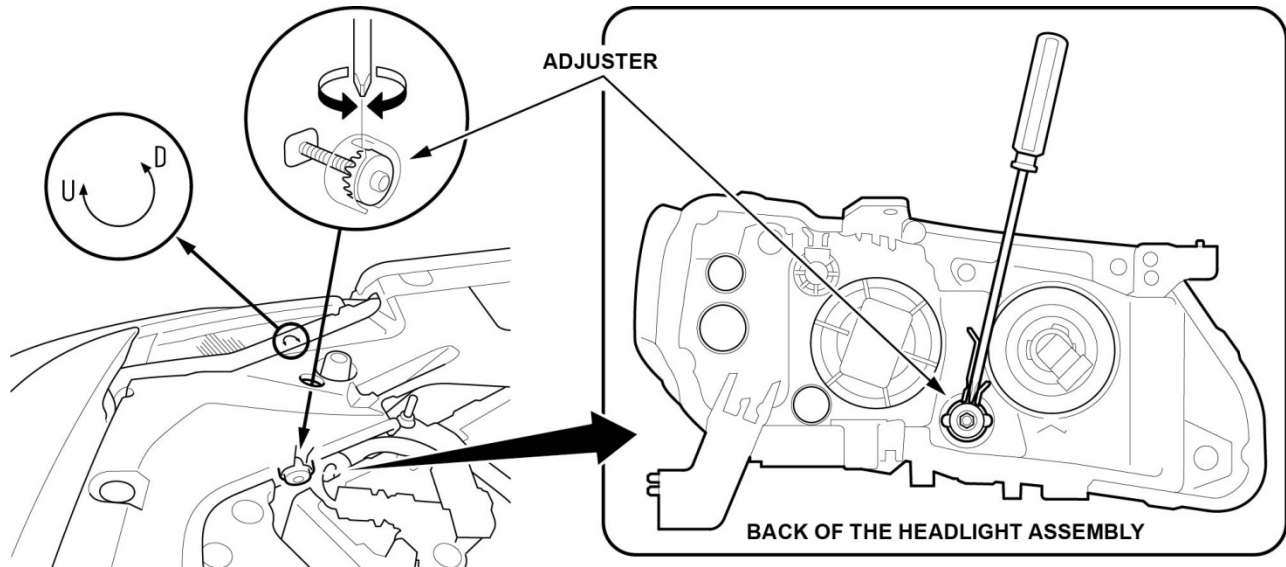
13. To see if the headlights are adjusted properly, look at the beams of the light projected on the wall or screen. The highest edge or cut line of the headlights should be equal with the masking tape.
- NOTE: To help determine if a headlight is out of adjustment, block one of the beams with a large piece of cardboard or equivalent and look at the other beam on the wall or screen. Repeat this for the other headlight.
14. If adjustment is necessary, open the hood and adjust the headlights to local requirements by turning the adjuster.
- NOTE: The headlights can only be adjusted vertically.
