BTB 51769 (1406)

## Safety Recall: ILX Headlights

### AFFECTED VEHICLES

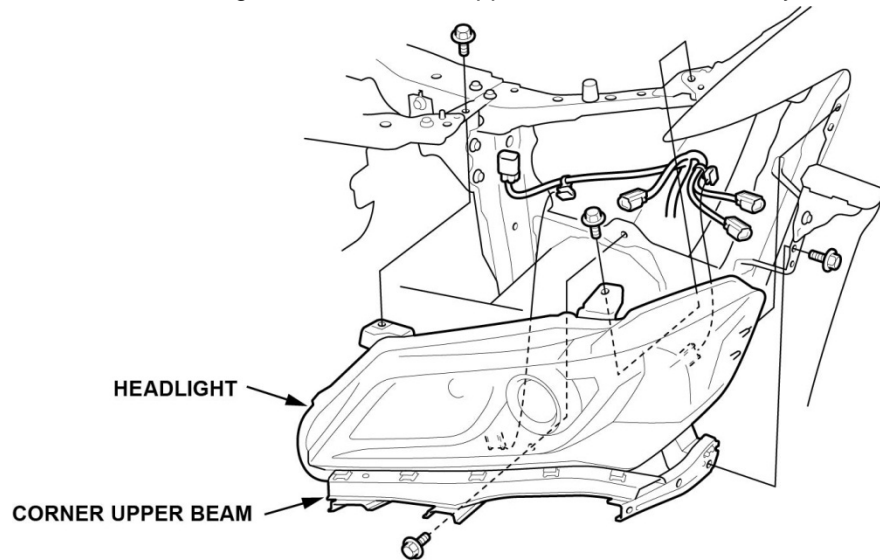
1. Remove the front bumper.
2. Remove the headlight with the corner upper beam as an assembly and disconnect the connectors.

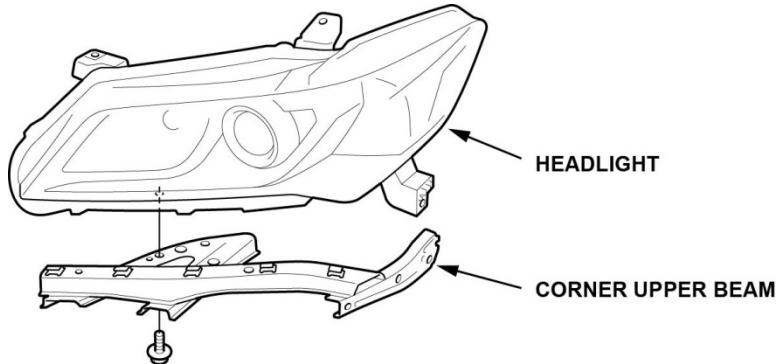
3. Remove the corner upper beam from the headlight.

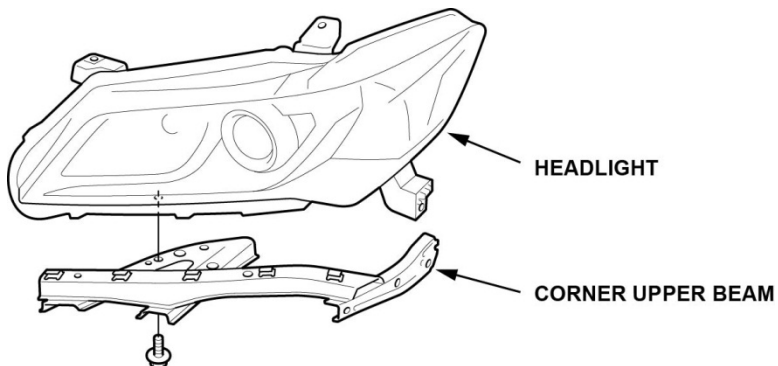
4. Install the corner upper beam to the new headlight and tighten the bolt to **9.3 N·m (6.9 lb-ft)**.

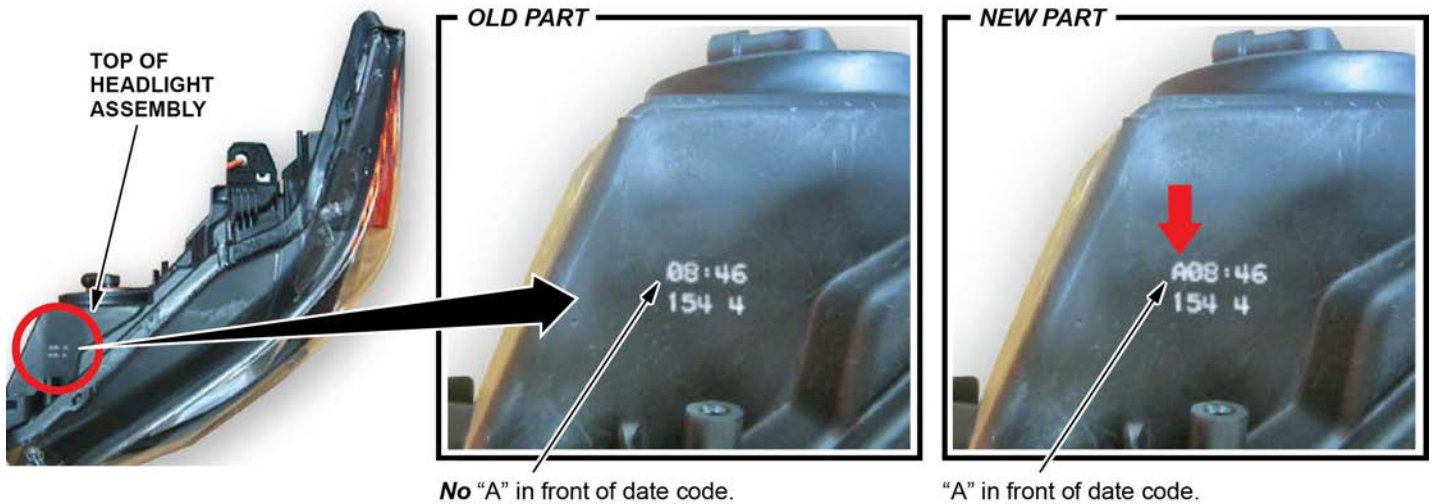
NOTE: Just in case the headlight assemblies get mixed up on your work bench, the improved head light assemblies

have the letter (A) in front of the date code.

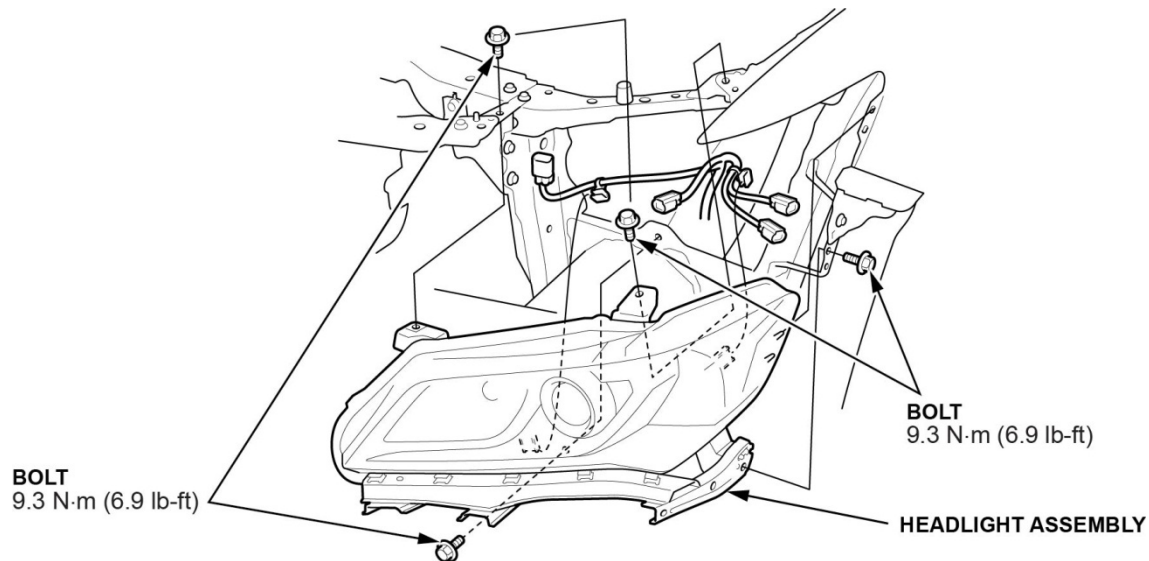
5. Install the new headlight, tighten the bolts to **9.3 N·m (6.9 lb-ft)** and reconnect the connectors. Then make sure the headlight bulbs are set into the headlight assembly.

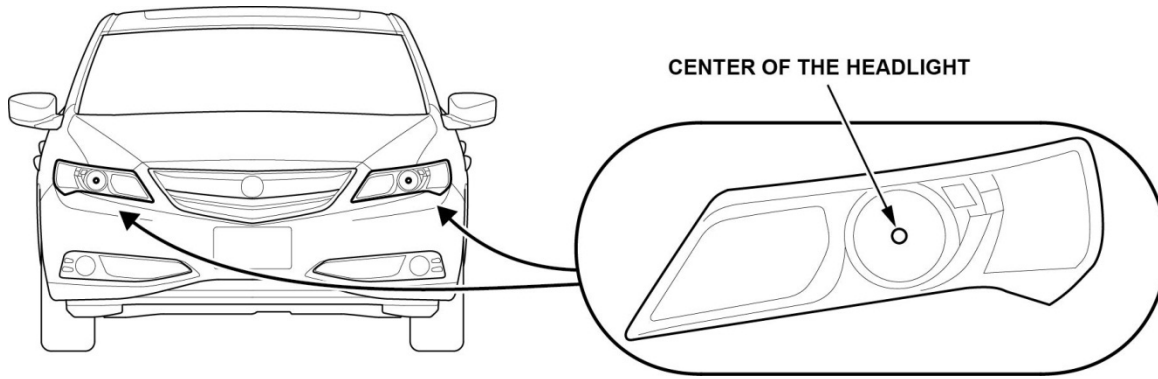
6. Repeat steps 2 through 5 on the other side.
7. Drill a  $\frac{1}{2}$ " hole in the lens of the old headlight assemblies to render them useless.
8. Before adjusting the headlights, do this:
  - Unload the vehicle.
  - Make sure the tire pressures are correct.
  - The driver or someone who weighs the same should sit in the driver's seat (or use an equivalent weight).
9. Make sure the outer lens is clean so that you can see the center of the headlights.

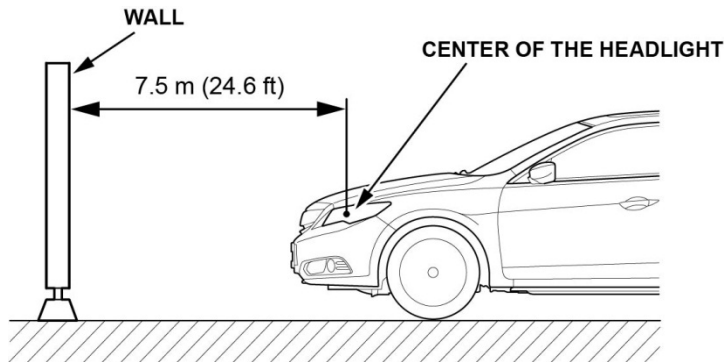
10. Park the vehicle on a level surface so that the center mark of the headlight is **7.5 m (24.6 ft)** away from a wall or screen.

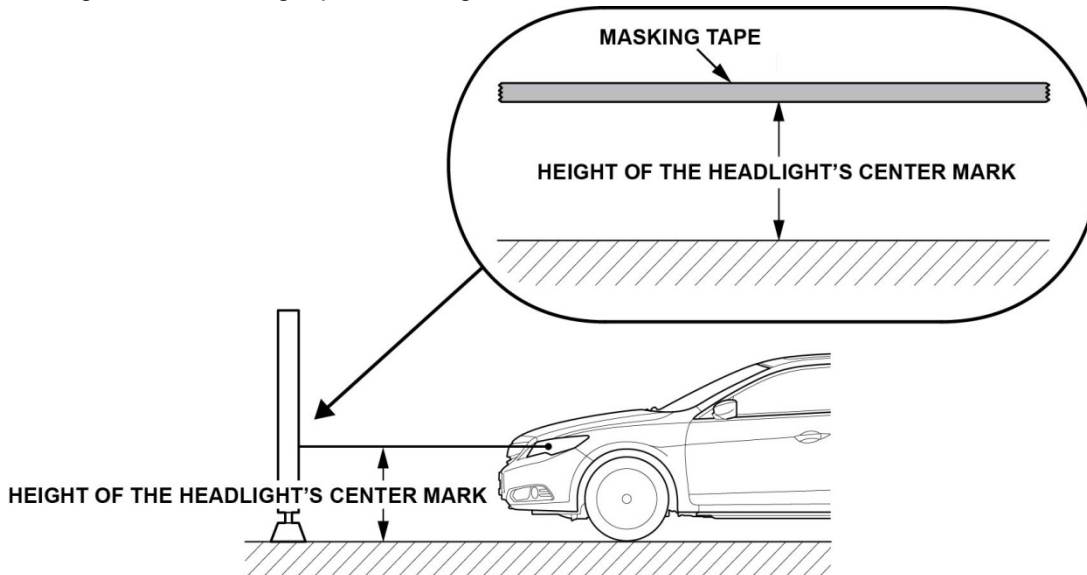
11. Measure the height of the headlight's center mark, then on the wall or screen, mark the same height of the headlights with masking tape in a straight line.

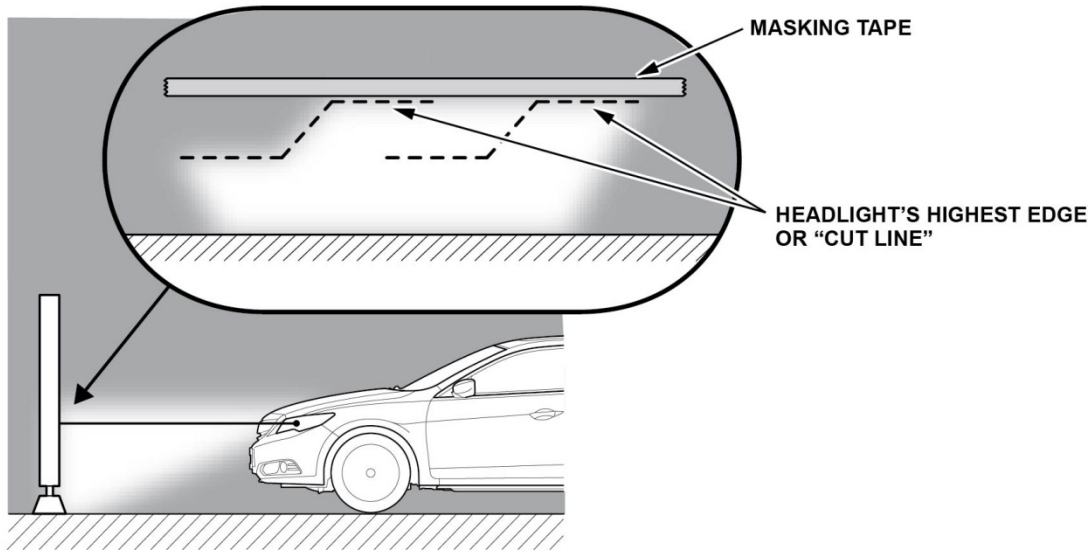
12. Turn on the low beam headlights.

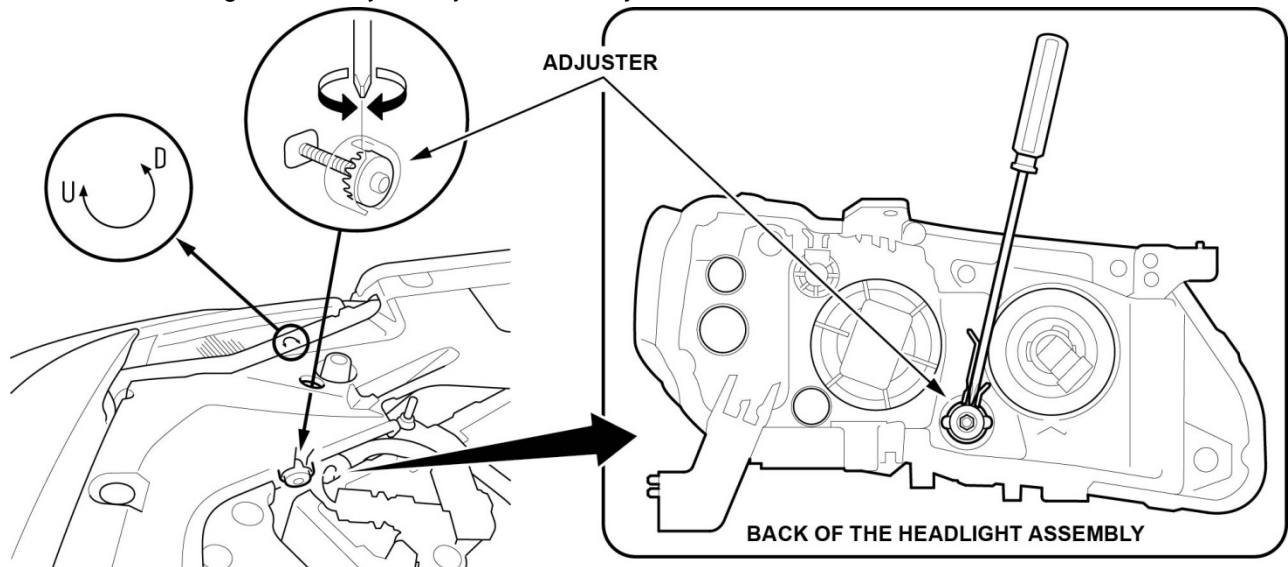
13. To see if the headlights are adjusted properly, look at the beams of the light projected on the wall or screen. The highest edge or cut line of the headlights should be equal with the masking tape.  
 NOTE: To help determine if a headlight is out of adjustment, block one of the beams with a large piece of cardboard or equivalent and look at the other beam on the wall or screen. Repeat this for the other headlight.
14. If adjustment is necessary, open the hood and adjust the headlights to local requirements by turning the adjuster.  
 NOTE: The headlights can only be adjusted vertically.
