# Recall Bulletin 140615ARG

ALLIED RECREATION GROUP

**RECALL  
BULLETIN:  
140615ARG**

**SUBJECT:**  
Inspection/  
correction of seat  
belt mounting  
hardware

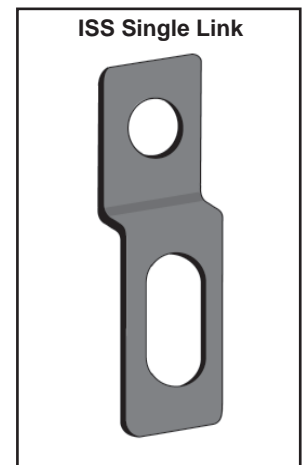
1. Park the motor home on level pavement. Place the transmission in Neutral and set the parking brake. Turn off the key and remove it from the ignition. Maintain control of keys until all repairs are performed.
2. Inspect both the pilot (driver) seat and co-pilot (passenger) seat:
  - a. Locate the seat belt mounting assembly attached to the seat.
  - b. Refer to Figure 1 and the inspection diagram supplied by Villa (Fig. 2 on Page 2) to determine whether or not the seat belt assembly is attached to the seat base by an ISS Single Link.
    - If the seat belt assembly is attached to the seat base by an ISS Single Link, proceed to Page 3, "Seat Belt Attachment Correction."
    - If the seat belt assembly is attached by a different hardware configuration, the seat is not part of the recall and no further action is required.

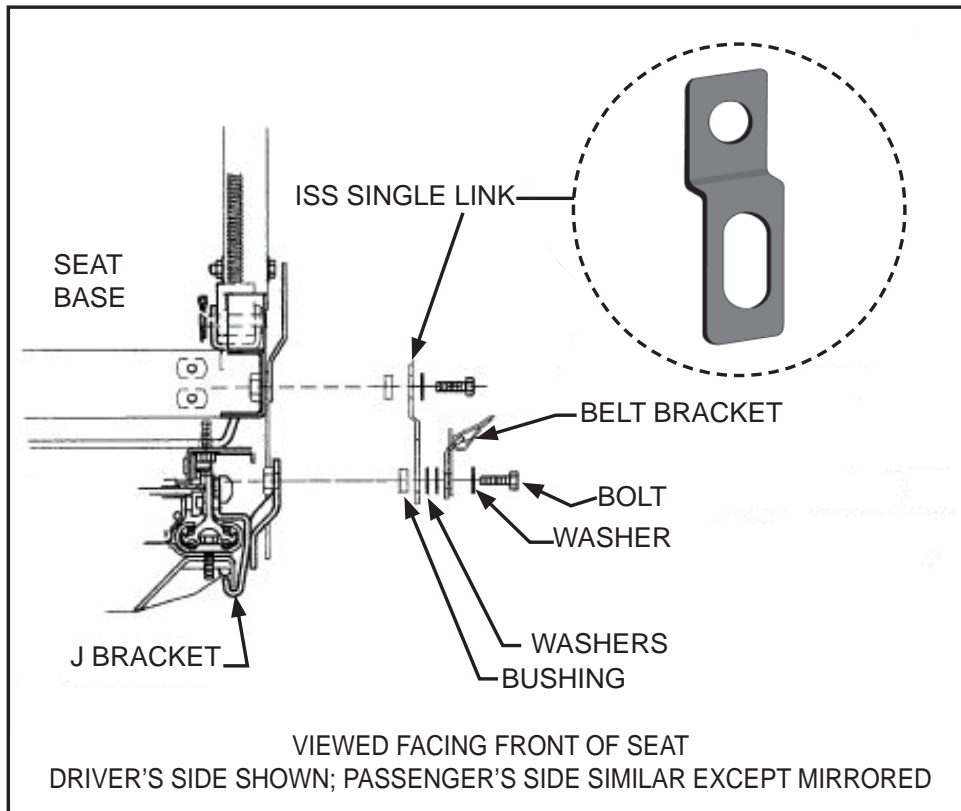
**Figure 2**

## INSPECTION DIAGRAM - RECALL 140615ARG

*If the seat belt is attached with an ISS single link, shown above, proceed to the Repair Instructions on Page 3.*

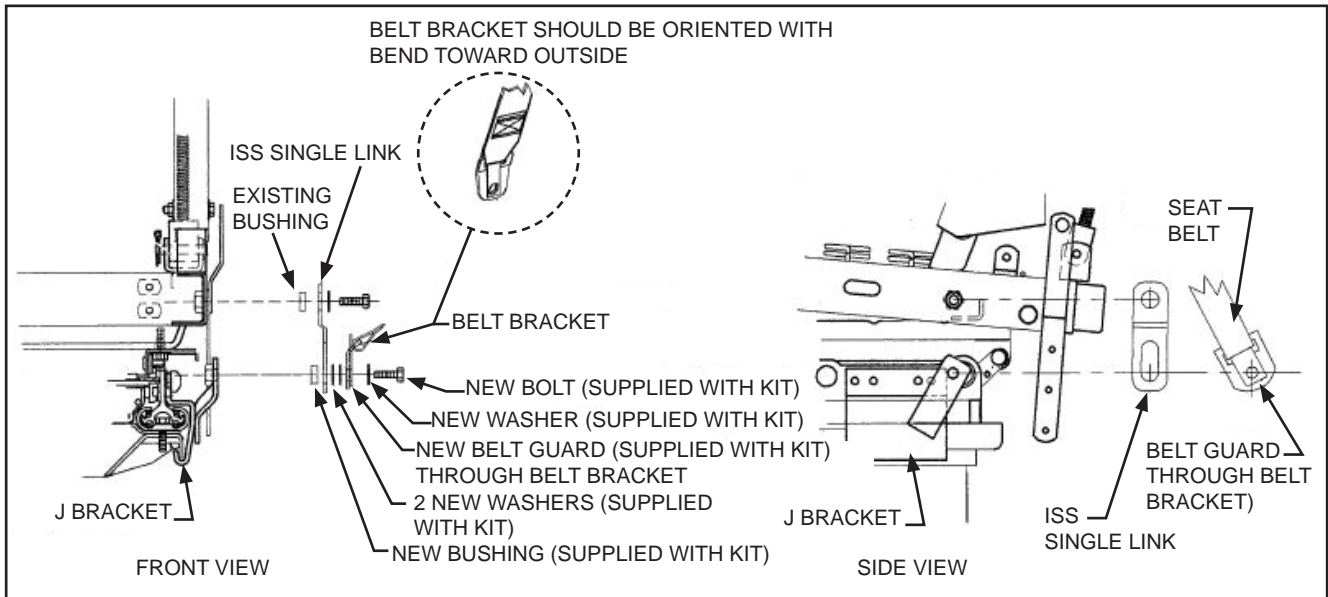
## SEAT BELT ATTACHMENT CORRECTION

1. Remove the hardware fastening the seat belt to the seat base assembly. Discard the original bolt, washers, and bushing.
2. Insert the new plastic belt guard, included with the recall kit, through the belt attachment bracket as shown in Figures, 3,4 and 5.

- Referring to the installation diagram in Figure 3 and the photos in Figures 4 and 5, reinstall the seat belt through the original ISS single link and to the seat base, using the new washers, bolts, and spacer bushings supplied with the recall kit. Ensure the assembly order is correct. Torque the attachment bolts to 20 ft-lbs.

- Hand-start the bolts to avoid cross-threading.
  - An extra bushing is supplied with the recall kit. Use it behind the top portion of the ISS single link, as shown in Figure 3, if one was not originally installed.
- Verify the seat belt is installed correctly and operates properly; correct as necessary. Reference photos of a completed installation appear in Figures 6 & 7.
  - Repeat steps 1-4 for the opposite seat if required.
