**April 28, 2016**

51969-01908 Version 10

## **Recall: Front Passenger's Airbag Inflator May Produce Excessive Pressure After Long-Term Exposure To High Absolute Humidity**

**Supersedes 14-030, dated December 22, 2015, to revise the information highlighted in yellow**

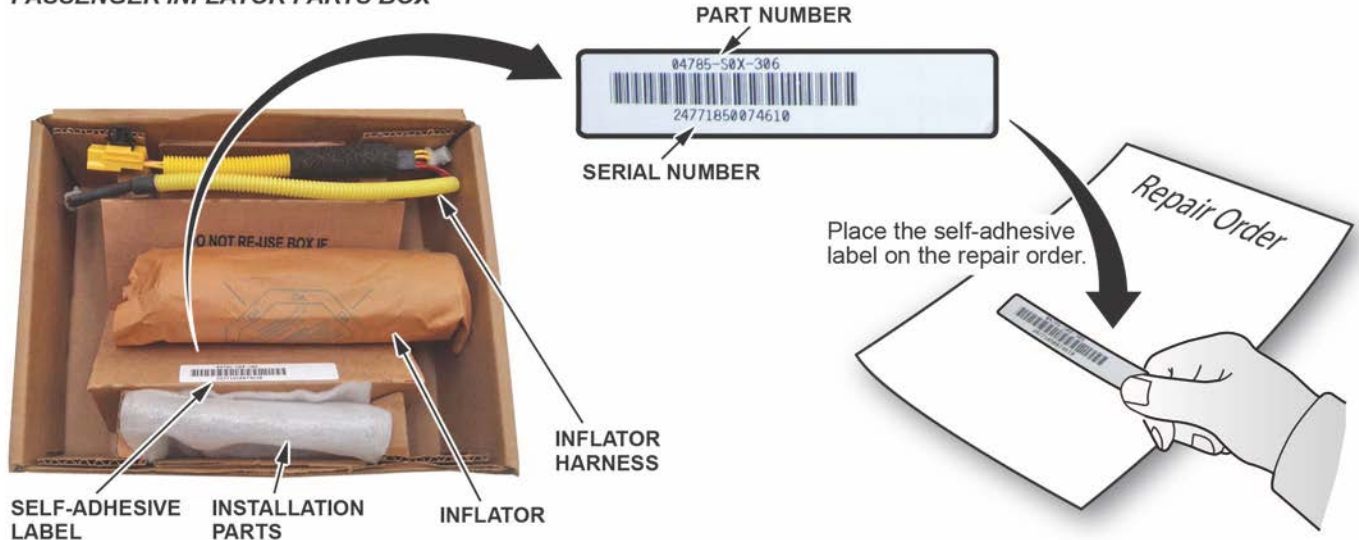
**PASSENGER INFLATOR PARTS BOX**

- The replacement part number is printed on the top part of the label and the serial number is printed on the bottom. **Make sure you attach the label to the R.O. and give it to the warranty clerk.**
- There may also be a colored sticker located in the kit, ignore it because it is not used.
- Not all inflator kits have a label included. In those cases, write the serial number and part number from the side of the inflator box on the R.O. The part number always starts with 047.

6. Peel the label located inside the inflator box from its backing and attach it to the RO. For the warranty claim to be paid, the **replacement inflator part number that you received** must be included in the warranty claim.

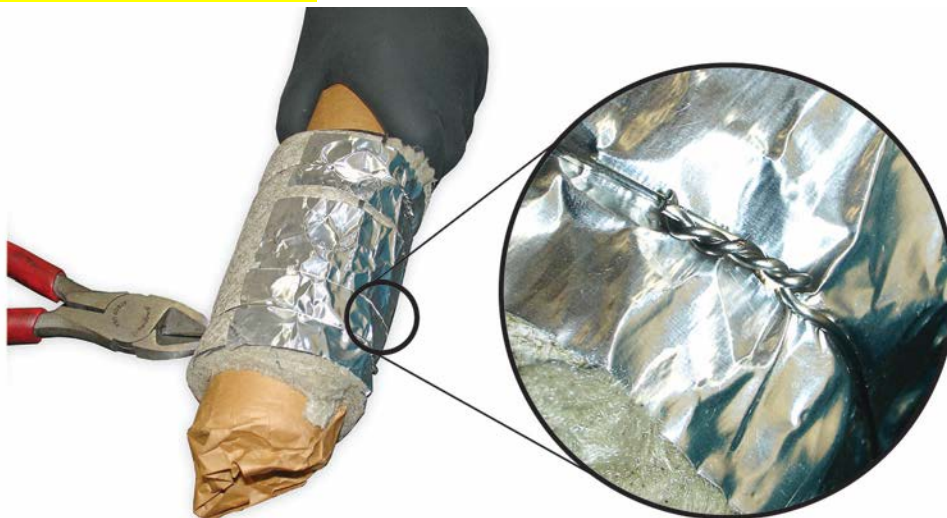
- Wear disposable gloves and protective glasses. The insulation is not toxic or dangerous, but some people may be sensitive to the insulation.
- Dispose of the insulation and wrapping paper to avoid getting the insulation dust/fibers on you or the airbag assembly.
- Do not reuse the insulation or wrapping paper. You do not need to wrap the inflator being removed from the vehicle when it is returned.
- Cut the wires off from the opposite side from where they are tied (twisted) together.

NOTE: Do not cut the insulation.

7. If the replacement inflator (P/N ends with 305) is wrapped with shipping insulation, remove it:

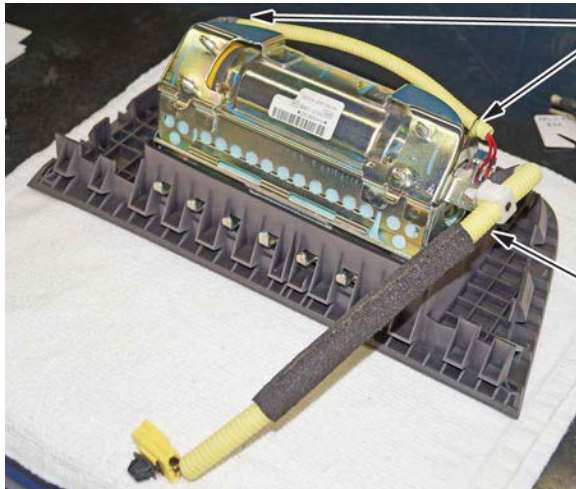
INFLATOR BRACKETS

8. Remove the harness from both ends of the inflator bracket.

Disconnect and remove the harness clip if applicable.

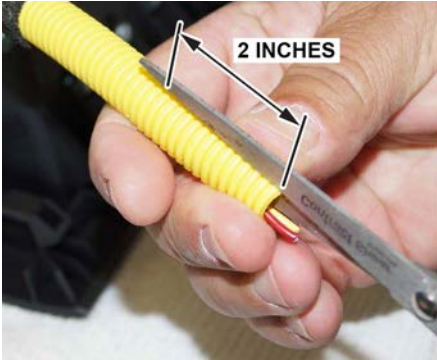
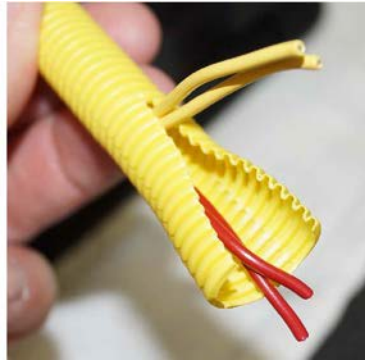
- Cut about 2 inches of the corrugated tube, then pull out the yellow wires.

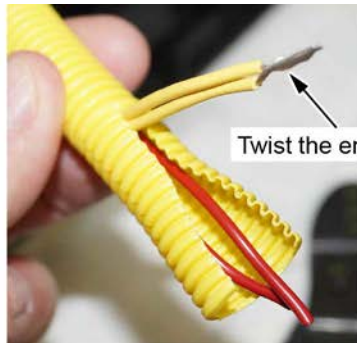
- Strip away about an inch of the wire insulation, then twist the wires together.

- Tape the twisted ends with electrical tape.

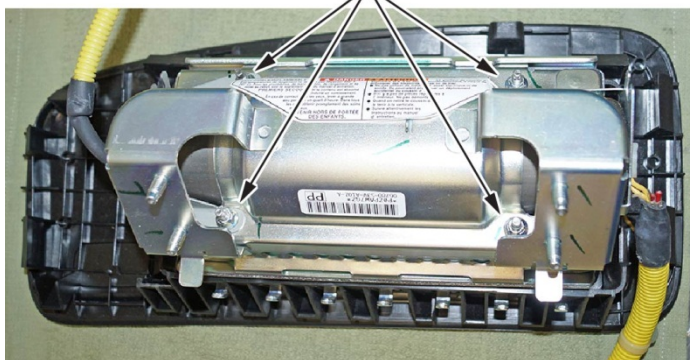
INFLATOR NUTS

11. Remove the four inflator nuts.

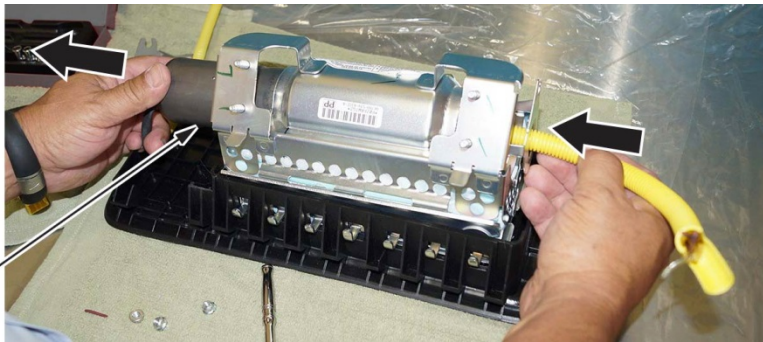
13. Remove the inflator by pushing it out.

INFLATOR  
Do not reuse.

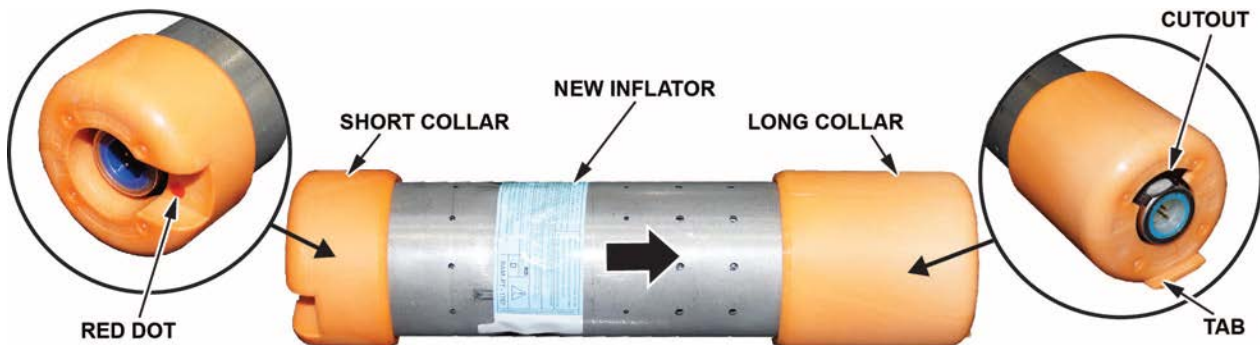
- The collars on this inflator are orange, not white. One side of the inflator has a longer collar, a tab, a plastic cutout, and a small flat spot on the connector. The other side of the inflator has a shorter collar, no tab, and a red dot. Make sure you insert the end with the longer collar into the airbag first.

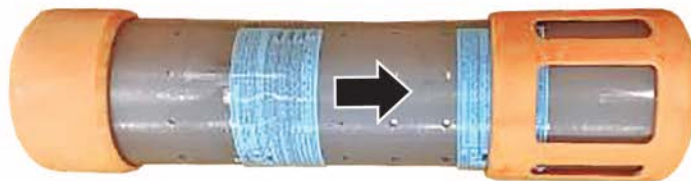
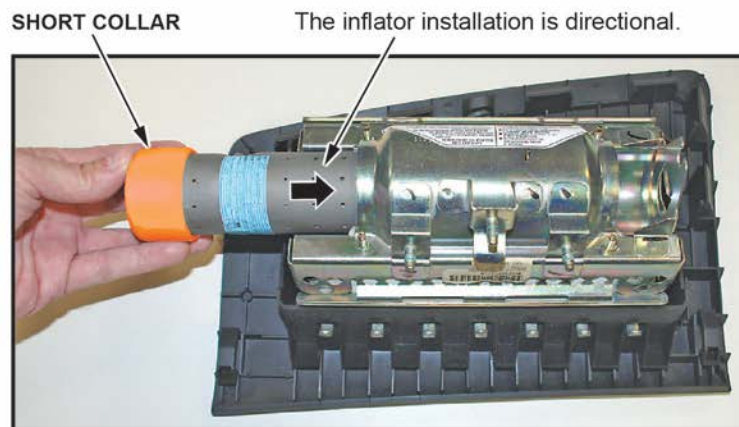
**NOTE:** Part numbers ending in 315 appear slightly different because they have square openings in the plastic caps.

(Part number ending with 315 appears slightly different.)

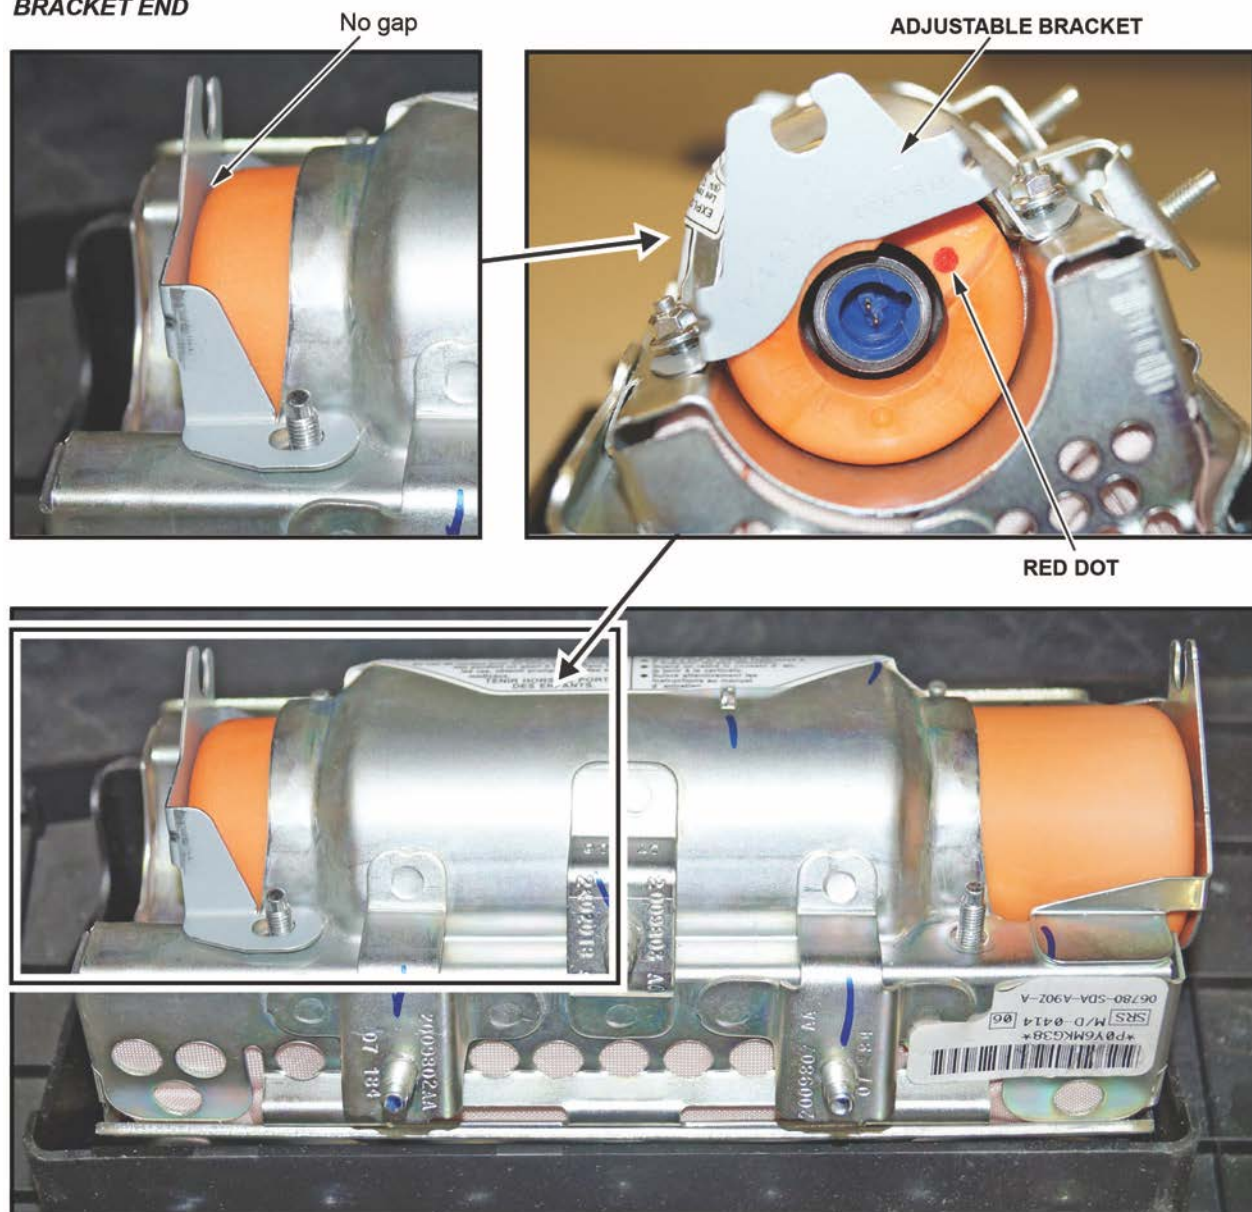
**ADJUSTABLE  
BRACKET END**

- Install the bracket included in the kit onto the airbag module. There should be a red dot visible on the end of the plastic connector. There should be no space or gap between the inflator and bracket.

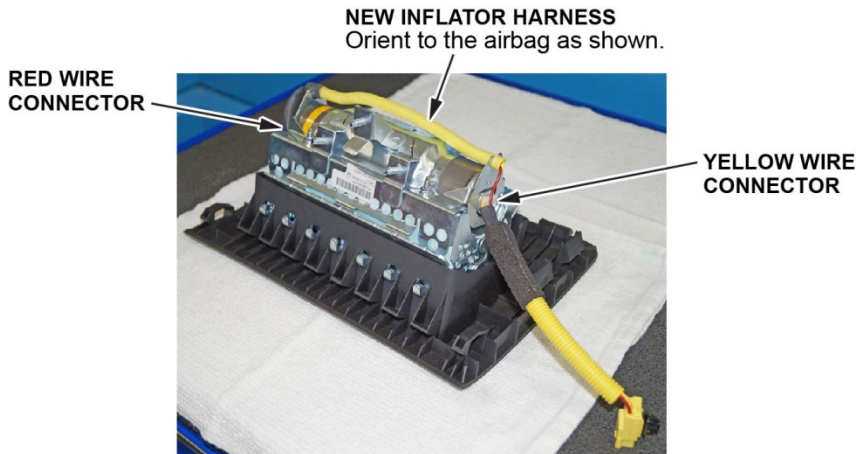
- Make sure the airbag and harness are aligned as shown.

NOTE: Make sure you have the orientation correct as shown below. If you connect the harness incorrectly, the harness cannot be removed, and you will not be able to reinstall the airbag because the harness will be too short.

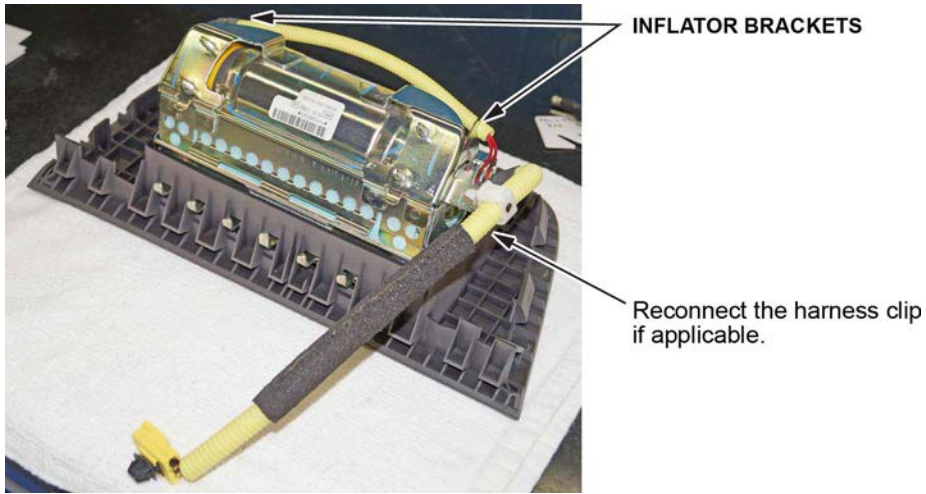
- Insert the side without the shrink-wrap tubing first. Insert the harness at the third “valley” in the corrugated tube.
- Insert the side of the harness with the shrink-wrap tubing into the inflator bracket. Make sure the harness is securely inserted and that it does not sag.

18. Connect the harness to the inflator brackets.
