BTB 51969-00412 REV4 (1412)

## **Recall: Front Passenger's Airbag Inflator May Produce Excessive Pressure After Long-Term Exposure To High Absolute Humidity**

Supersedes 14-030, dated September 12, 2014, to revise the information highlighted in **yellow**

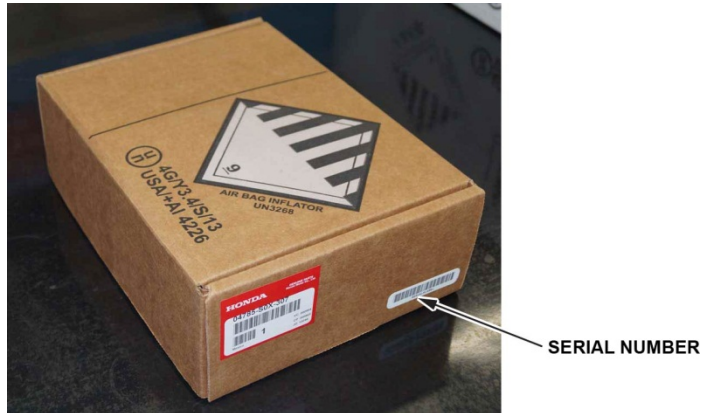
- If the VIN status inquiry indicates that the vehicle is subject to any open safety recalls, including the driver's airbag inflator, make sure to also complete those recall repairs before returning the vehicle to the client. If you are unable to complete any open recall, advise the client of the recall status and when the recall could be completed.
  - Be careful not to damage any parts when replacing the inflator, and follow the procedure exactly.
  - If, before removing the airbag, you suspect that it may be the incorrect airbag for the vehicle or a counterfeit, **do not remove the airbag**. Contact your DPSM for assistance.
1. Write down the serial number located on the right side of the new inflator box. For the warranty claim to be paid, your warranty clerk must enter this serial number in the Diagnostic Trouble Codes field on the warranty claim.

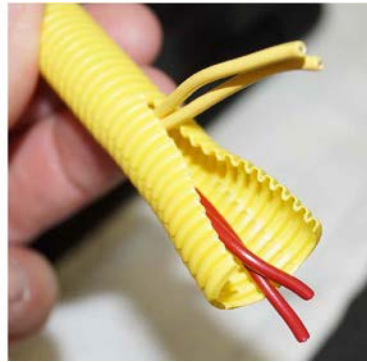
- Cut about 2 inches of the corrugated tube, then pull out the yellow wires.
