51969-01908 Version 6

## Recall: Front Passenger's Airbag Inflator May Produce Excessive Pressure After Long-Term Exposure To High Absolute Humidity

Supersedes 14-030, dated December 11, 2014, to revise the information highlighted in **yellow**

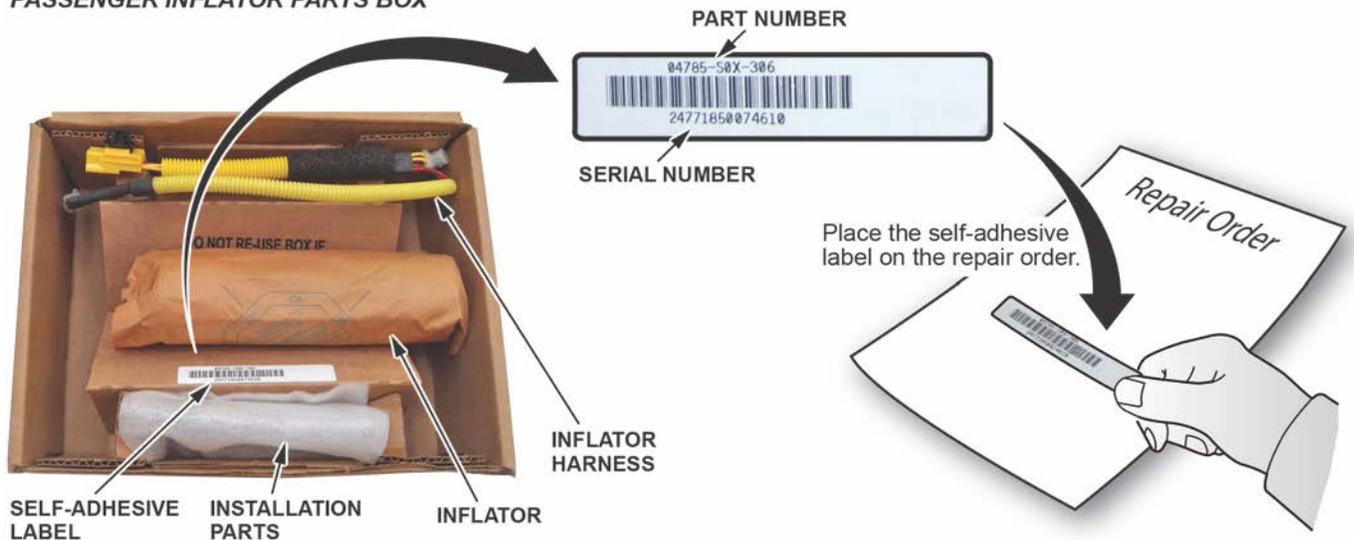
### PASSENGER INFLATOR PARTS BOX

- The replacement part number is printed on the top part of the label and the serial number is printed on the bottom. **Make sure you attach the label to the R.O. and give it to the warranty clerk.**
- There may also be a colored sticker located in the kit, ignore it because it is not used.
- Not all inflator kits have a label included. In those cases, write the serial number and part number from the side of the inflator box on the R.O. The part number always starts with 047.

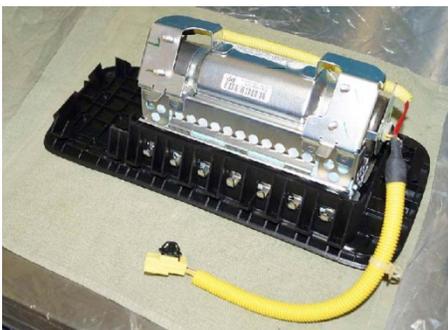
2. Remove the front passenger's airbag.
3. Place the airbag face-down on a clean shop towel as shown.

- The orientation of the airbag is critical because if the inflator is installed incorrectly, the harness will be too short when you reinstall the airbag.
- The brackets between the various models are similar but may differ from the example shown.

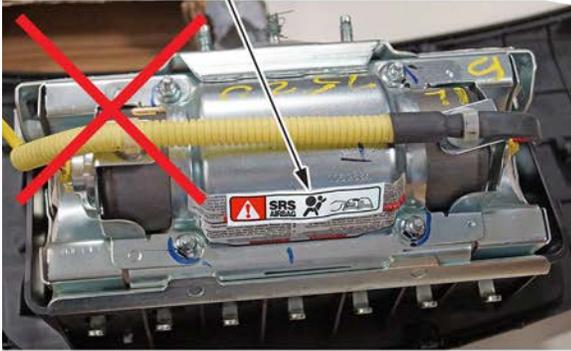
NON-STANDARD SAFETY LABEL

4. Visually inspect the airbag and the inflator for any unusual writing or markings.
  - If there is nothing unusual about the airbag or the inflator, go to step 5.
  - If there are any unusual markings, like an incorrect label or a model year written in marker, the airbag and inflator may not be the correct airbag and/or inflator for the vehicle or it may be a counterfeit part. For more information about counterfeit airbags, you can refer to [safercar.gov](http://safercar.gov), enter keywords **MANAGING COUNTERFEIT**, and select **Recommended Dealer Guidance for Managing Counterfeit Air Bags** from the list. **If you suspect that the airbag or inflator is counterfeit, do not continue this procedure.** Contact your DPSM for assistance.

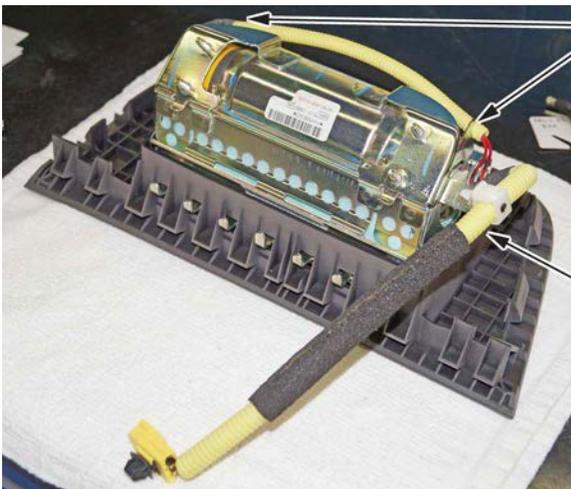
INFLATOR BRACKETS

5. Remove the harness from both ends of the inflator bracket.

Disconnect and remove the harness clip if applicable.

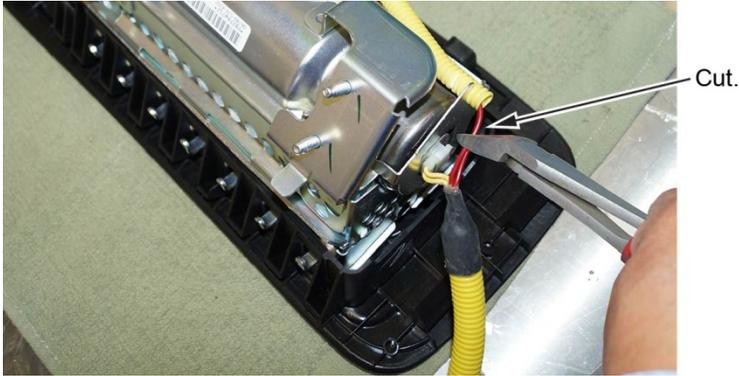
NOTE: You must cut and short the wires as indicated to prevent accidental deployment.

- Cut the red wires as shown.

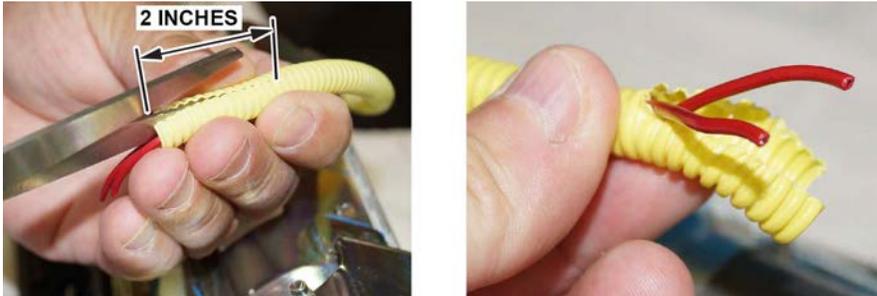
- Cut about 2 inches of the corrugated tube, then pull out the two red wires.

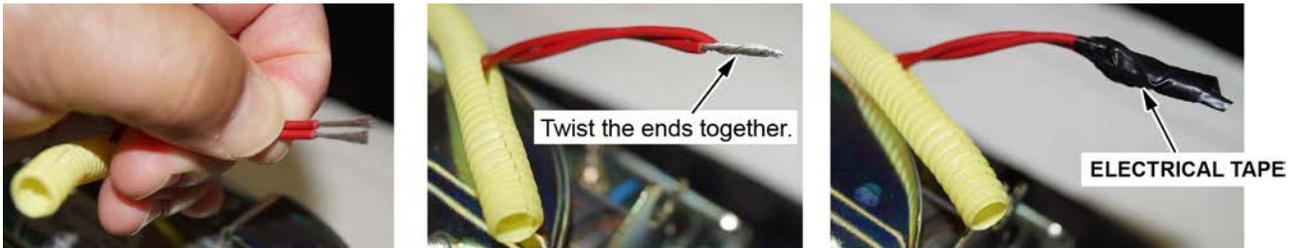
- Strip away about 1 inch of the wire insulation, then twist the wires together.

- Tape the twisted ends with electrical tape.

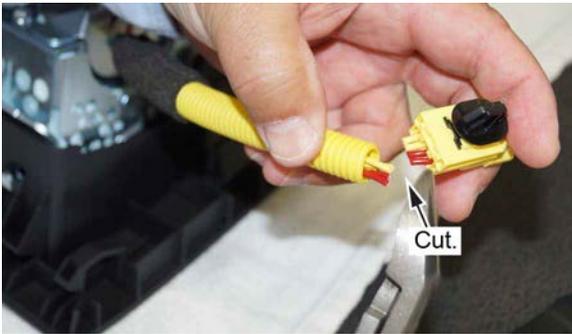
You must cut and short the wires as indicated to prevent accidental deployment.

- Cut all four wires to remove the connector.

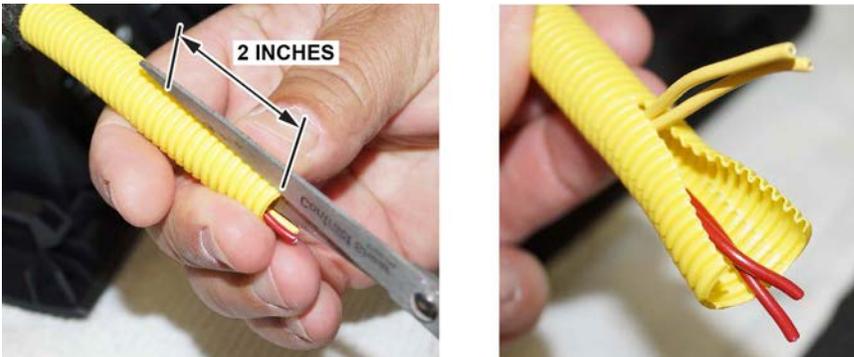
- Cut about 2 inches of the corrugated tube, then pull out the yellow wires.

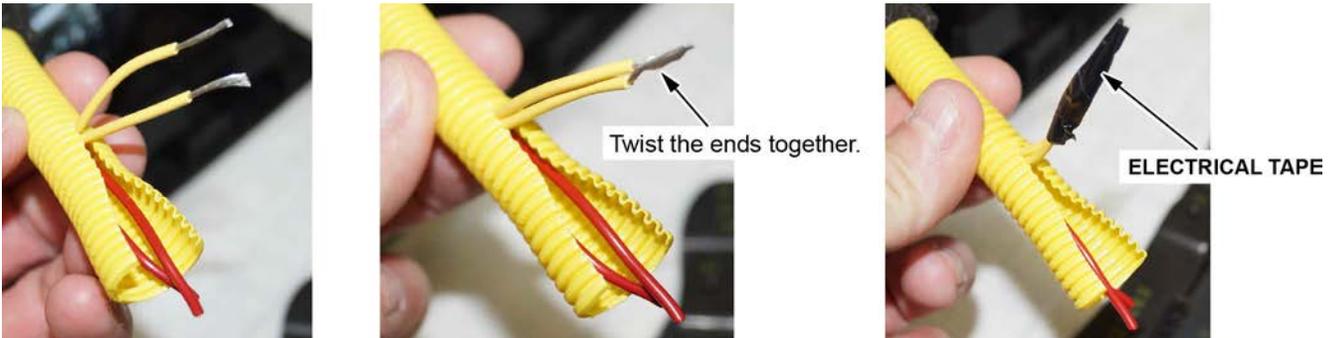
- Strip away about an inch of the wire insulation, then twist the wires together.

- Tape the twisted ends with electrical tape.

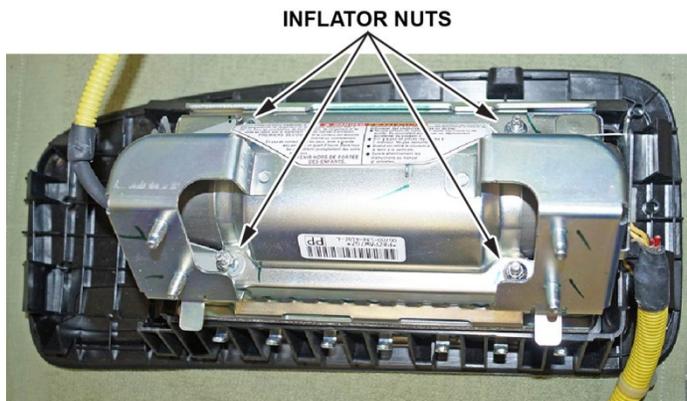
8. Remove the four inflator nuts.

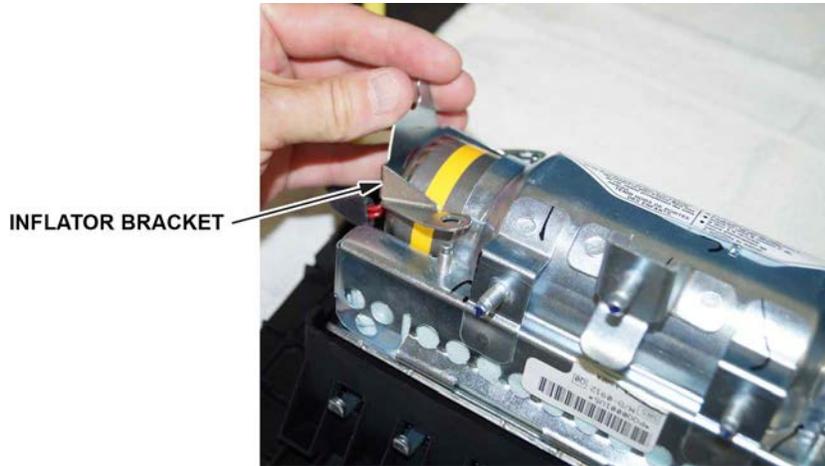
9. Remove the inflator bracket.

NOTE: You can only remove one of the brackets, as the other is welded to the airbag housing.

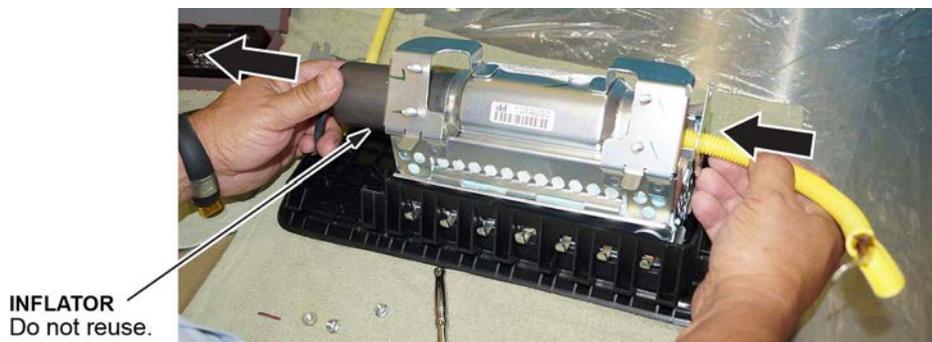
10. Remove the inflator by pushing it out.

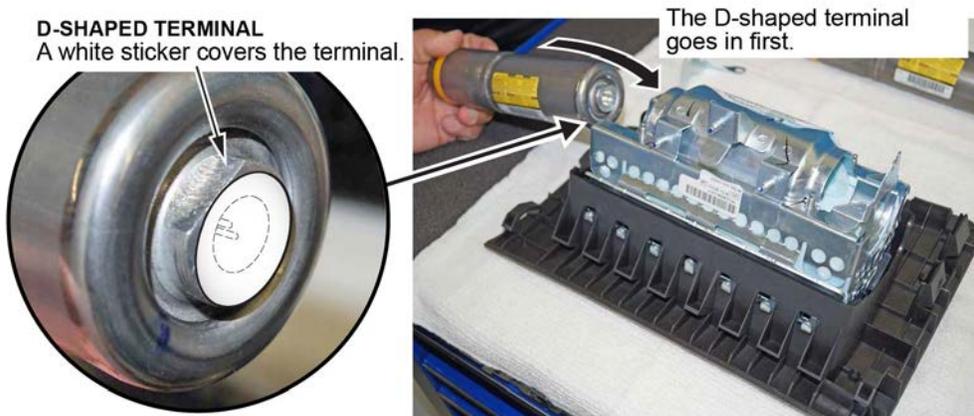
- One connector looks like a “D” whereas the other connector is a circle. Make sure you insert the “D” connector into the airbag first.

NOTE: There is a yellow band marking on the circle side.

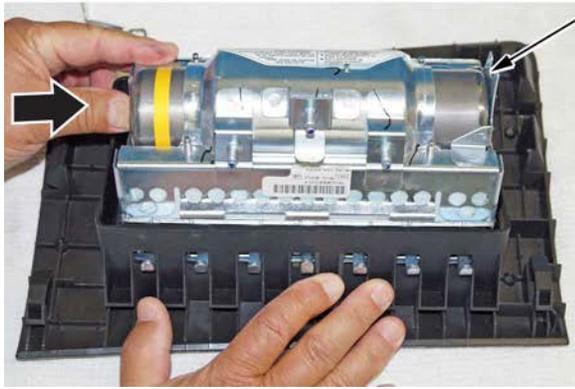
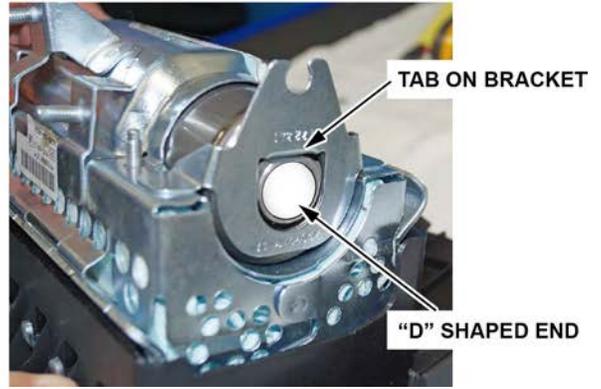
- Slide the inflator in until the “D” aligns with the tab on the inflator bracket. There should be no space or gap between the inflator and bracket.

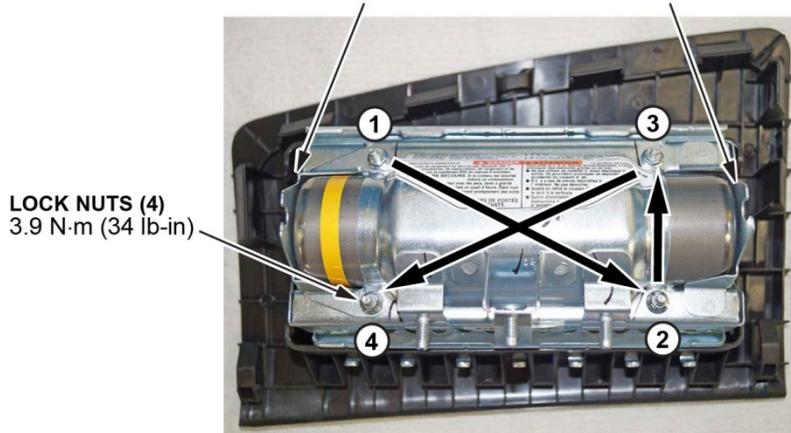
- Install the new 5 mm locknuts and torque them in sequence to **3.9 N•m (34 lb-in)**.  
Be sure there are no gaps between the inflator ends and the inflator brackets.

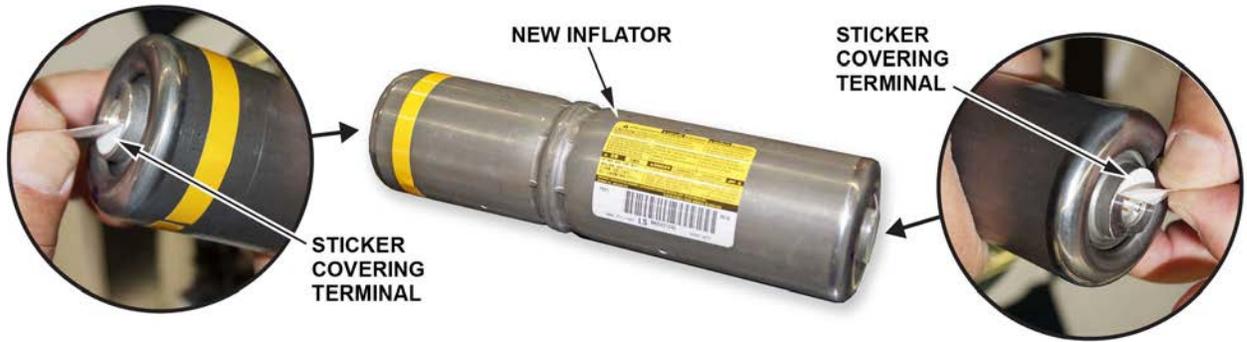
12. Remove the stickers covering the terminals on both sides of the new inflator.

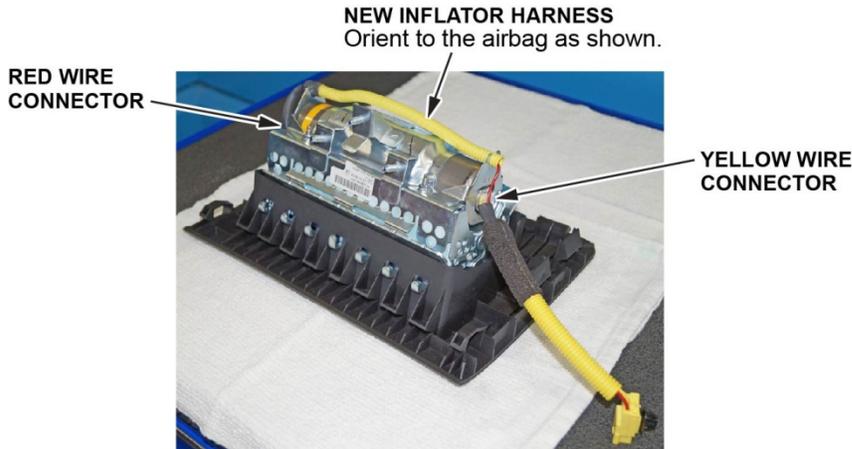
- Make sure the airbag and harness are aligned as shown.

NOTE: Make sure you have the orientation correct as shown below. If you connect the harness incorrectly, the harness cannot be removed, and you will not be able to reinstall the airbag because the harness will be too short.

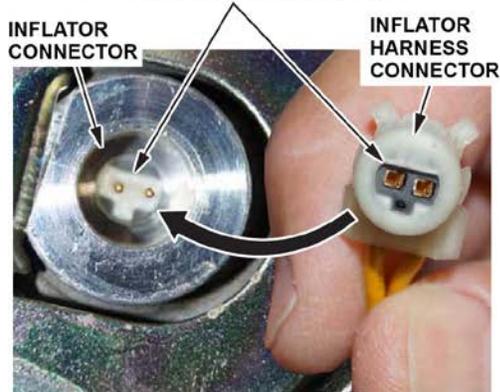
- Connect the two connectors. Align the "T" shape in the inflator harness connector with the T-shaped inflator connector, then press the connector into place.

① Match up the "T" shape as shown. The connectors are directional.

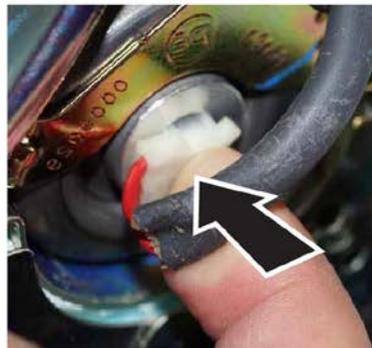
② Press the connector into place until it clicks.

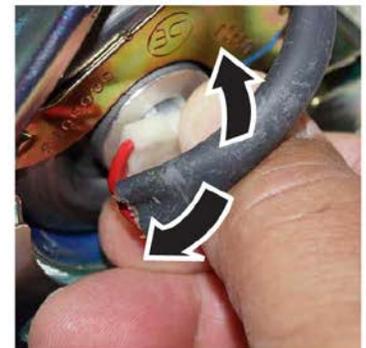
③ Wiggle the connector to make sure it's secure.

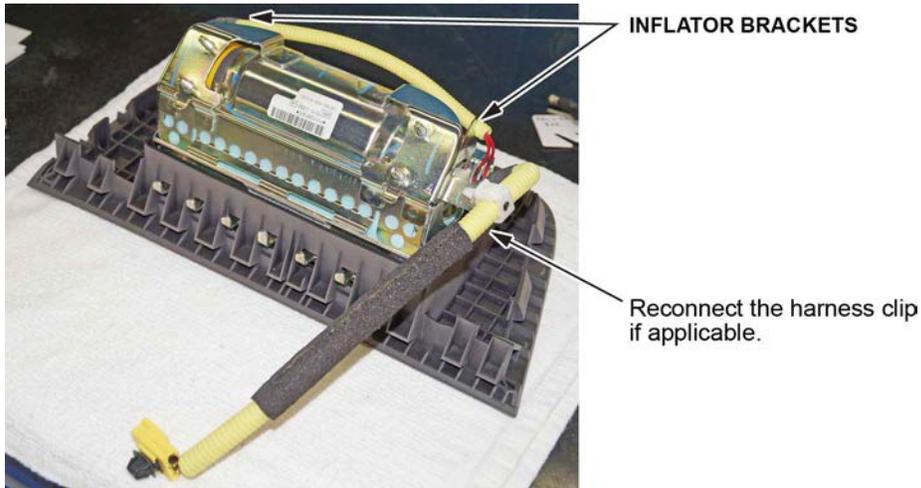
- Insert the side without the shrink-wrap tubing first. Insert the harness at the third “valley” in the corrugated tube.
- Insert the side of the harness with the shrink-wrap tubing into the inflator bracket. Make sure the harness is securely inserted and that it does not sag.
