**December 19, 2015**

51968-01885 Version 11

## **Recall: Front Passenger's Airbag Inflator May Produce Excessive Pressure After Long-Term Exposure To High Absolute Humidity**

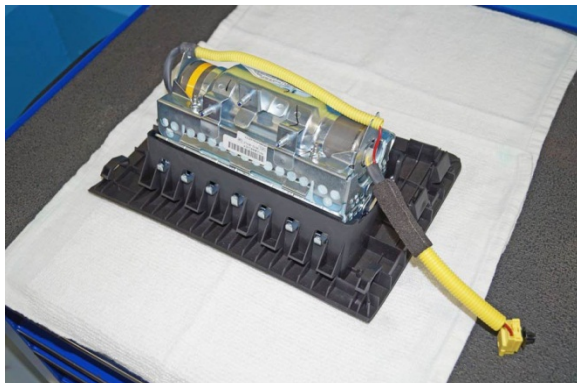
4. Place the airbag, face-down, on a clean shop towel.

- The orientation of the airbag is critical because if the inflator is installed incorrectly, the harness will be too short when you reinstall the airbag.
- The brackets between the various models are similar but may differ from the example shown.
