BTB 51969-52551 REV1 (1409)

## Recall: Front Passenger's Airbag Inflator May Produce Excessive Pressure After Long-Term Exposure To High Absolute Humidity

(Supersedes 14-030, dated July 23, 2014; parts, warranty, and repair information have been added. Make sure to read this bulletin in its entirety)

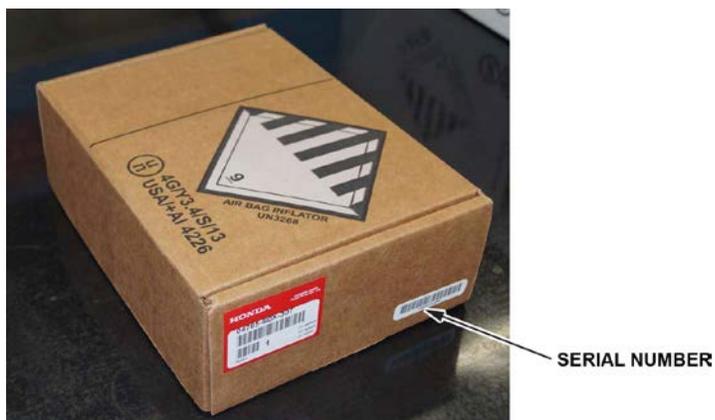
- Be careful not to damage any parts when replacing the inflator, and **follow the procedure exactly**.
  - If, before removing the airbag, you suspect that it may be the incorrect airbag for the vehicle or a counterfeit, **do not remove the airbag**. Contact your DPSM for assistance.
1. Write down the serial number located on the right side of the new inflator box. For the warranty claim to be paid, your warranty clerk must enter this serial number in the Diagnostic Trouble Codes field on the warranty claim.

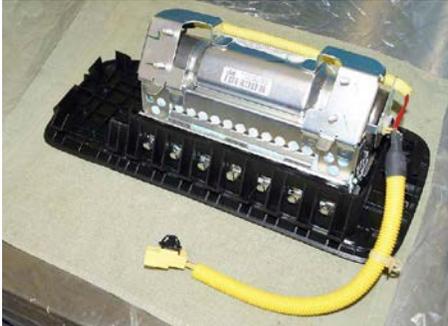
3. Place the airbag face-down on a clean shop towel as shown.

- The orientation of the airbag is critical because if the inflator is installed incorrectly, the harness will be too short when you reinstall the airbag.
- The brackets between the various models are similar but may differ from the example shown.

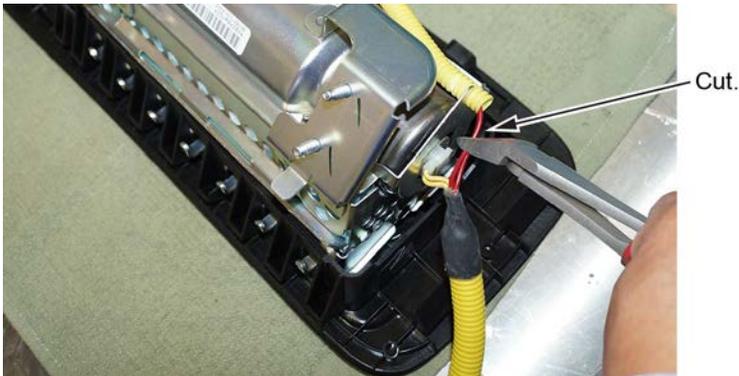
6. Short the red wires.

NOTE: You must cut and short the wires as indicated to prevent accidental deployment.

- Cut the red wires as shown.

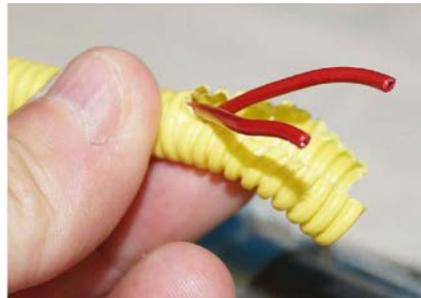
- Cut about 2 inches of the corrugated tube, then pull out the two red wires.

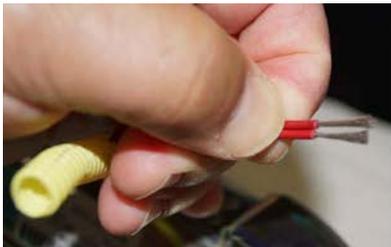
- Strip away about 1 inch of the wire insulation, then twist the wires together.

- Tape the twisted ends with electrical tape.

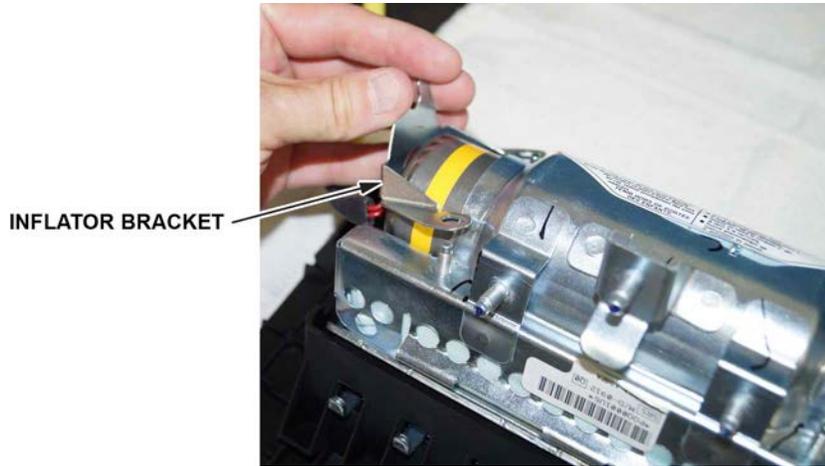
9. Remove the inflator bracket.

NOTE: You can only remove one of the brackets, as the other is welded to the airbag housing.

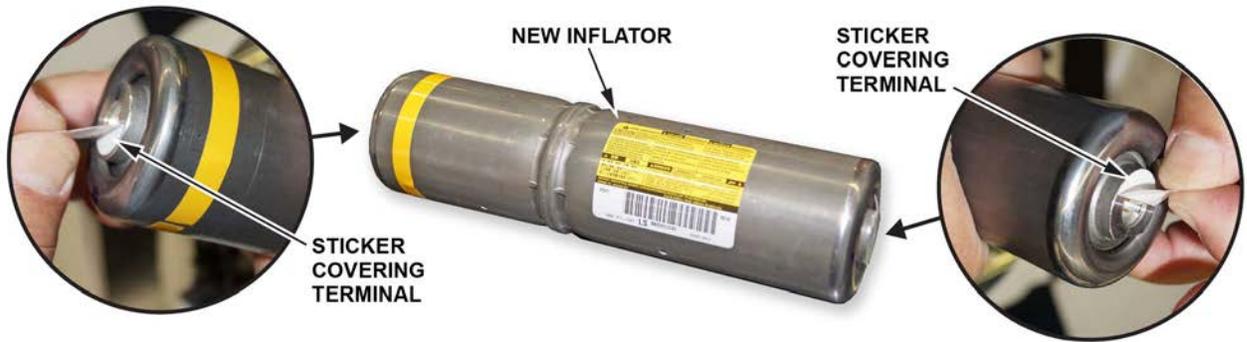
12. Remove the stickers covering the terminals on both sides of the new inflator.
