51969-01908 Version 7

Recall: Front Passenger's Airbag Inflator May Produce Excessive Pressure After Long-Term Exposure To High Absolute Humidity

Supersedes 14-030, dated May 1, 2015; see Revision Summary

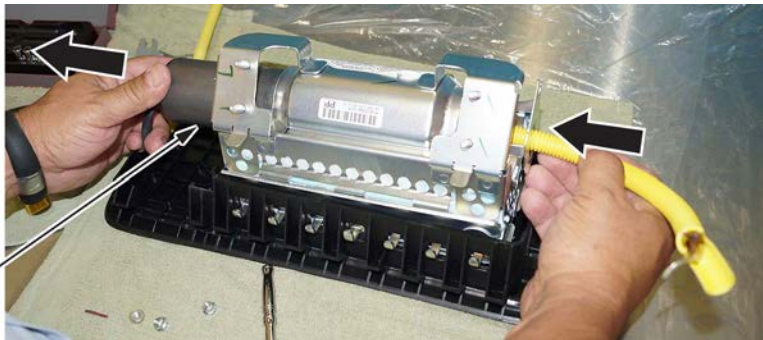
12. Remove the inflator by pushing it out.

INFLATOR
Do not reuse.

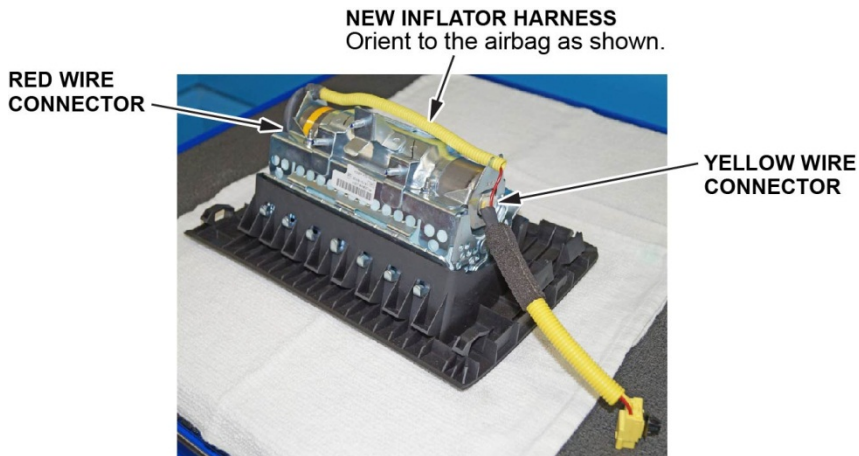
16. Install the new inflator harness.

- Make sure the airbag and harness are aligned as shown.

NOTE: Make sure you have the orientation correct as shown below. If you connect the harness incorrectly, the harness cannot be removed, and you will not be able to reinstall the airbag because the harness will be too short.
