**September 16, 2015**

51968-01885 Version 10

## **Recall: Front Passenger's Airbag Inflator May Produce Excessive Pressure After Long-Term Exposure To High Absolute Humidity**

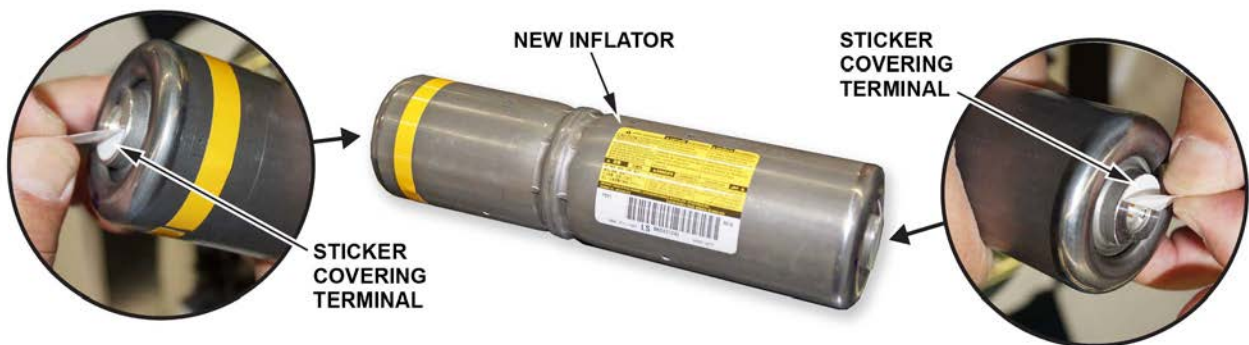
15. Remove the stickers covering the terminals on both sides of the new inflator.
