51968-01885 Version 9

Recall: Front Passenger's Airbag Inflator May Produce Excessive Pressure After Long-Term Exposure To High Absolute Humidity

Supersedes 14-046, dated June 16, 2015; see Revision Summary

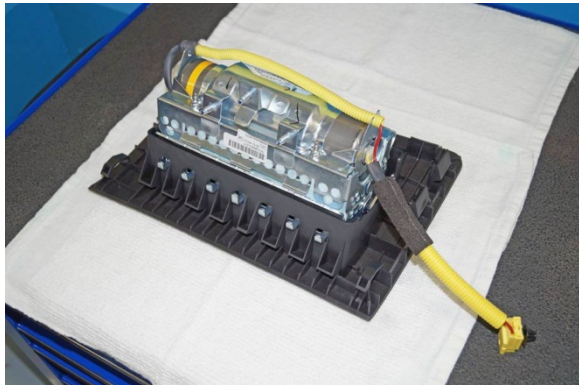
3. Remove the front passenger's airbag by referring to the applicable electronic service manual.
 4. Place the airbag, face-down, on a clean shop towel.

- The orientation of the airbag is critical because if the inflator is installed incorrectly, the harness will be too short when you reinstall the airbag.
- The brackets between the various models are similar but may differ from the example shown.

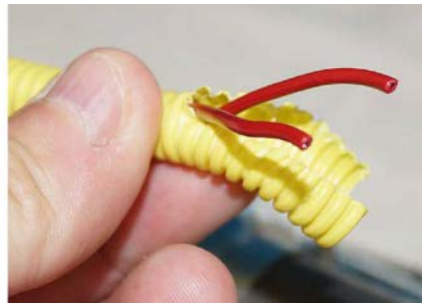
- Cut about 2 inches of the corrugated tube, then pull out the two red wires.

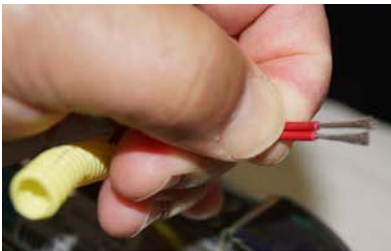
- Strip away about 1 inch of the wire insulation, then twist the wires together.

- Tape the twisted ends with electrical tape.

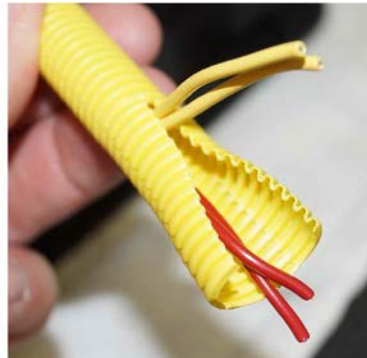
- Cut about 2 inches of the corrugated tube, then pull out the yellow wires.

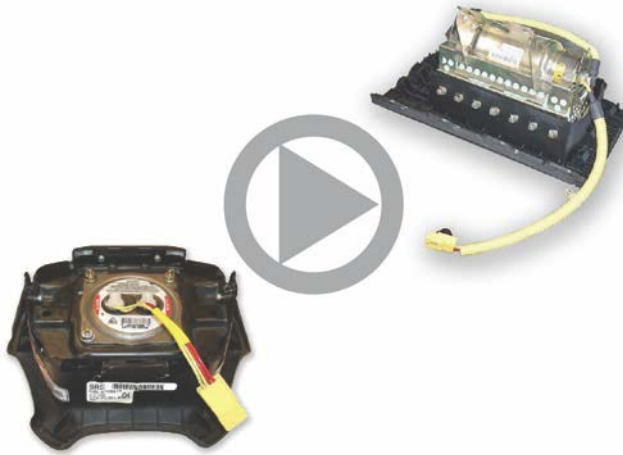
Click on the image below for a short video about the different variations of the driver's and front passenger's replacement inflators involved with the recalls related to inflators. While both the driver's and front passenger's inflators are shown in the video, this is informational only. Replace inflators only as directed by the iN VIN status inquiry.

13. Install the new inflator.

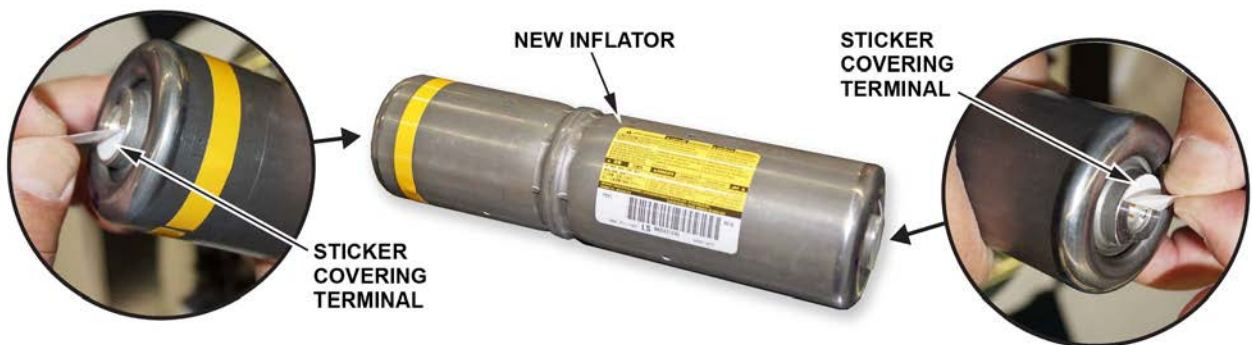
15. Remove the stickers covering the terminals on both sides of the new inflator.

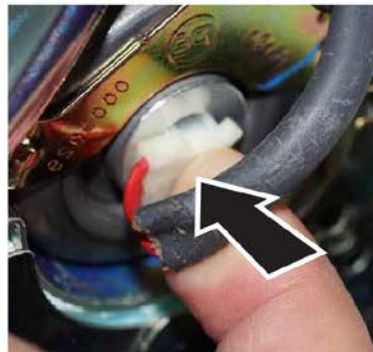
② Press the connector into place until it clicks.
