**September 15, 2015**

51969-01908 Version 8

## **Recall: Front Passenger's Airbag Inflator May Produce Excessive Pressure After Long-Term Exposure To High Absolute Humidity**

**Supersedes 14-030, dated July 1, 2015, to revise the information highlighted in yellow**

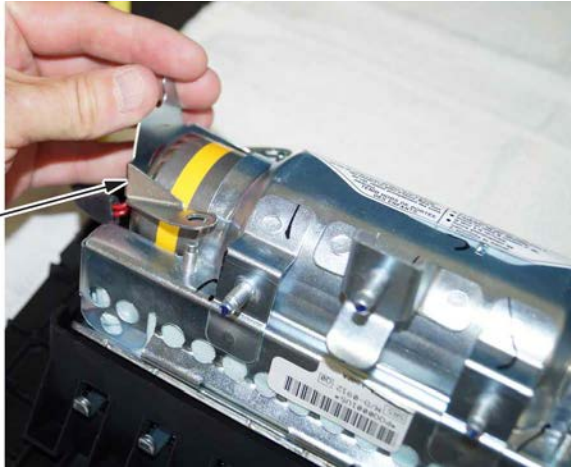
INFLATOR BRACKET

11. Remove the inflator bracket.

NOTE: You can only remove one of the brackets, as the other is welded to the airbag housing.

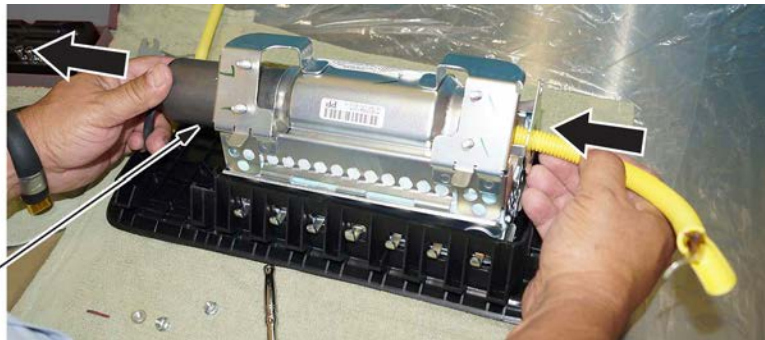
12. Remove the inflator by pushing it out.

INFLATOR  
Do not reuse.

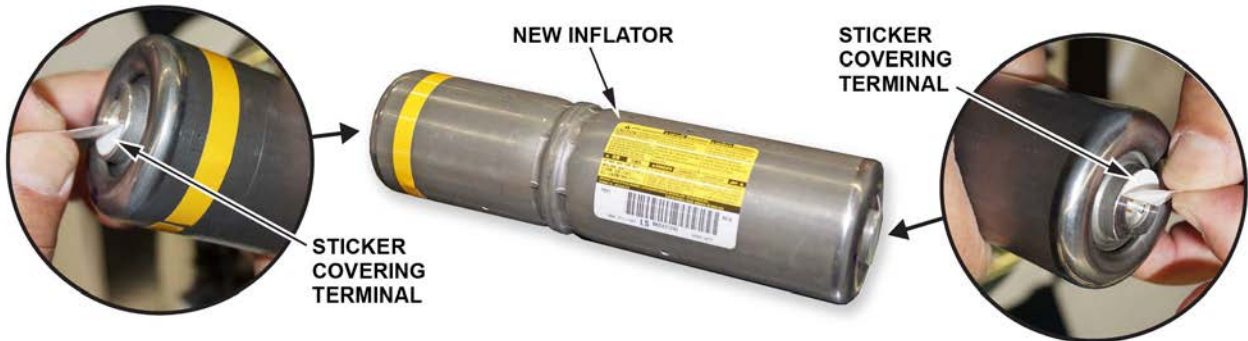
15. Remove the stickers covering the terminals on both sides of the new inflator.
