December 22, 2015

51969-01908 Version 9

## Recall: Front Passenger's Airbag Inflator May Produce Excessive Pressure After Long-Term Exposure To High Absolute Humidity

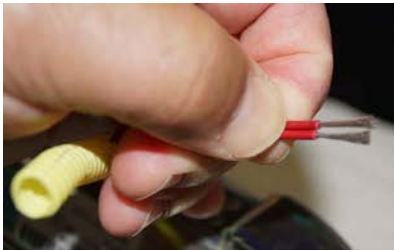
- Strip away about 1 inch of the wire insulation, then twist the wires together.

- Tape the twisted ends with electrical tape.

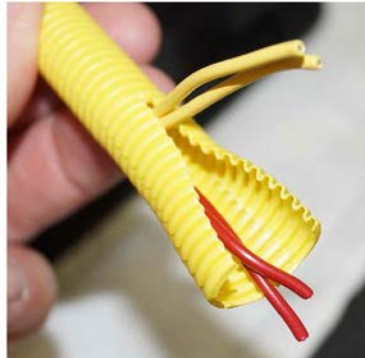
- Cut about 2 inches of the corrugated tube, then pull out the yellow wires.

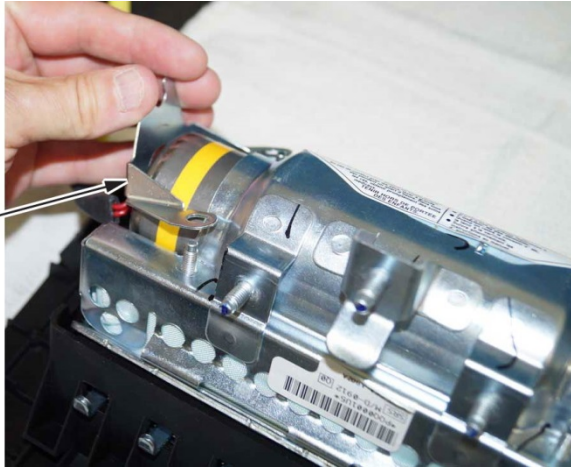
INFLATOR BRACKET

11. Remove the inflator bracket.

NOTE: You can only remove one of the brackets, as the other is welded to the airbag housing.

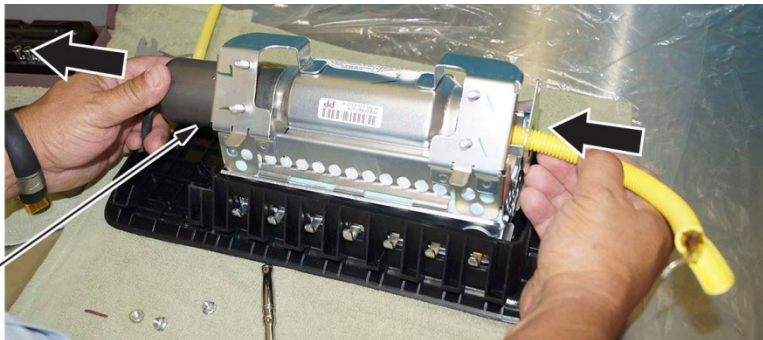
12. Remove the inflator by pushing it out.

INFLATOR  
Do not reuse.

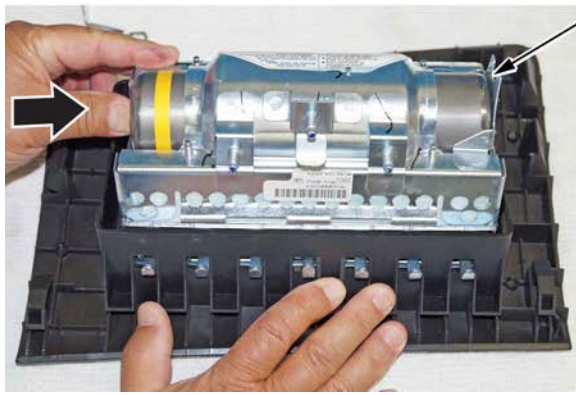
- Slide the inflator in until the “D” aligns with the tab on the inflator bracket. There should be no space or gap between the inflator and bracket.
