51968-01885 Version 8

## **Recall: Front Passenger's Airbag Inflator May Produce Excessive Pressure After Long-Term Exposure To High Absolute Humidity**

**Supersedes 14-046, dated April 24, 2015; see Revision Summary**

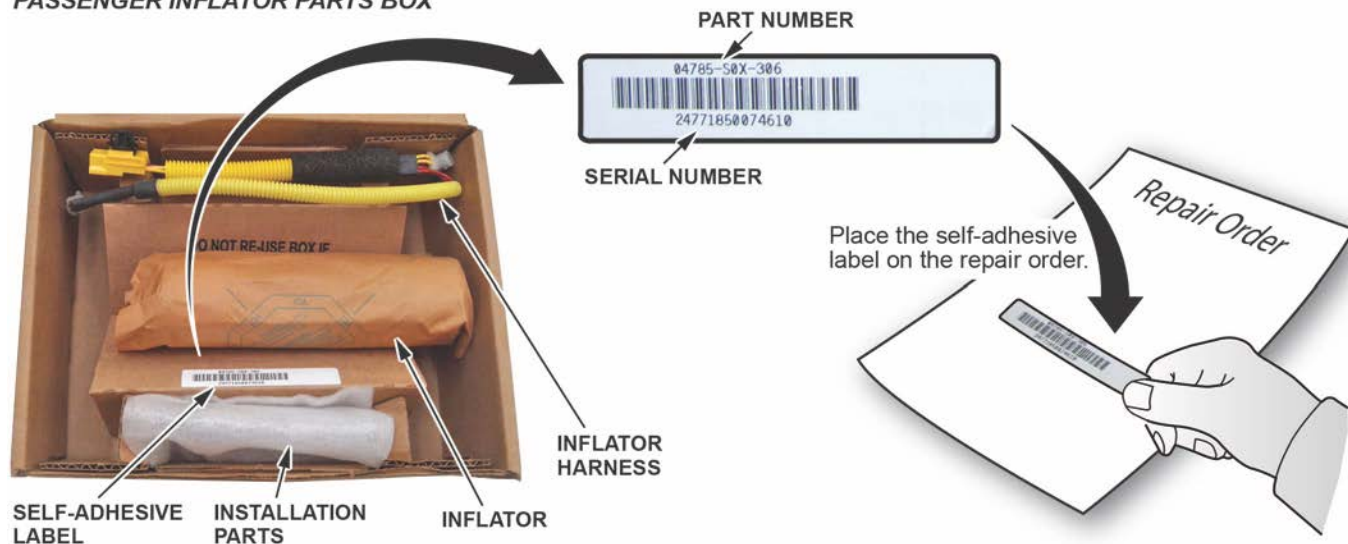
### PASSENGER INFLATOR PARTS BOX

- The replacement part number is printed on the top part of the label and the serial number is printed on the bottom. **Make sure you attach the label to the RO and give it to the warranty clerk.**
- There may also be a colored sticker located in the kit, ignore it because it is not used.
- Not all inflator kits have a label included. In those cases, write the serial number and part number from the side of the inflator box on the RO. The part number always starts with 047.

1. Peel the label located inside the inflator box from its backing and attach it to the RO. For the warranty claim to be paid, the **replacement inflator part number that you received** must be on the warranty claim and your warranty clerk must enter the serial number in the Diagnostic Trouble Codes field.

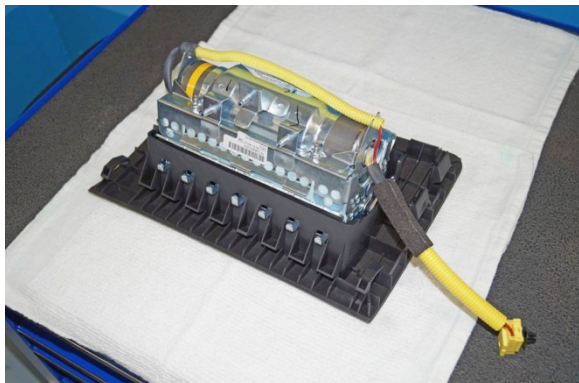
2. Remove the front passenger's airbag.
3. Place the airbag, face-down, on a clean shop towel.

- The orientation of the airbag is critical because if the inflator is installed incorrectly, the harness will be too short when you reinstall the airbag.
- The brackets between the various models are similar but may differ from the example shown.

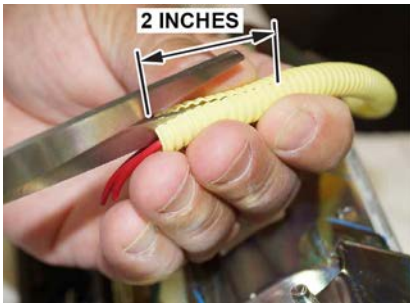
- Cut about 2 inches of the corrugated tube, then pull out the two red wires.

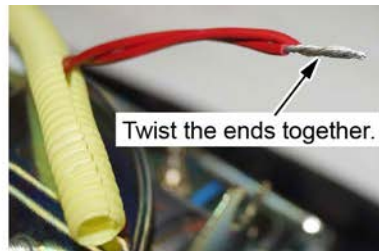
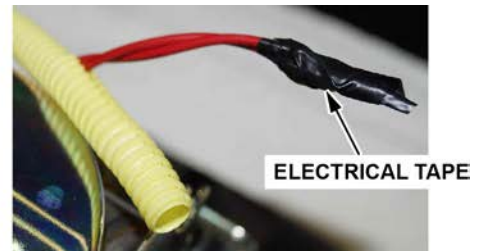
- Strip away about 1 inch of the wire insulation, then twist the wires together.

- Tape the twisted ends with electrical tape.

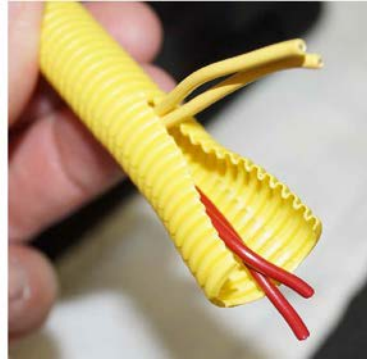
- Cut about 2 inches of the corrugated tube, then pull out the yellow wires.

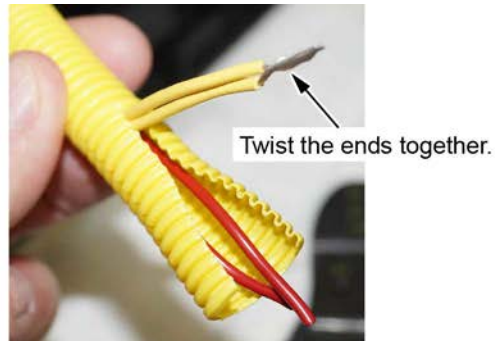
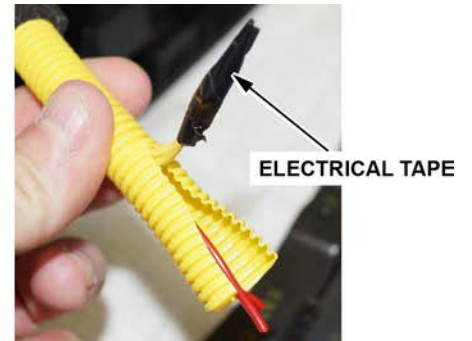
- Strip away about an inch of the wire insulation, then twist the wire ends together.

- Tape the twisted ends with electrical tape.

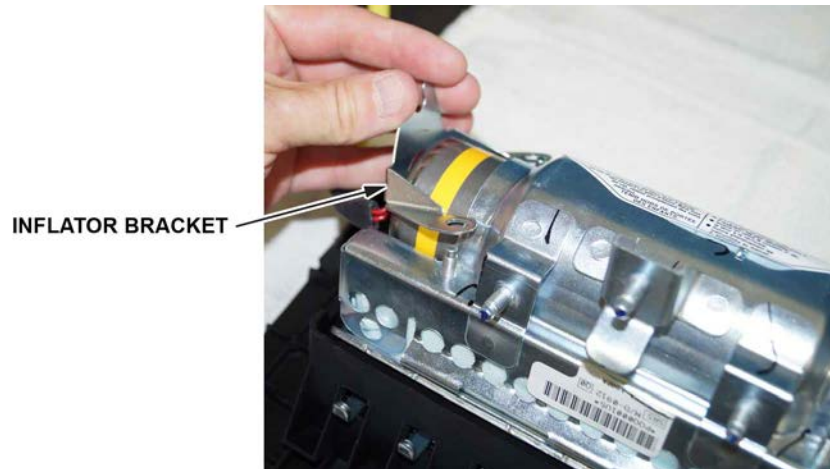
9. Remove the inflator bracket.

NOTE: You can only remove one of the brackets, as the other is welded to the airbag housing.

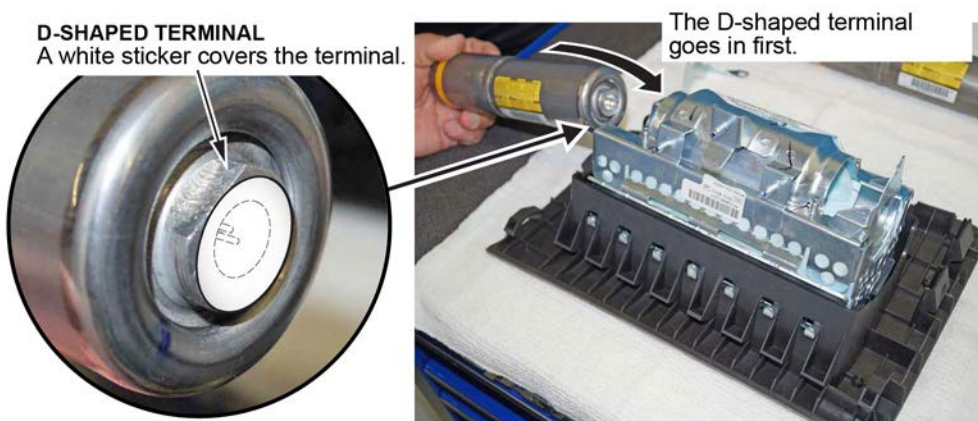
- One connector looks like a “D” whereas the other connector is a circle. Make sure you insert the “D” shaped terminal into the airbag first.

NOTE: There is a yellow band marking on the circle side.

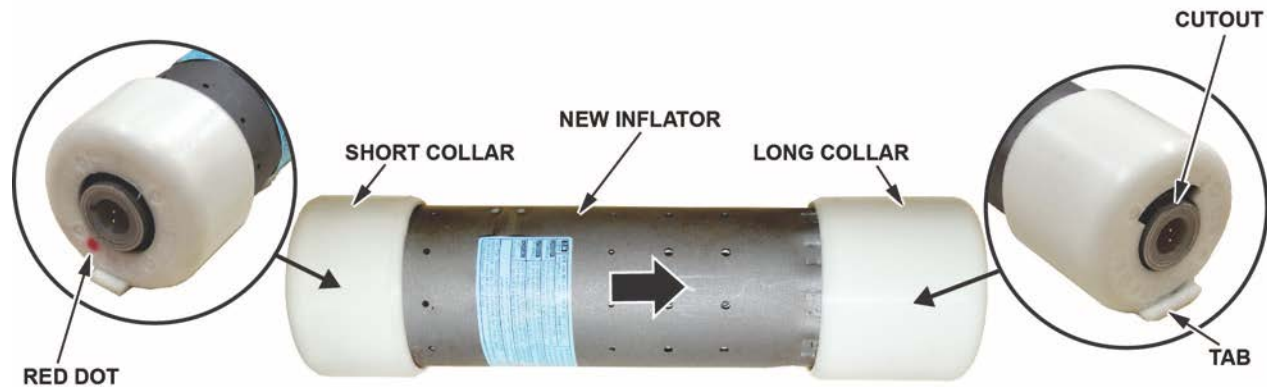
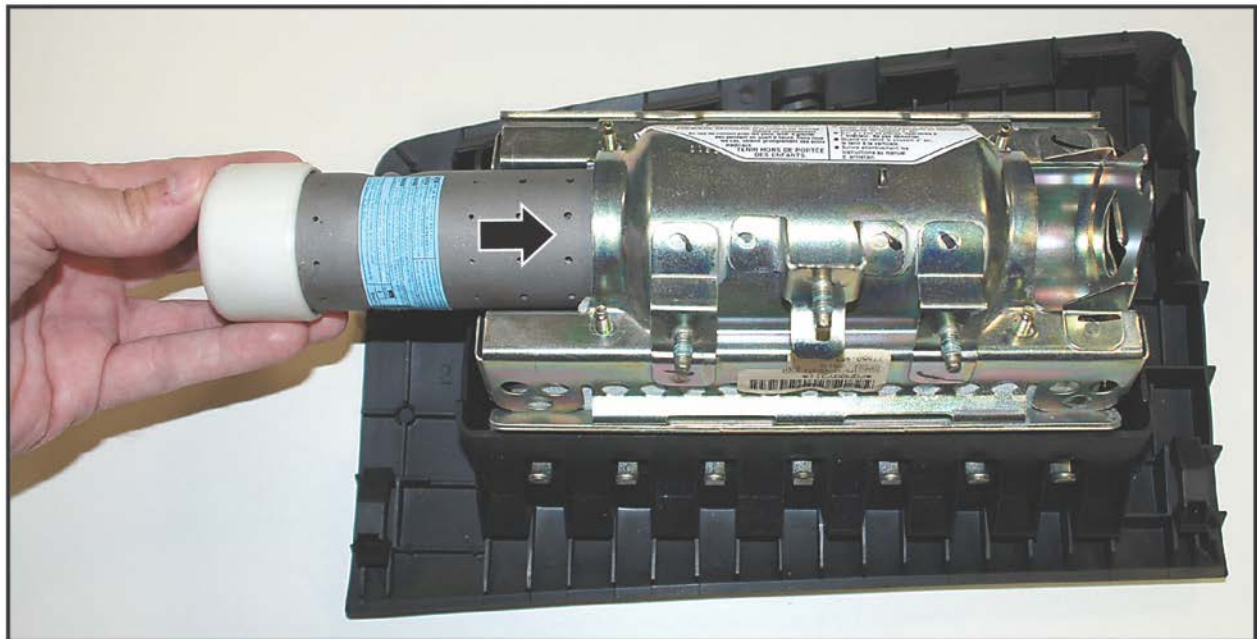
- One side of the inflator has a longer collar, a longer tab, a plastic cutout, and a small flat spot on the connector. The other side of the inflator has a shorter collar, a shorter tab, and a red dot. Make sure you insert the end with the longer collar into the airbag first.

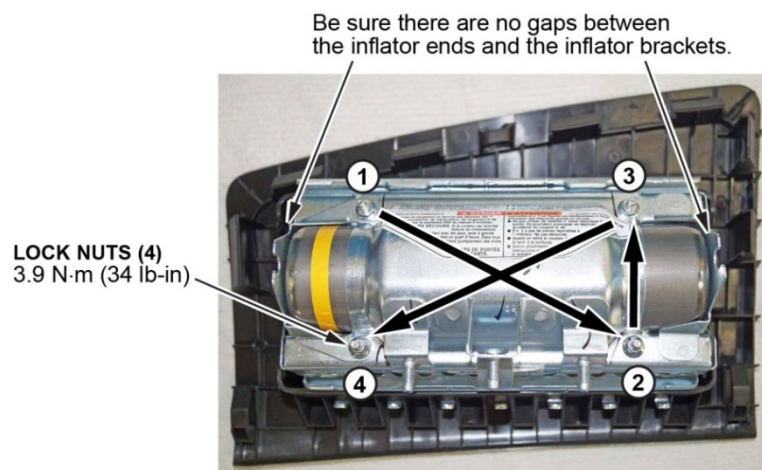
13. Install the new 5 mm locknuts and torque them in sequence to **3.9 N•m (34 lb-in)**.

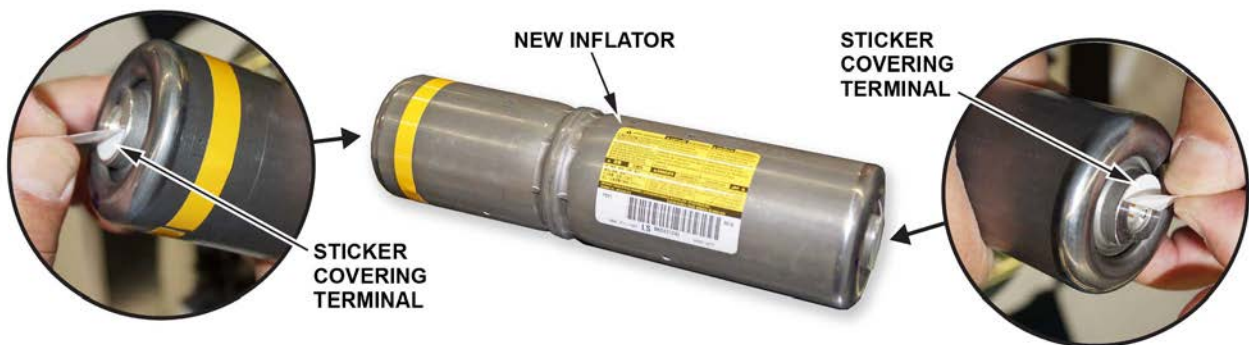
14. Remove the stickers covering the terminals on both sides of the new inflator.

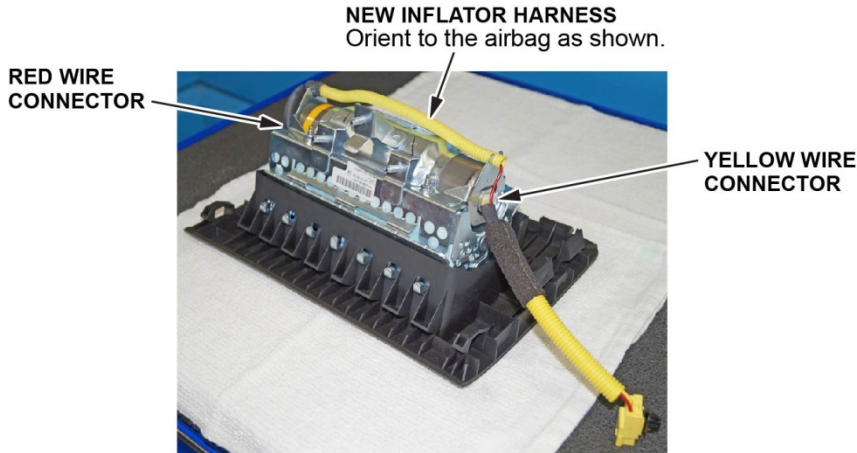
- Make sure the airbag and harness are aligned as shown.

- **Make sure you have the orientation correct as shown below.** If you connect the harness incorrectly, the harness cannot be removed, and you will not be able to reinstall the airbag because the harness will be too short.
- On the replacement inflators with plastic collars, connect the red wire connector to the connector with the red dot.
- On the replacement inflators without plastic collars, connect the red wire connector to the connector nearest the yellow band.

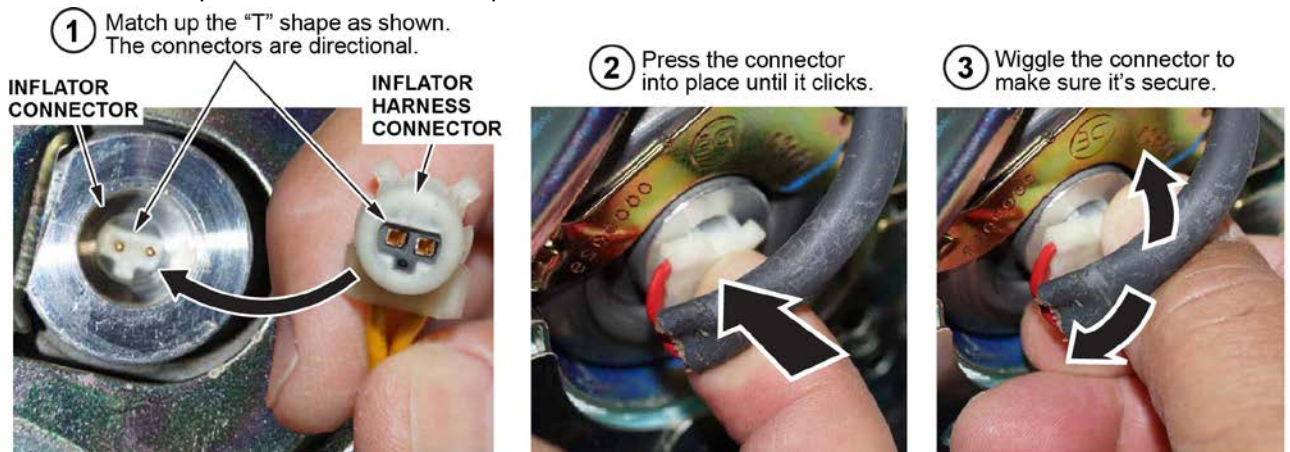
- Connect the two connectors. Align the “T” shape in the inflator harness connector with the T-shaped inflator connector, then press the connector into place.

- After you hear each connector click, wiggle it to make sure it is secure.

NOTE: If the connector is not properly aligned, it will come out.

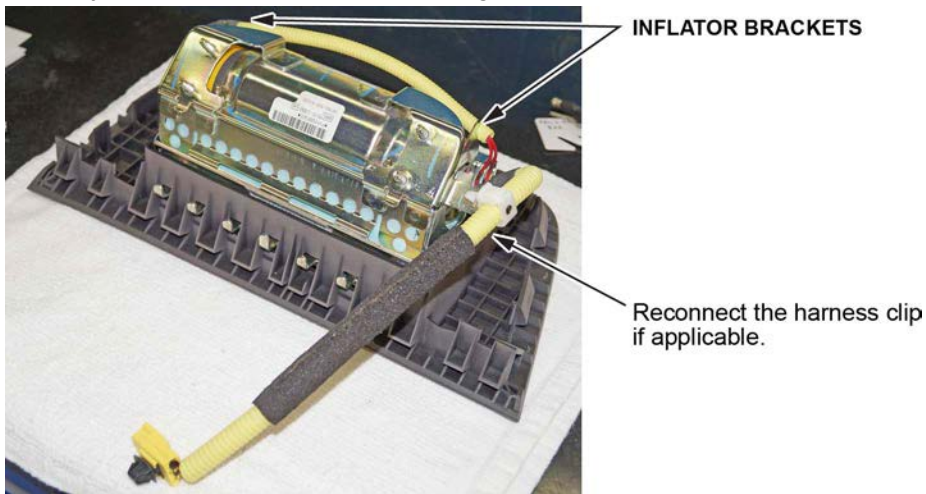
16. Connect the harness to the inflator brackets.

- Insert the side without the shrink-wrap tubing first. Insert the harness at the third “valley” in the corrugated tube.
- Insert the side of the harness with the shrink-wrap tubing into the inflator bracket. Make sure the harness is securely inserted and that it does not sag.
