Technical Service Bulletin

14-01-026-1

SONATA (LFA)

SUBJECT: SONATA FRONT BRAKE CALIPER INSPECTION AND REPAIR
(RECALL CAMPAIGN 120)

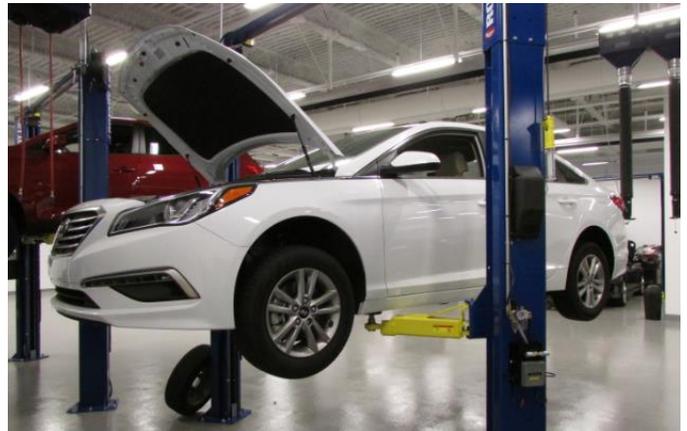
1. Remove both front wheel assemblies for caliper inspection.

**Tightening torque: 65.1~79.6 lb-ft
(88.3~107.9 Nm, 9.0~11.0 kgf.m)**

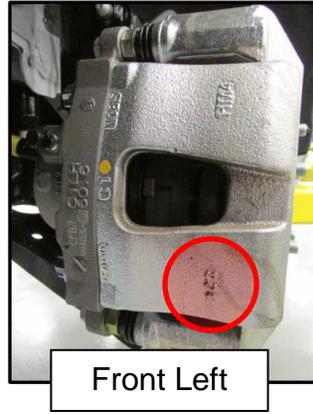
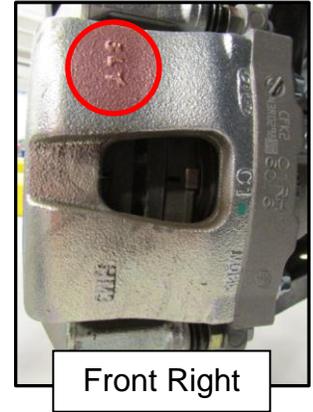
2. Inspect front left and right calipers to verify lot code.

- If the lot code is **'4CB'**, the caliper(s) must be replaced. Proceed with the rest of the service procedure.
- If the lot code is **not '4CB'**, the caliper(s) do not require replacement. Re-install the front wheel assembly/assemblies to complete the service procedure.

When viewing the caliper from the front of the vehicle looking towards the rear, the lot code is located on the bottom for the left side, and the top for the right side, as seen in the pictures above.

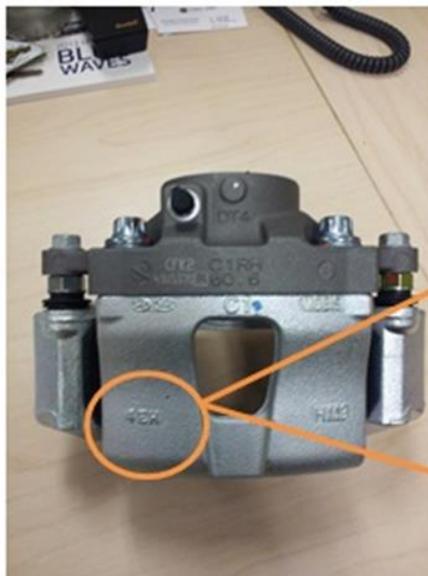
LOT CODE IS GOOD - DO NOT REPLACE

Some calipers may have lot codes with 4 digits. Any caliper with a lot code that has '4CB' in the first 3 digits requires replacement.

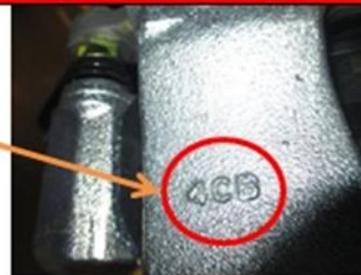
LOT CODE 4CB IS BAD - REPLACE

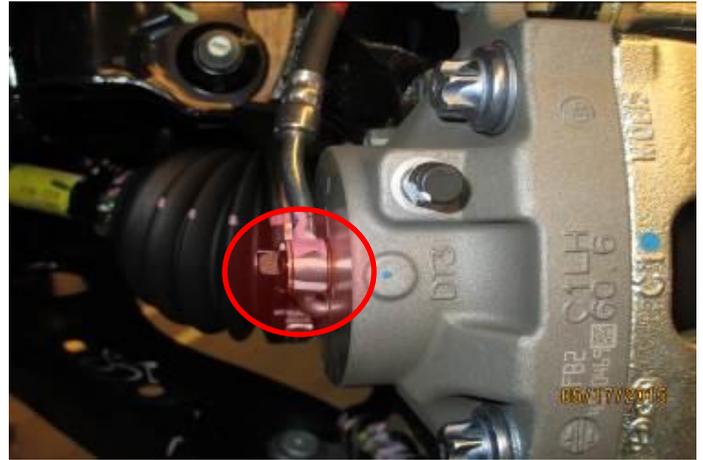
3. Remove brake line from caliper.

There are 2 copper washers on the brake line bolt that must be replaced when installing new caliper(s).

Tightening torque: 18.1~21.7 lb-ft
(24.5~29.4 Nm, 2.5~3.0 kgf.m)

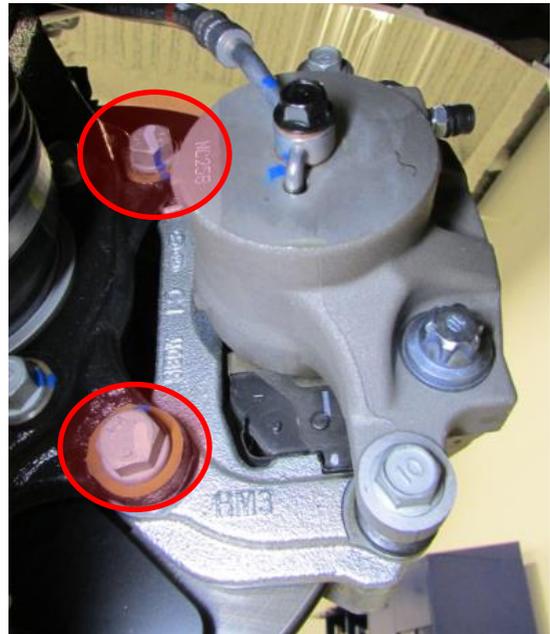
4. Remove caliper mounting bolts.

Tightening torque: 57.9~72.3 lb-ft
(78.5~98.1 Nm, 8.0~10.0 kgf.m)

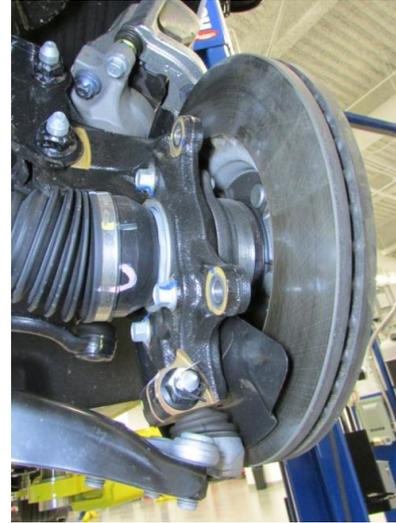
5. Remove caliper assembly from axle assembly.

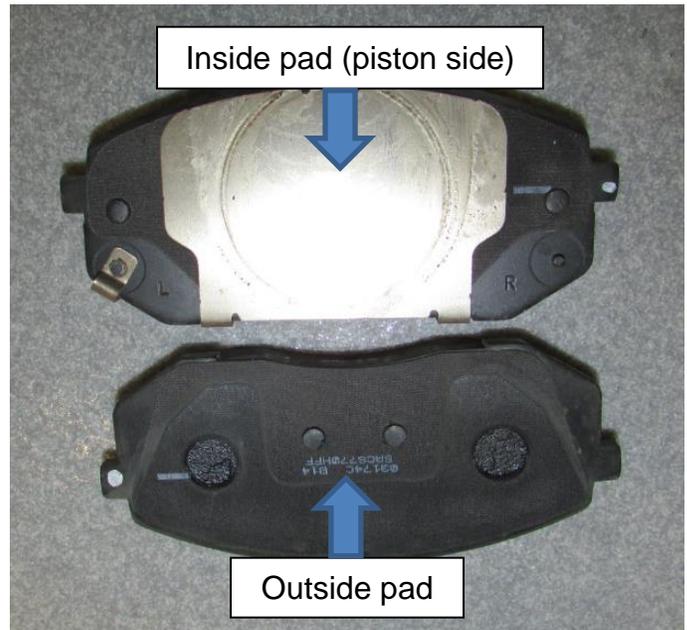
6. Remove the brake pads from the removed caliper, and install them into the new caliper.

Install the brake pad with the shim plate so it faces the caliper piston (inside position).

Install the brake pad without the shim plate on the opposite side (outside position).

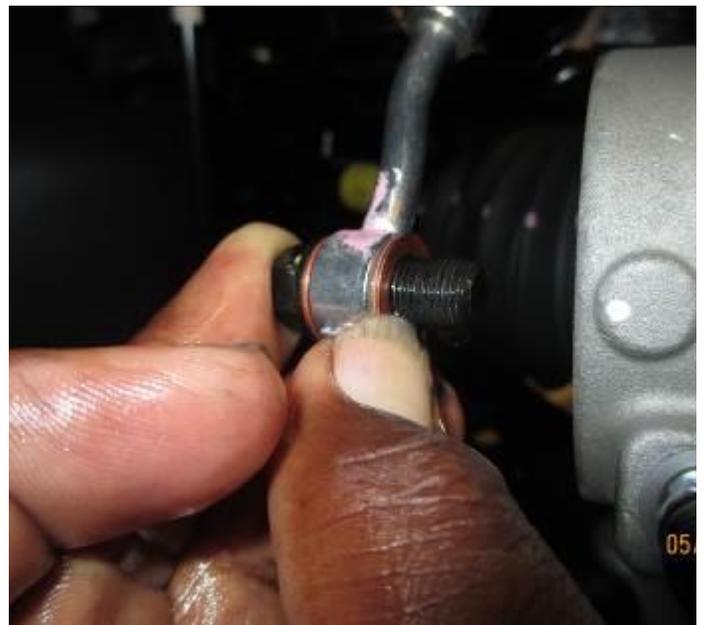
7. Install the new caliper and reassemble axle assembly in reverse order of removal.

Failure to install both copper washers may result in a leak.

Be sure to use new washers on the brake line during re-assembly.

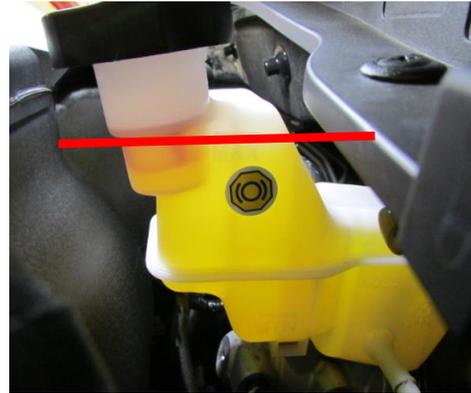
- 8. Ensure the brake fluid reservoir is filled to the MAX line.

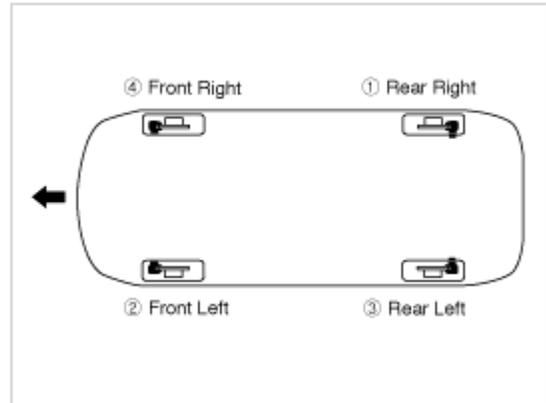
- 9. Bleed the brake lines at the caliper bleeders until no air bubbles appear in the fluid in the correct bleeding order:
 1. Rear Right
 2. Front Left
 3. Rear Left
 4. Front Right

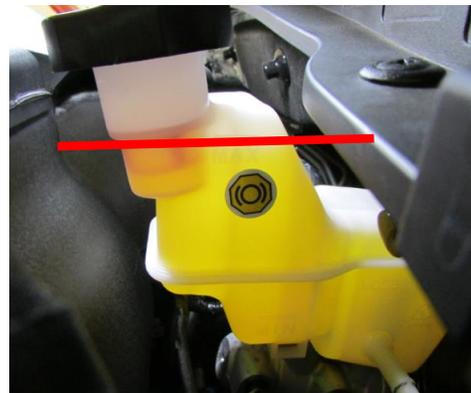
- 10. Re-install wheels, and fill brake fluid reservoir to the MAX line.

Tightening torque: 65.1~79.6 lb-ft (88.3~107.9 Nm, 9.0~11.0 kgfm)
