**Technical Service Bulletin**

GROUP <b>CAMPAIGN</b>	NUMBER <b>14-01-025</b>
DATE <b>JUNE, 2014</b>	MODEL(S) <b>SONATA (LFA)</b>

**SUBJECT:** SONATA FRONT BRAKE CALIPER INSPECTION AND REPAIR  
(SERVICE CAMPAIGN TT5)

**Description:** This bulletin describes the procedure to inspect the left and right front brake caliper assemblies, and replace if necessary on certain 2015 model year Sonata (LFA) vehicles.

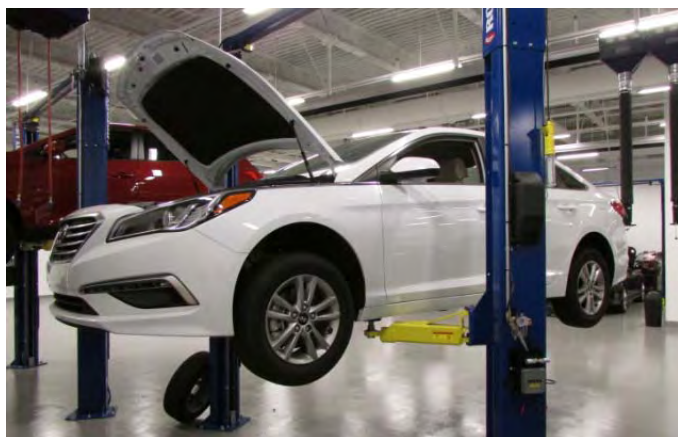
1. Remove both front wheel assemblies for caliper inspection.

**Tightening torque: 65.1~79.6 lb-ft  
(88.3~107.9 Nm, 9.0~11.0 kgf.m)**

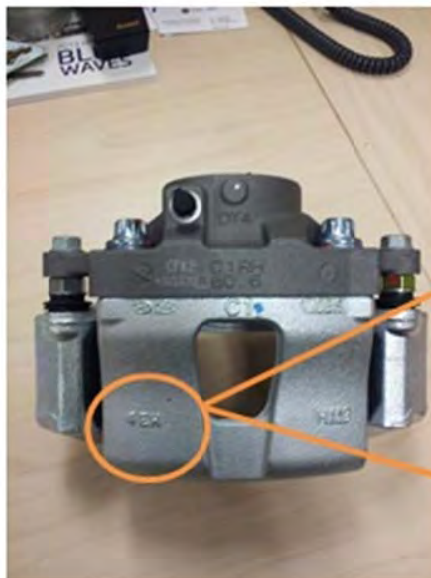
Some calipers may have lot codes with 4 digits. Any caliper with a lot code that has '4CB' in the first 3 digits requires replacement.

LOT CODE IS GOOD - DO NOT REPLACE

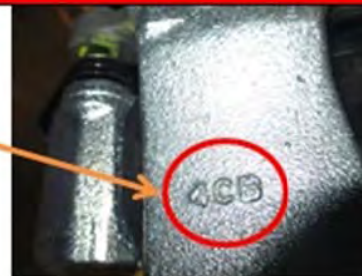
LOT CODE 4CB IS BAD - REPLACE

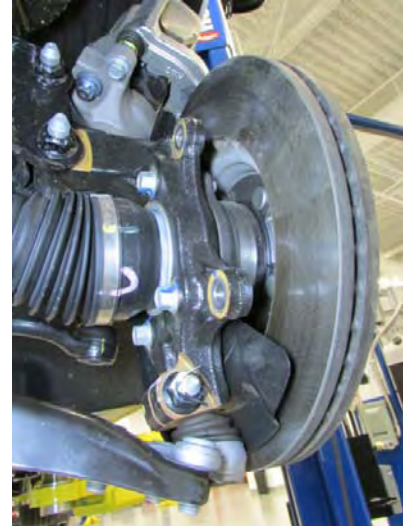
5. Remove caliper assembly from axle assembly.

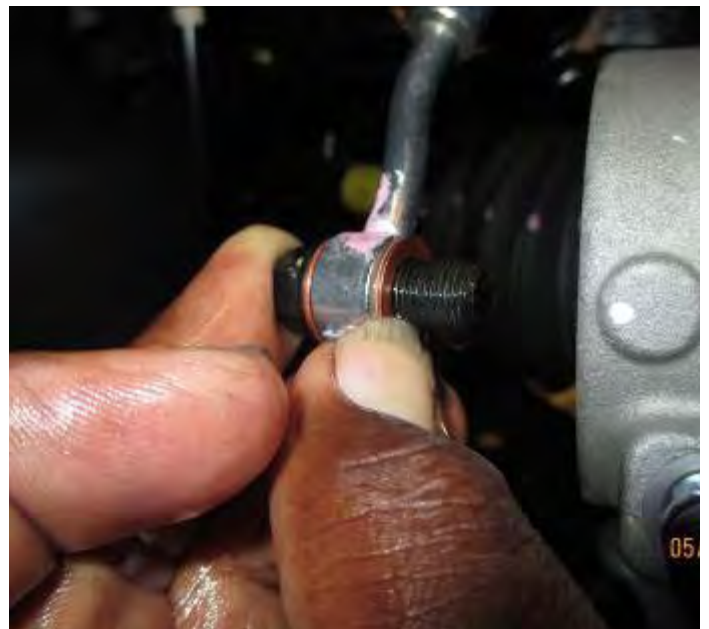
7. Install the new caliper and reassemble axle assembly in reverse order of removal.

Failure to install both copper washers may result in a leak.

Be sure to use new washers on the brake line during re-assembly.
