# Recall Bulletin

## PRODUCT SAFETY RECALL

**SUBJECT:** Cracked Heater Cord

**MODELS:** 2013-2014 Buick Encore AWD, Verano  
2011-2014 Chevrolet Cruze  
2012-2014 Chevrolet Sonic  
2013-2014 Chevrolet TRAX AWD  
Equipped with Oil Pan Heater (KPK) or Engine Block Heater (KO5)

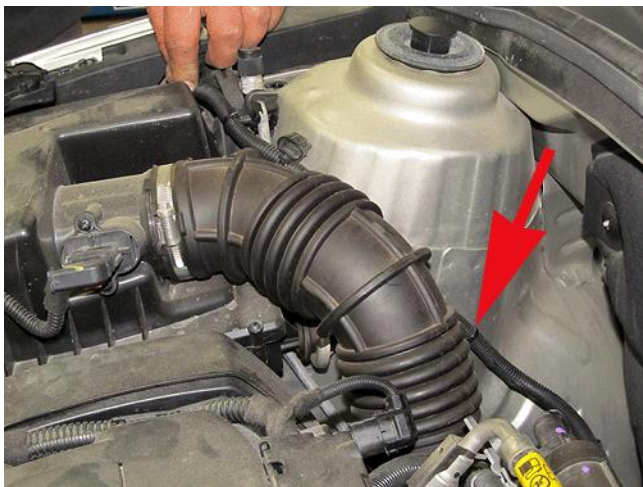
3950370

1. Detach the push fastener from the shock tower.

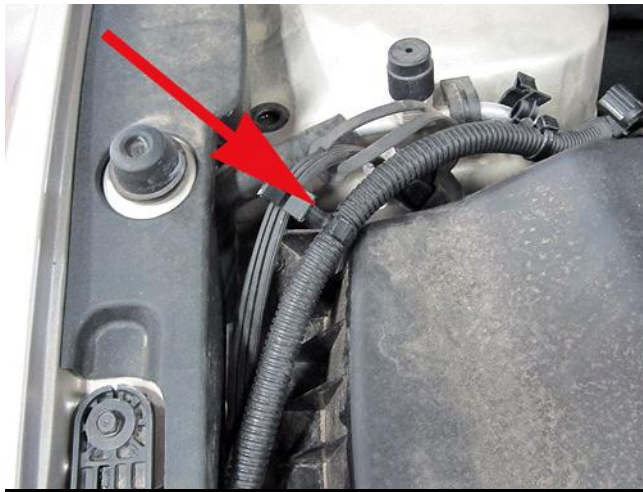
3950371

2. Detach the power cable clip from the engine harness.

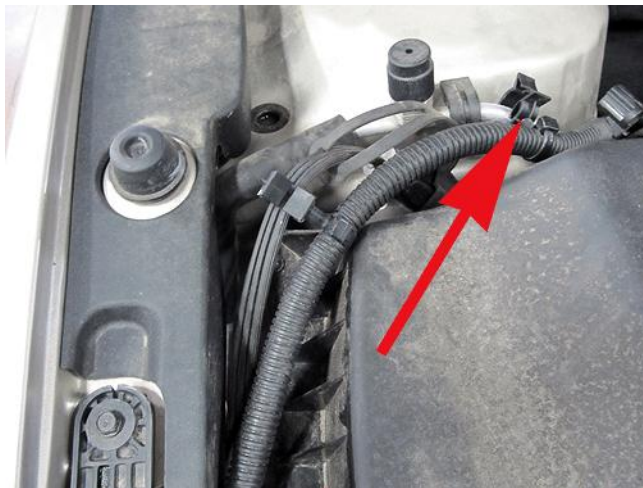
3950372

3. Pull the power cable from along the front side of the strut tower and detach the clip to the A/C line.

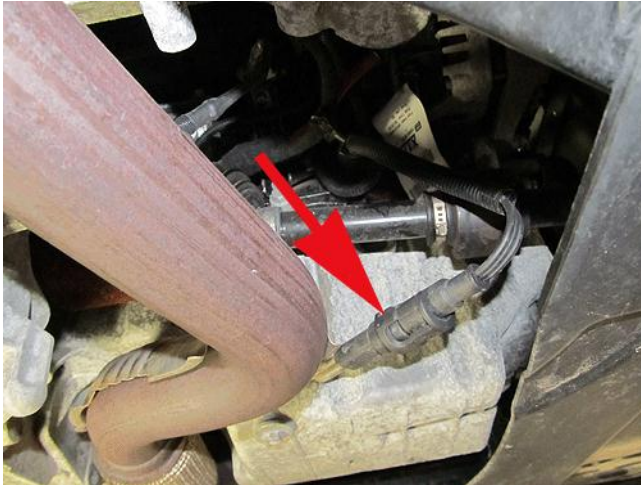
3950368

8. Unsecure the lock feature and disconnect the engine oil pan/block heater power cable from the heater assembly.

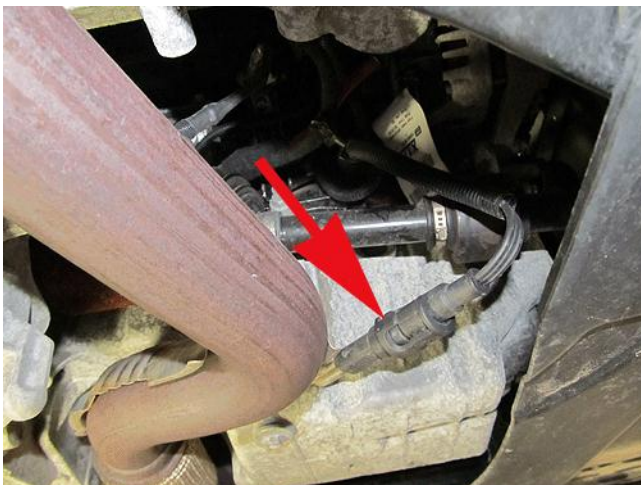
3950368

10. Plug the new power cable into the heater assembly and lock the retaining feature.

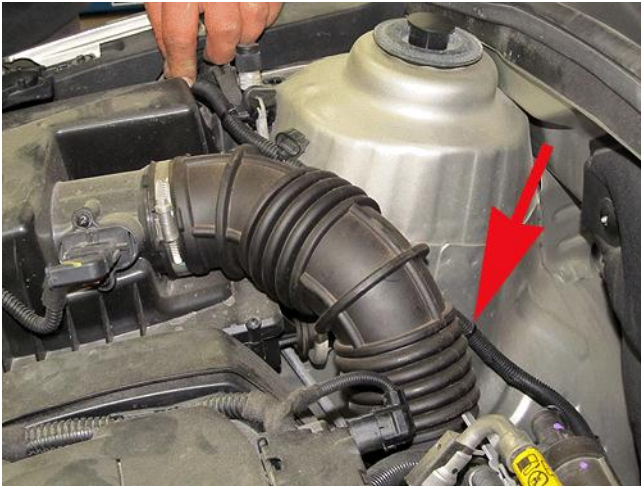
3950370

13. Attach the power cord push fastener to the shock tower.

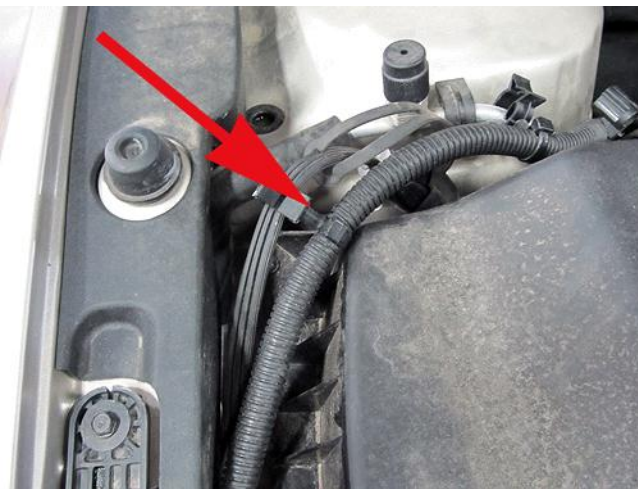
3950371

14. Attach the power cable clip to the engine harness.

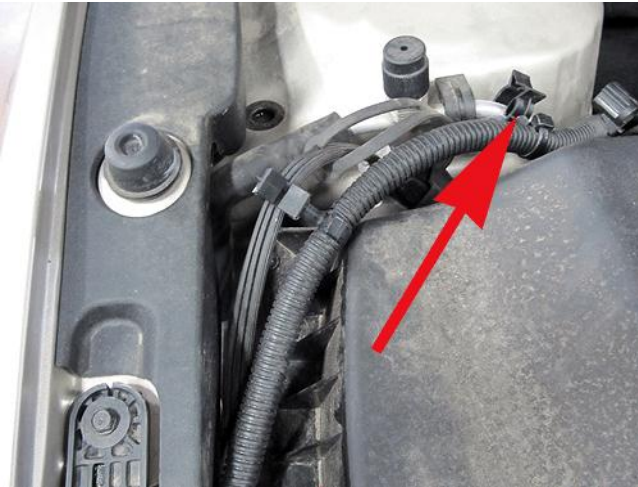
15. Route the power cable along the front side of the strut tower and attach the clip to the A/C line.

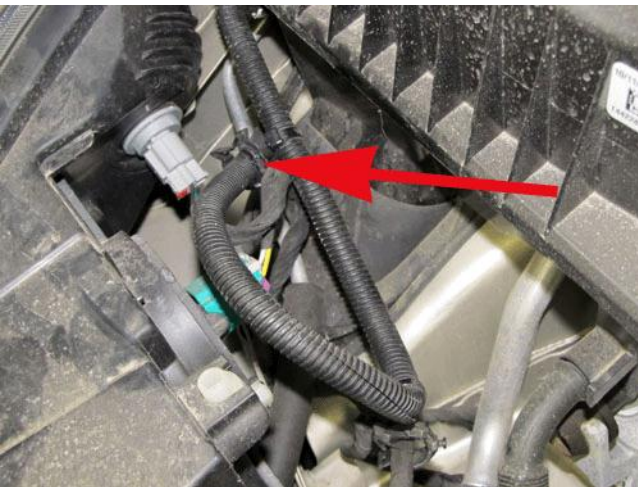
16. Route the power cable along the side of the air cleaner assembly and attach the clip to the forward lamp harness (just to the left of the headlamp).
17. Route the power cable along the side of the air cleaner and attach the clips. Tuck the electrical plug between the air cleaner housing and the strut tower.

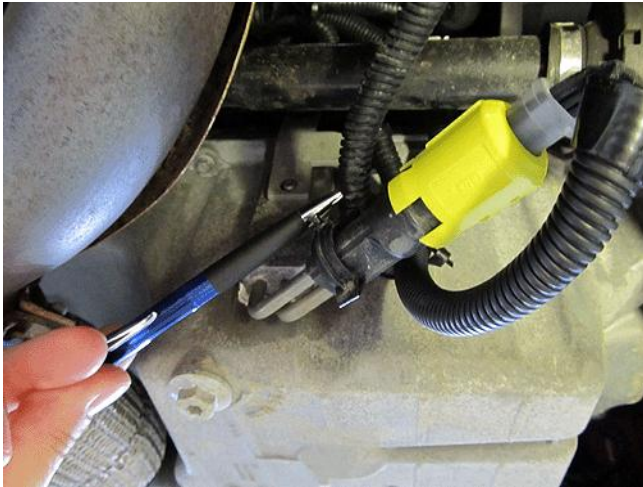
3950375

4. Plug the new power cable into the heater assembly and lock the retaining feature.

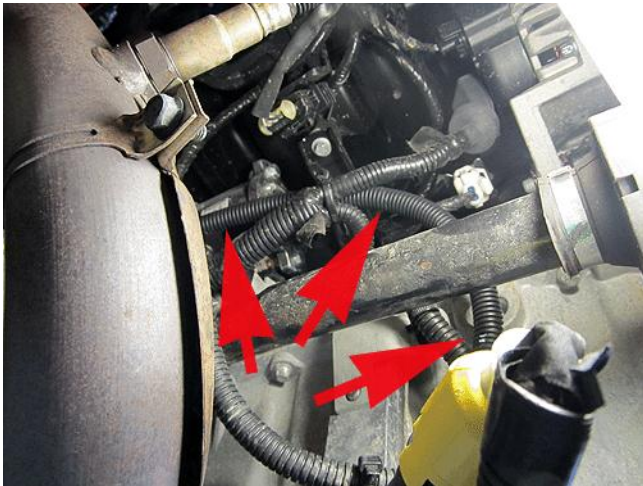
3950376

5. Route the new power cable up between the axle shaft and the engine. Secure it to the old cable with a tie strap, just above the heater assembly.
6. Lower the vehicle
7. Route the new cable alongside/on top of existing vehicle harness using tie straps to secure.

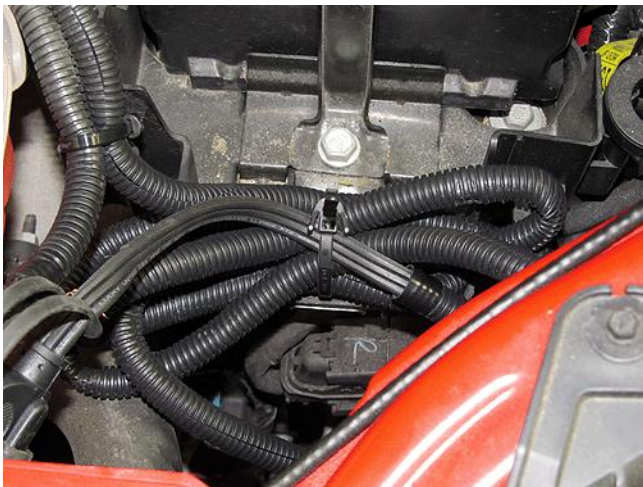
3950378

8. Tie strap the new cord to the existing hole on the battery tray while routing the cord underneath the ECM harness as shown in the illustration above.
