RECALL CAMPAIGN 14V-428: REPLACE PASSENGER'S FRONT AIR BAG MODULE:

MODEL

E46 (3 Series)			
Model Year from 2000 to 2006

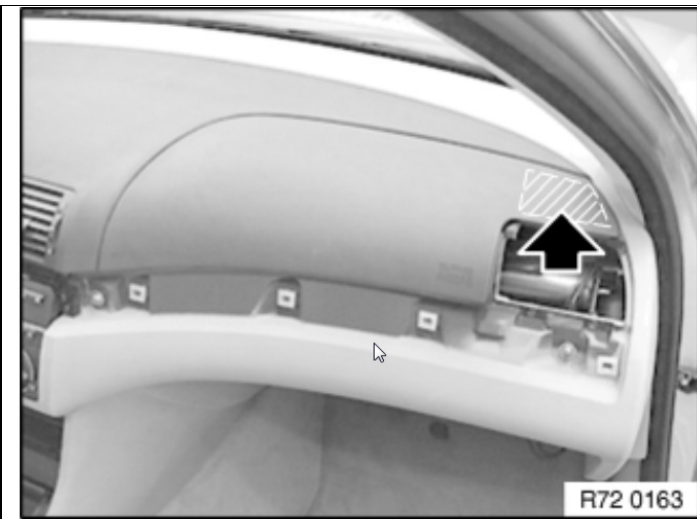
- Position of the retaining clip of the front passenger's airbag cover

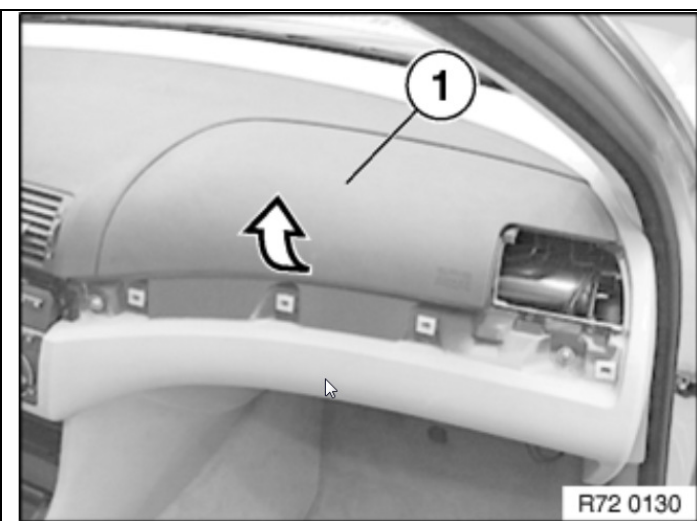
- Lever out the front passenger's airbag cover (1).

The retaining clip remains in the dashboard when removing the cover.
