## RECALL CAMPAIGN 14V-428: REPLACE PASSENGER'S FRONT AIR BAG MODULE:

### MODEL

E46 (3 Series)			
----------------	--	--	--

Model Year from 2000 to 2006

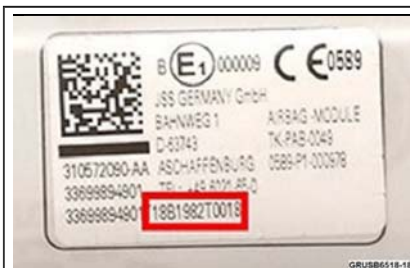
**Please make sure to document the serial number before installation.**
