**HYUNDAI**NEW THINKING.  
NEW POSSIBILITIES.**Technical Service Bulletin**

**14-01-033**

**SONATA (YF)****SUBJECT:****AUTOMATIC TRANSAXLE SHIFT LEVER  
(RECALL CAMPAIGN 123)****★ IMPORTANT****\*\*\* Dealer Stock and Retail Vehicles \*\*\***

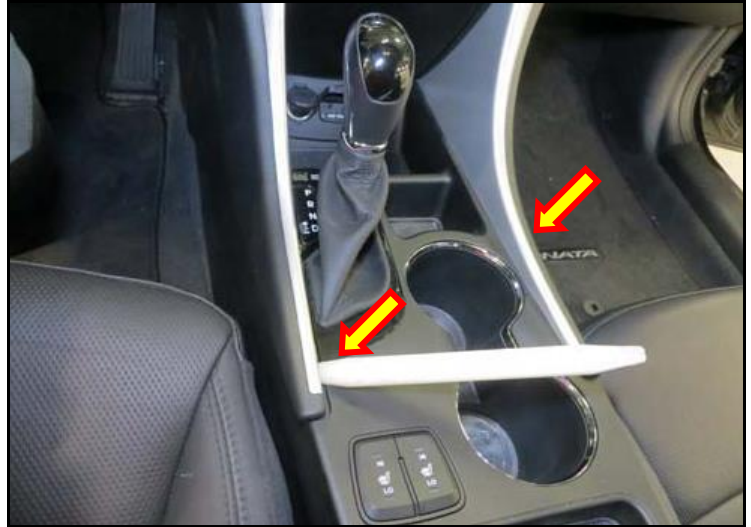
1. Turn the engine off and apply the parking brake.

Use a plastic trim tool to remove the dash pad garnish.

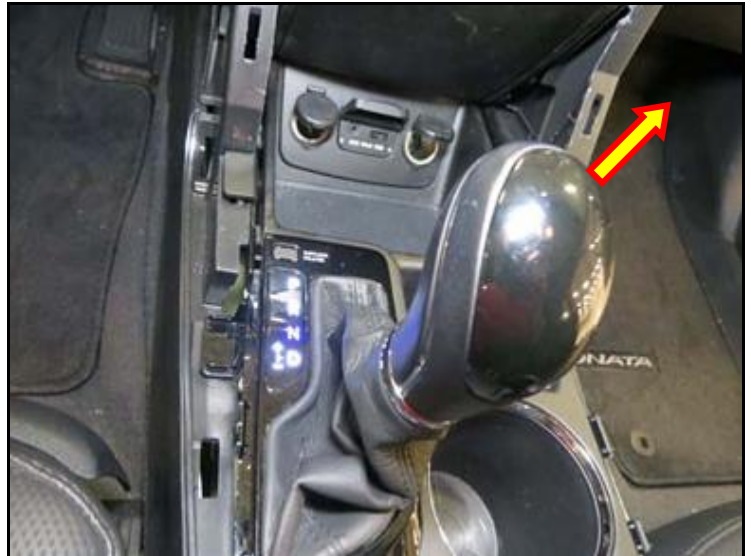
2. Turn the ignition to the ON position and depress the brake pedal.

Move the shift lever to the "N" position.

Turn the ignition to the OFF position.

Pull up on the shift knob until the knob is disconnected from the shift lever.

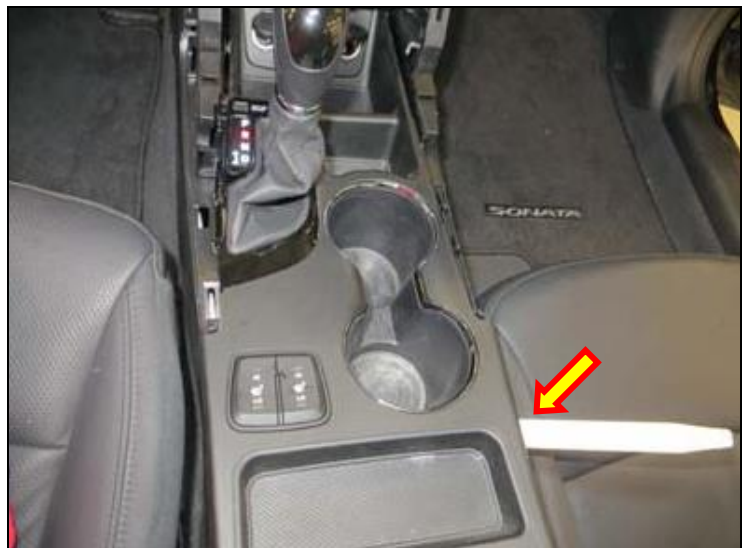
3. Use a plastic trim tool to remove the console upper cover.

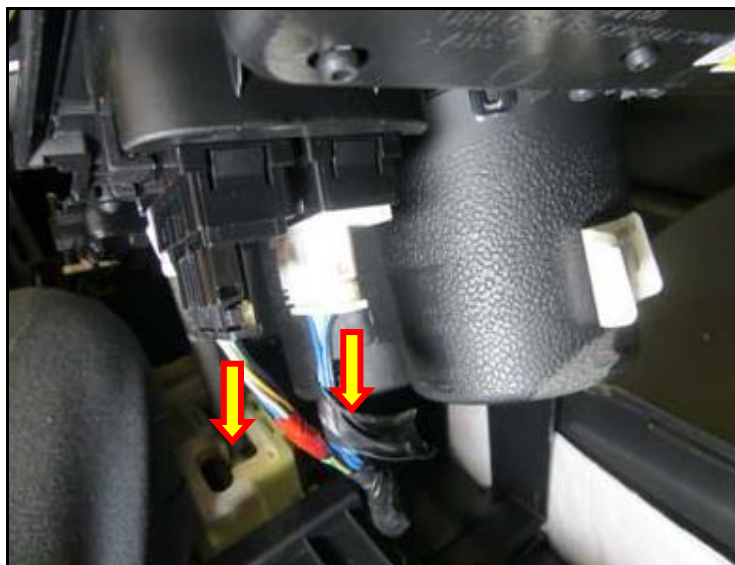
4. Disconnect one black connector.

Disconnect one white connector (on early model years).

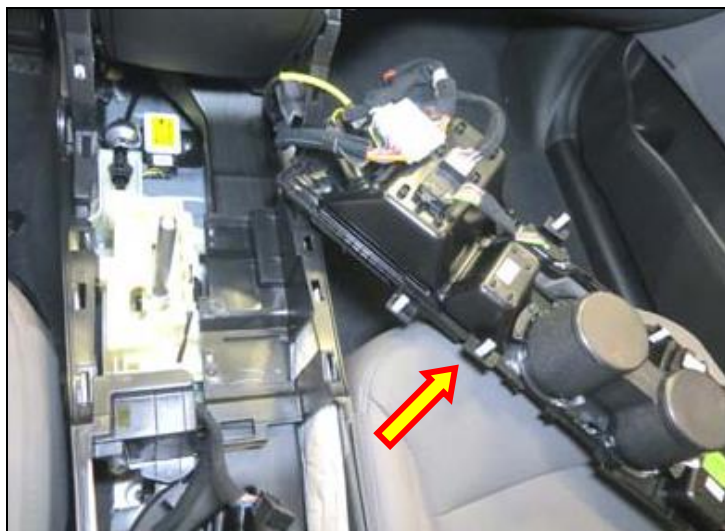
6. Lay the console cover on the passenger seat.

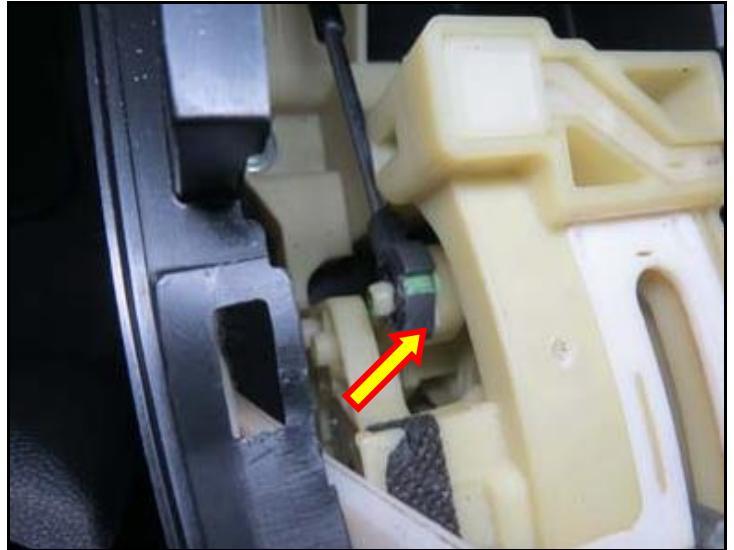
10. Turn the ignition to the ON position and depress the brake pedal.

Move the shift lever through gears P-R-N-D and confirm the E-clip is securely installed.

Reassemble all parts in the reverse order of disassembly.

Confirm the P-R-N-D lights illuminate in the dash cluster and on the console cover.

Confirm the seat warmers operate (if equipped).
