Technical Service Bulletin

GROUP CAMPAIGN	NUMBER 17-01-065
DATE NOVEMBER, 2017	MODEL(S) SANTA FE (SM)

SUBJECT: SANTA FE (SM) FRONT COIL SPRING PROTECTOR
(RECALL CAMPAIGN 124)

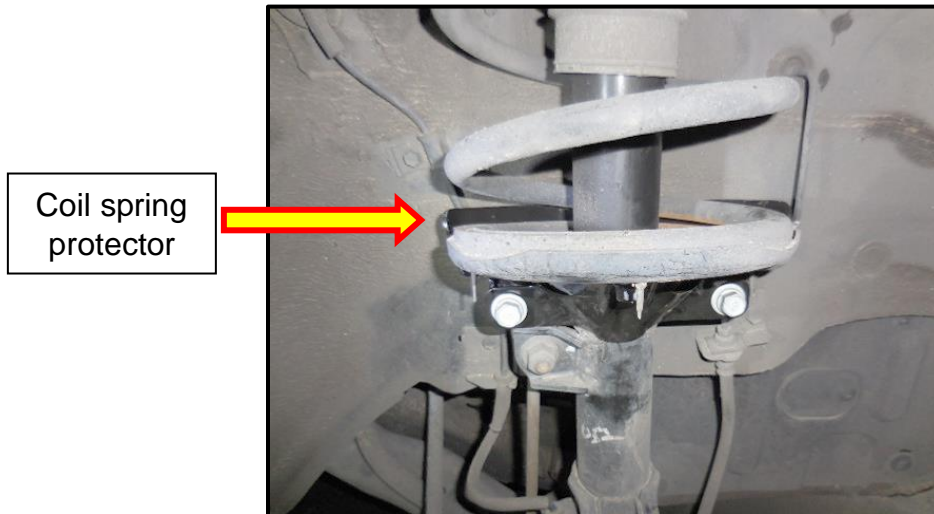
Description: This bulletin describes the procedure to install front coil spring protectors to prevent the spring from contacting the tire in the event the coil spring fractures. A fractured coil spring can make contact with the tire, potentially resulting in a tire puncture and increasing the risk of a crash.

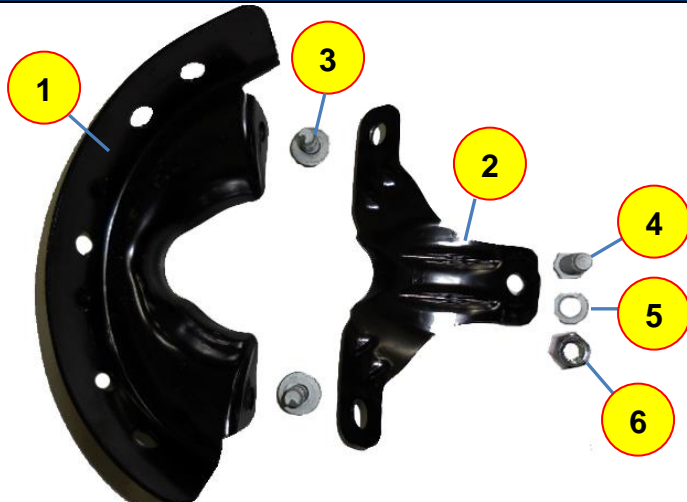
<p data-bbox="535 1879 909 1911">Part #: 54631-26000-QQH</p>	<p data-bbox="1157 1459 1299 1491">Contents:</p> <ul style="list-style-type: none"> <li data-bbox="1201 1501 1485 1564">1) 2 x Inner Spring Protector <li data-bbox="1201 1575 1485 1638">2) 2 x Outer Spring Protector <li data-bbox="1201 1648 1485 1711">3) 4 x Bolt/Washer Assy <li data-bbox="1201 1722 1364 1753">4) 2 x Bolt <li data-bbox="1201 1764 1485 1795">5) 2 x Lock Washer <li data-bbox="1201 1806 1364 1837">6) 2 x Nut

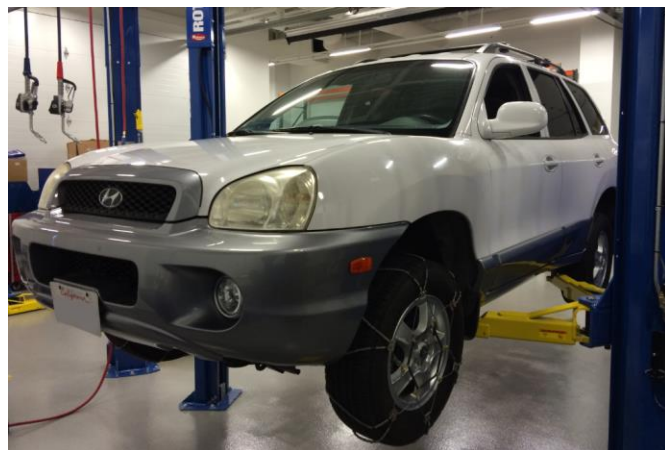
2. Starting on the left side strut, locate the spring perch hole (A).

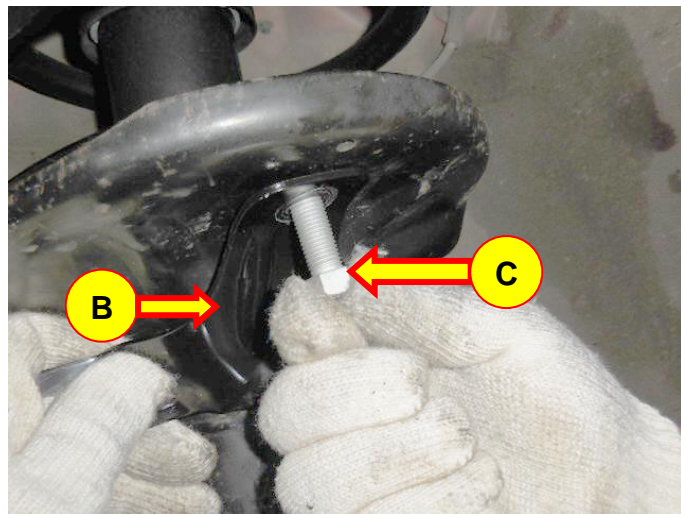
4. Loosely install the lock-washer (D) and nut (E) on the top side of the spring perch.

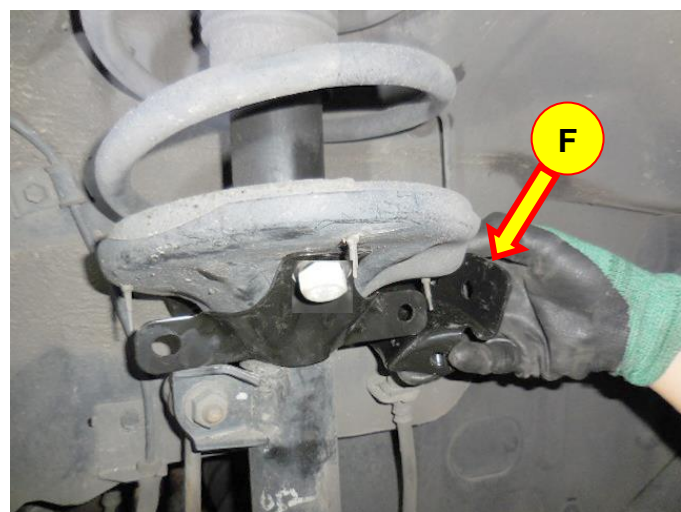
- 5a. When placing the spring protector into position, the two triangular “teeth” (G) must sit on top of the strut spring perch lip.

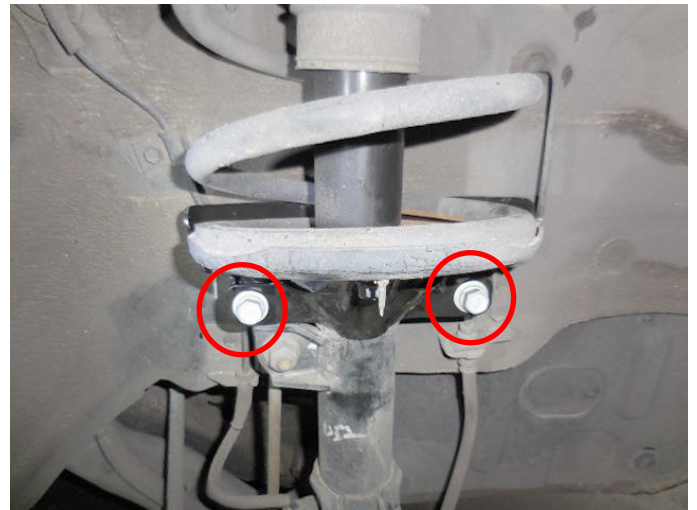
7. Tighten the outer spring protector nut (H) first.

Hold the bolt head stationary while tightening the nut. DO NOT tighten from the bolt head. Doing so may remove the paint from the bracket surface.

Tightening torque: 43.4~50.6 lb-ft (58.8~68.6 Nm, 6.0~7.0 kgf.m)

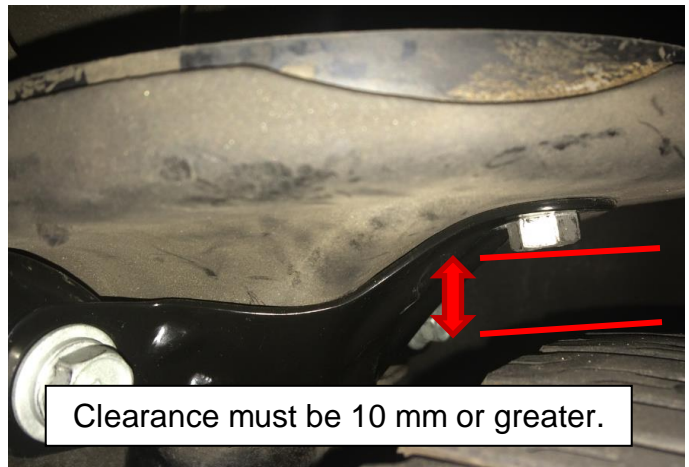
- 10a. After installing the spring protectors, measure to verify that the clearance between the tire and the bolt head is at least 10mm.

Minimum clearance between tire and bolt: 10 mm

Clearance must be 10 mm or greater.

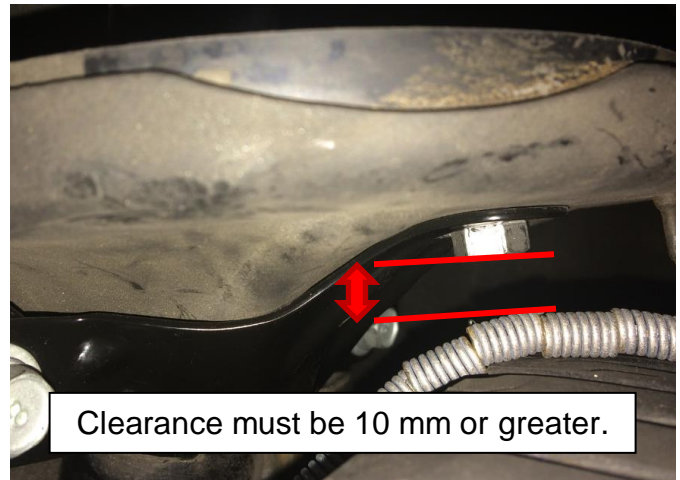
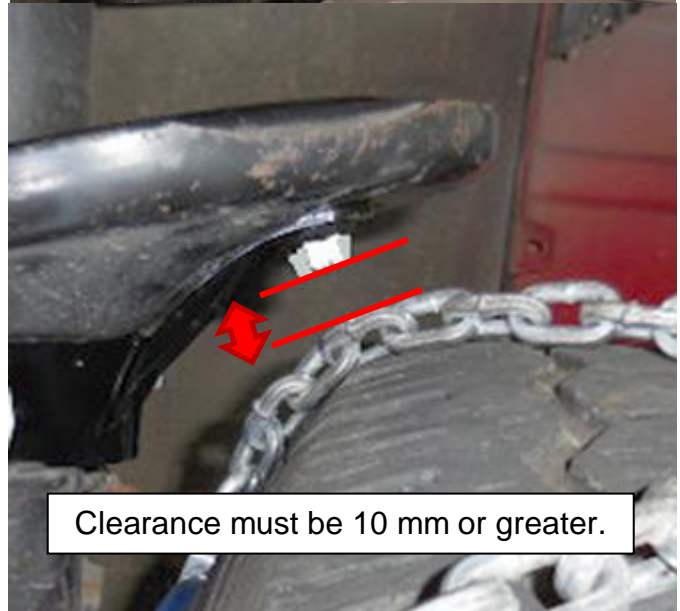
- 10b. If snow chains are used, the minimum clearance between the chain and the bolt head is 10mm.

Measure the gap to verify the specification is met.

Minimum clearance between snow chain and bolt: 10 mm
