Recall Bulletin

PRODUCT SAFETY RECALL

SUBJECT: Incomplete Weld on the Seat Hook Bracket Assembly

MODELS: 2013-2014 Buick Encore (*)
2013-2014 Cadillac ATS
2014 Cadillac CTS Sedan (VIN A)
2014 Cadillac ELR
2013-2014 Chevrolet Trax (*)
2014 Chevrolet SS
2014 Chevrolet Caprice PPV
2014 Chevrolet Silverado 1500
2014 GMC Sierra 1500
2015 Chevrolet Silverado 2500/3500 HD
2015 GMC Sierra 2500/3500 HD

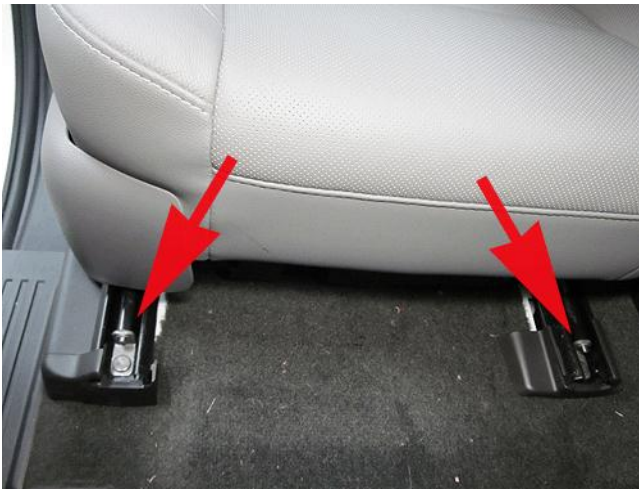
3960104

Important: Use the following steps to inspect the left and right front seat front mounting hook welds located in the area shown above (*).

Important: In some cases, it may also be necessary to follow SI procedures to remove some of the seat cushion trim and/or seat track trim for a better view of the weld area shown above. A full size pick up truck is shown in the photos for this procedure. Other models may appear slightly different and contain additional trim.

1. Move both front seats to the rear most position (*).
2. Clean any grease from the inspection area using a shop rag.

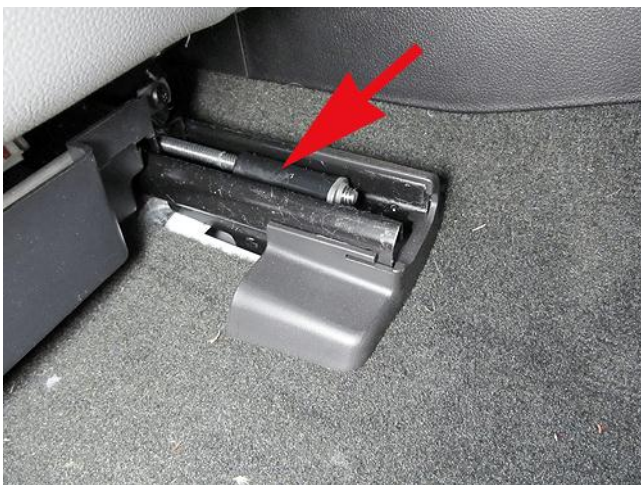
3960106

Note: On vehicles equipped with power seats, the inspection area is under the threaded rods on the seat track.

Note: The passenger seat has black plastic collars around the threaded seat adjuster rods. Use a screwdriver to push the collars rearward on the rod to allow the weld inspection. The collars will reposition themselves into the correct location when the power seat is cycled to the full forward position.

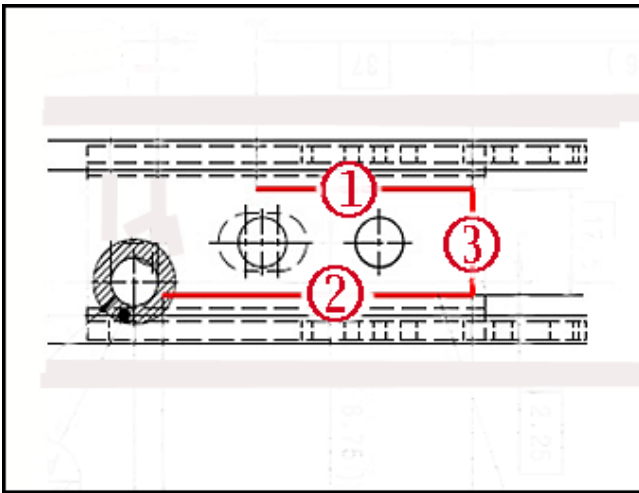
3963505

3. Illuminate the inspection area with a flashlight. Using a ruler, measure the length of the weld penetrations on the seat track as shown below.

- Ensure the short weld length is a minimum of 35 mm (1.38") in length (1).
- Ensure the long weld length is a minimum of 51 mm (2.0") in length (2).
- Ensure the cross car weld connects to both of the parallel welds (3).
- Repeat this inspection on all four front seat tracks (*).

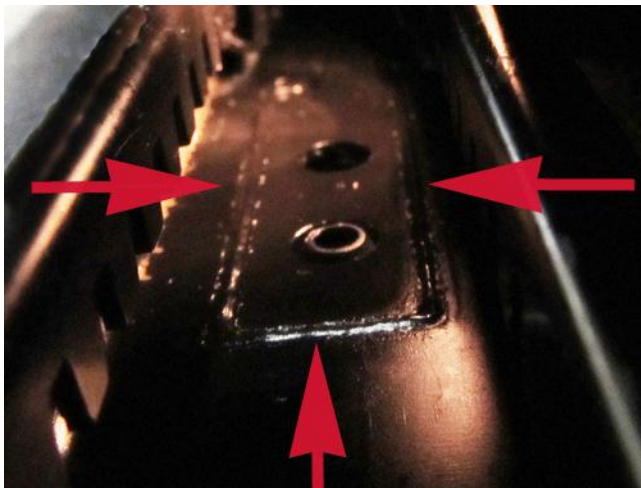
3963504

Example of Complete Weld:

Important: The actual seat hook weld is on the underside of the rail but the weld penetration is visible from the top, which is what is inspected during this procedure. For

reference, a complete weld should have a continuous U shape with one side longer than the other as shown above (the red arrows in the photo above show the continuous weld penetration on all three sides). The photo below shows an example of an incomplete weld that is not the proper length and does not have a continuous U shape (the red arrows point out the missing weld penetration).

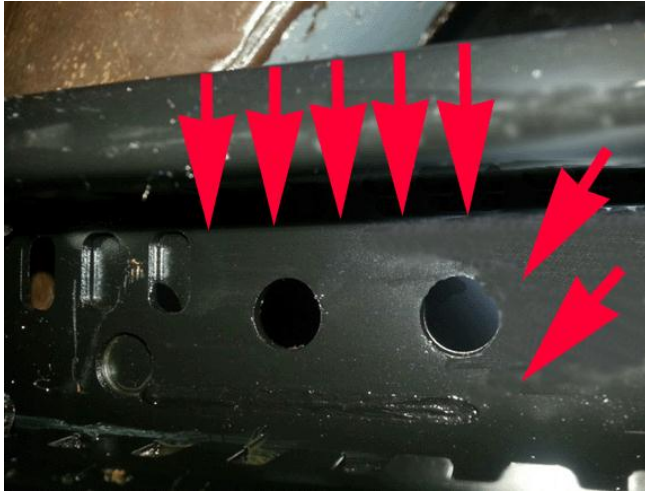
3966951

Example of Incomplete Weld:

5. If all of the welds pass the inspection above, no further action is required. If any of the welds **do not pass** the inspection above, proceed to the *Seat Cushion Frame Replacement* section below.

If the vehicle fails the seat frame mounting hook weld inspection above, it will be necessary to replace the related seat cushion frame by ordering the standard replacement part number listed in the parts catalog for the VIN being serviced. Refer to *Driver or Passenger Seat Cushion Frame Replacement* in SI for replacement procedure.
