# SERVICE BULLETIN

## SB-07-011

### IMPORTANT SAFETY RECALL NOTICE – Dealer Notification

**Subject: Pintle Hook LOOP for the Secondary (Safety) Chain – INSPECTION**

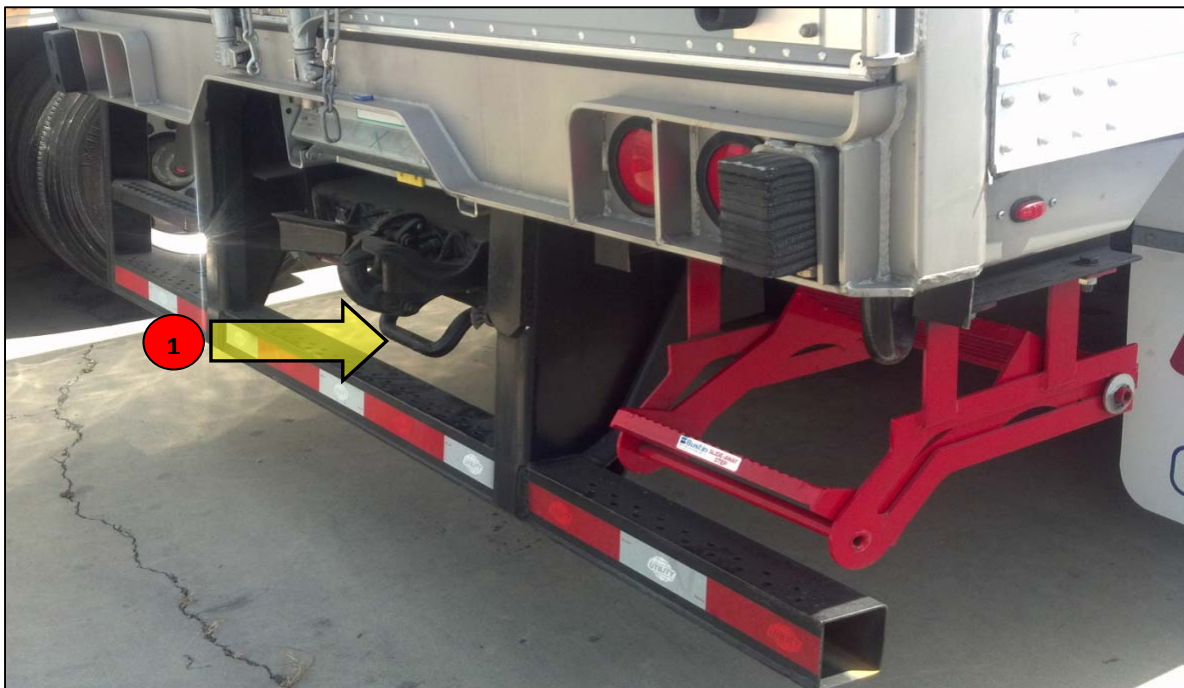
## Field Test Procedure (1):

- Stand at the rear of the trailer perpendicular to the pintle hook loop.
- Swing the 10 lbs. sledge and strike the safety loop's rearward surface, striking towards the front of the trailer.
- The impact should leave a mark but not crack the loop in any location.
- Inspect for cracks at the welds to the box beam and any cracks to the loop.

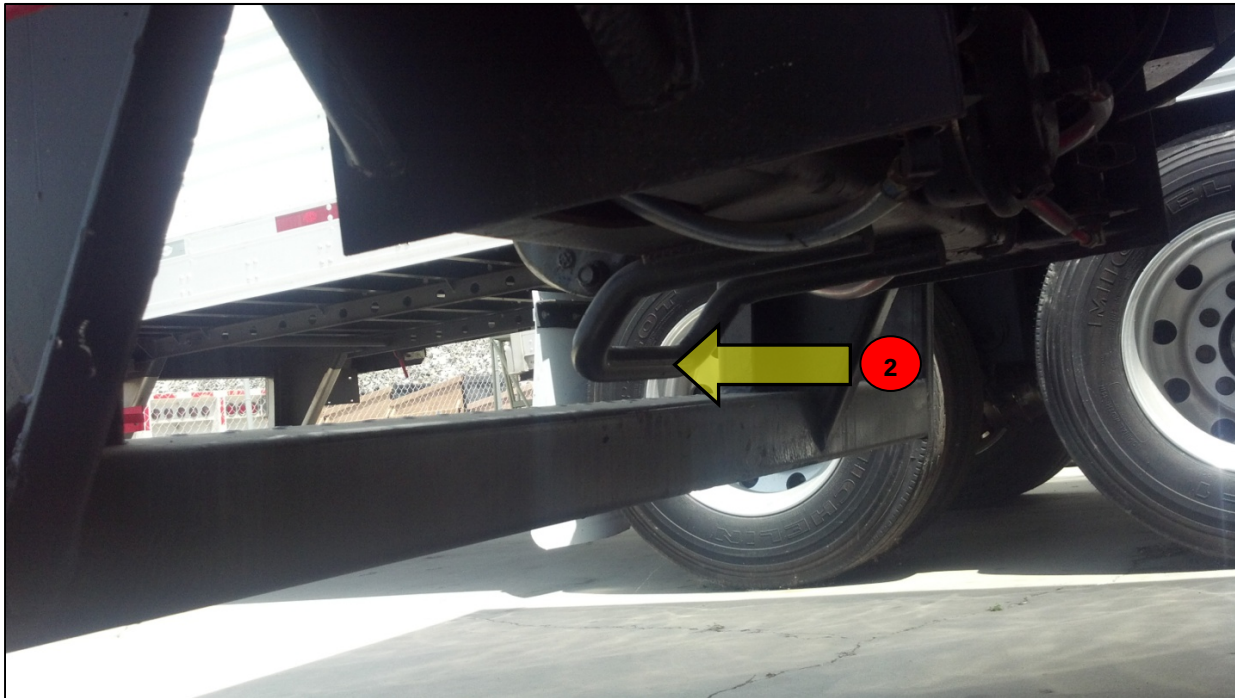
## Field Test Procedure (2):

- Repeat sledge hammer strike procedure on the rearward surface of the loop, striking towards the rear of the trailer.
- The impact should leave a mark but not crack the loop in any location.
- Inspect for cracks at the welds to the box beam and any cracks to the loop.

- If you observe any cracks on the pintle hook loop, remove and replace the loop, as follows:
  - Vans and reefers with 1-1/4" diameter loop: [PN 03-5300-027](#)

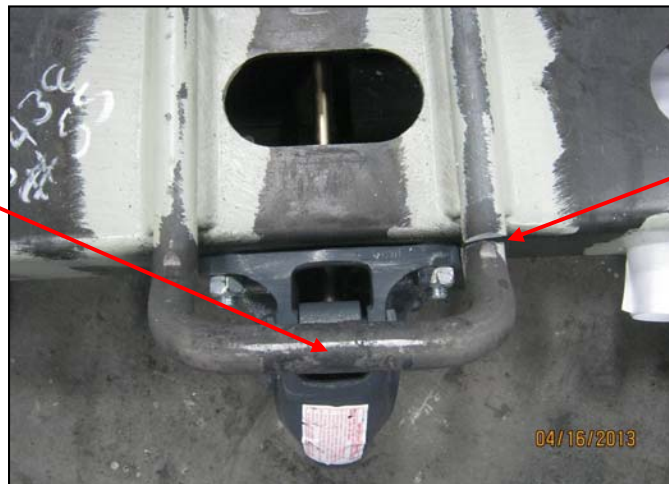
Example of flat mark from sledge hammer impact.

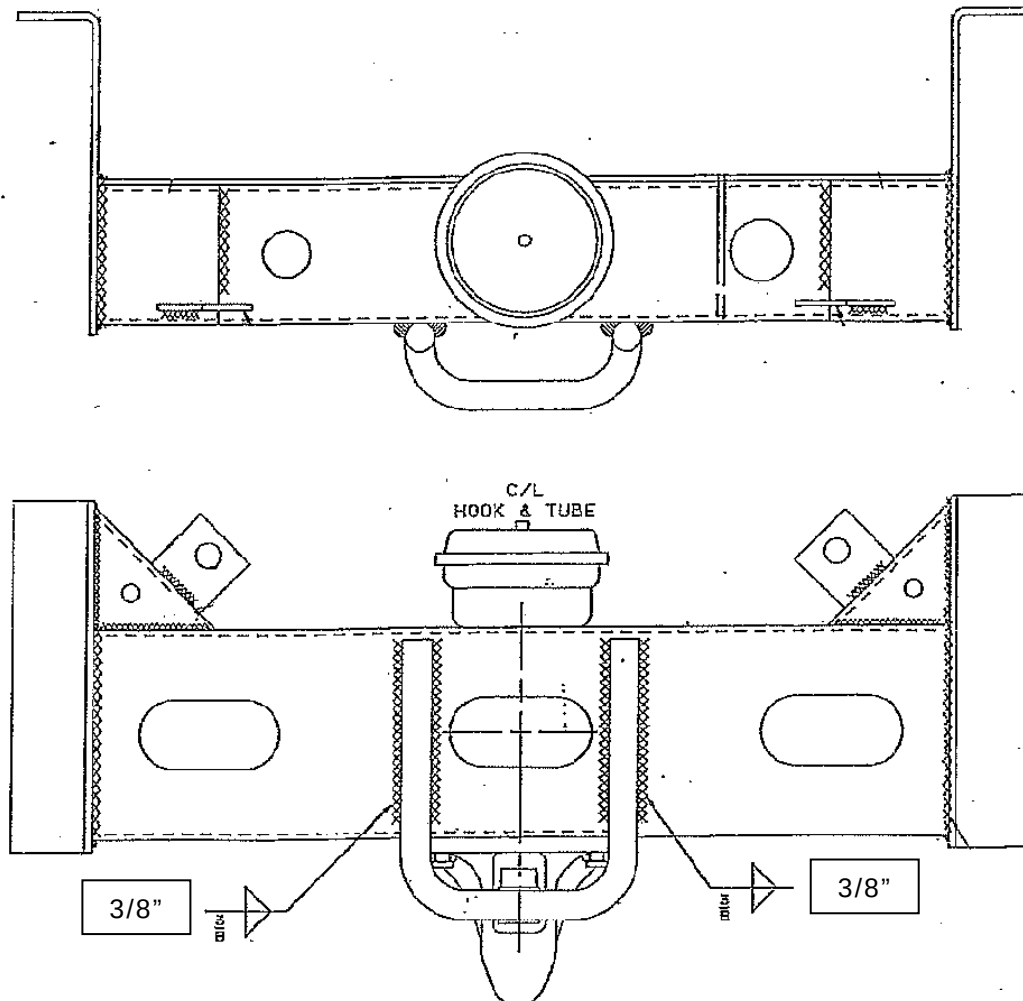
- Weld detail as follows:
