Recall Bulletin

SUBJECT: Compressed Natural Gas (CNG) High Pressure Regulator

MODELS: 2014 Chevrolet Express
Dedicated CNG Vans (RPO LC8&FHZ&UFP&UFM)
Equipped with Rear Air Conditioning and Heating (RPO C69&C36)

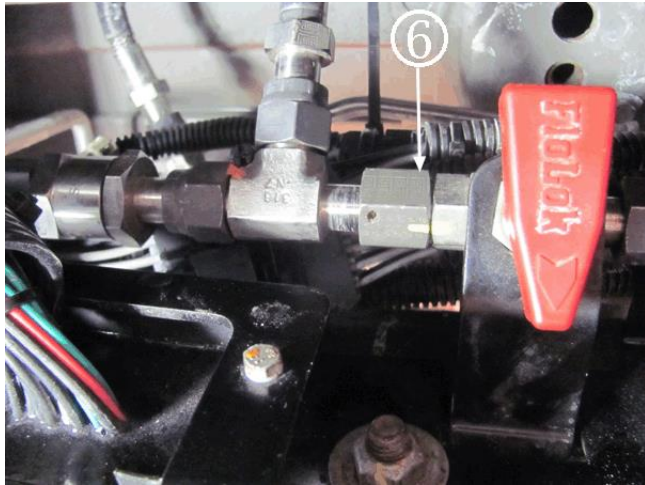
16. Disconnect the tee fitting (6).
17. Disconnect the CNG control module electrical connections. Refer to *CNG Control Module Replacement* in SI.

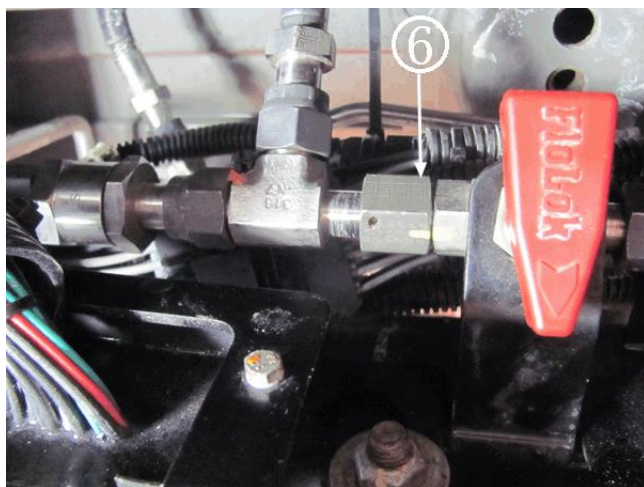
4068011

Note: The high pressure regulator comes equipped with a vent cap on the pressure relief tube. This cap prevents contaminants from entering the regulator and should NOT be removed.

32. Connect tee fitting (6) to the 1/4 turn valve.
33. Tighten tee fitting to **25 Nm (18 lb ft)**.

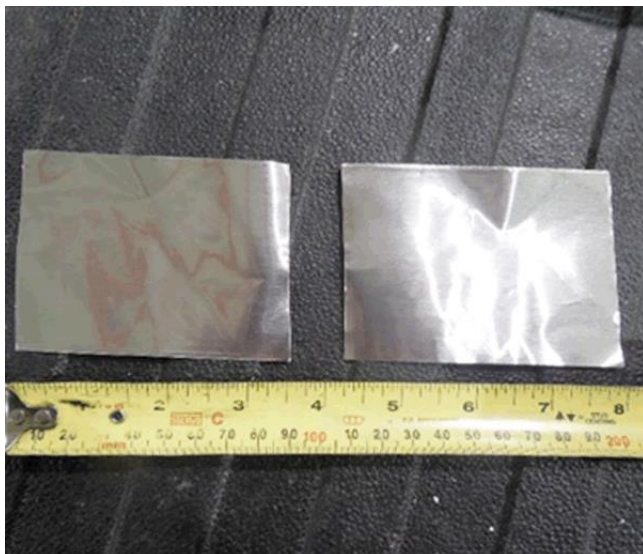
4068010

- 47.1 Cut the heat tape in half. Each piece of tape will be approximately 89 mm (3.5 in) long.

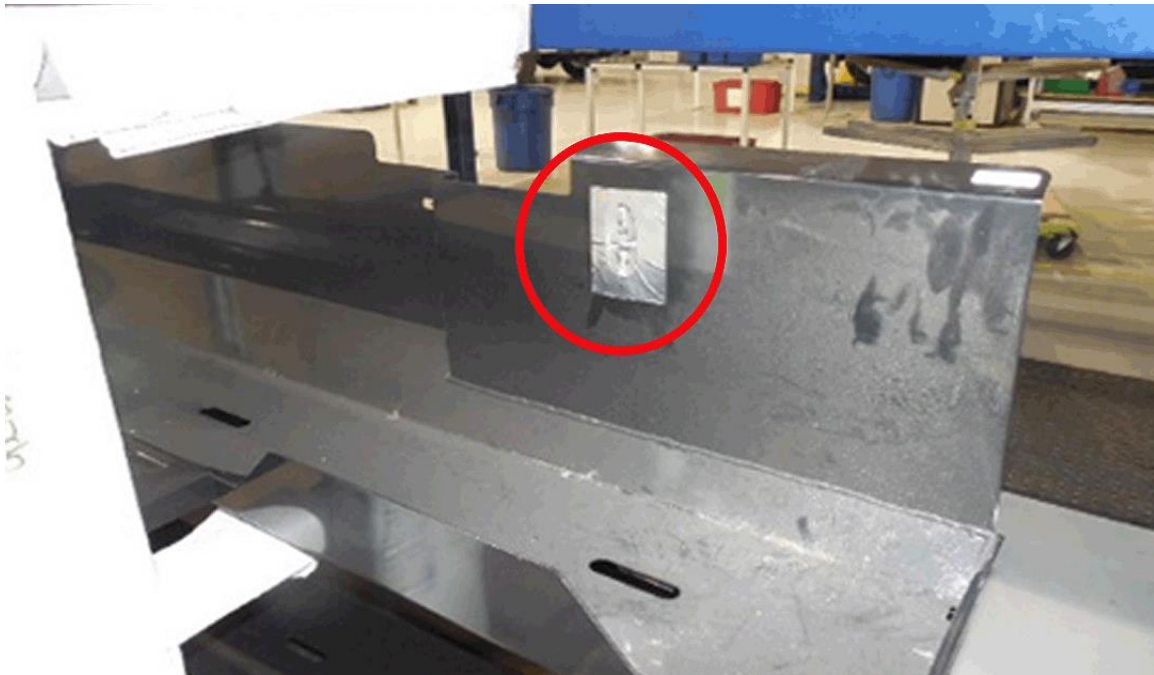
4068007

- 47.2 Peel and discard the heat tape backing material and apply one half of the cut heat tape over the PRD vent opening on the inside of the mid ship tank shield as shown. Make sure the tape is centered and covers the opening.

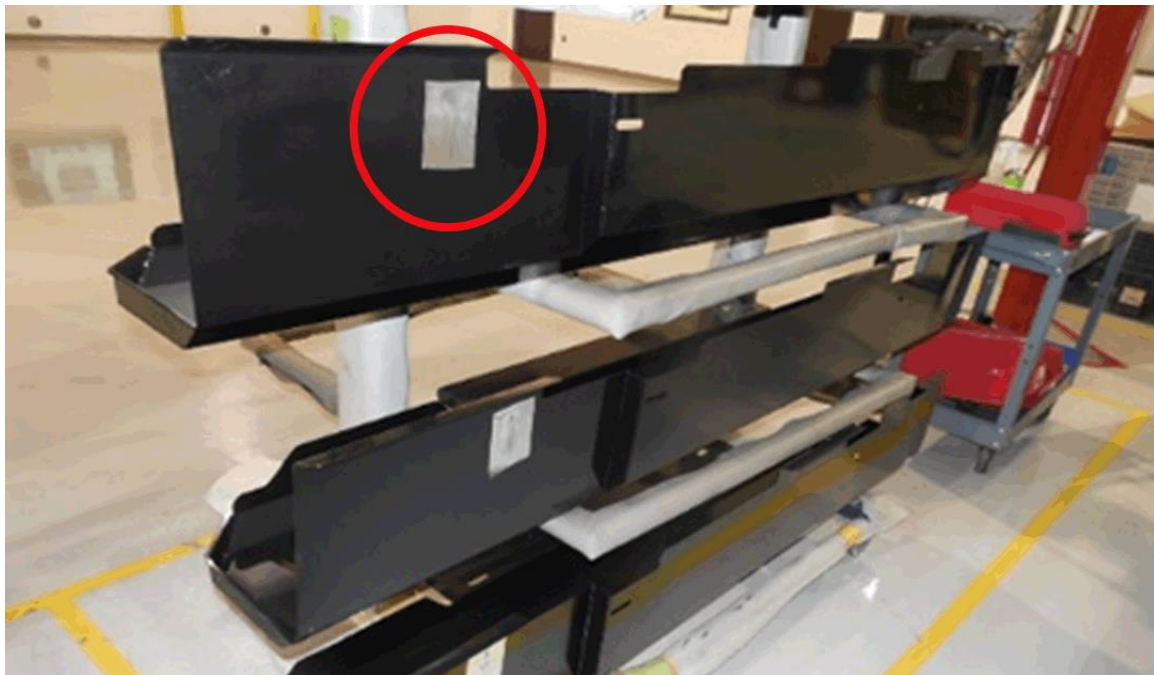
4068008

- 47.3 Peel and discard the heat tape backing material and apply one half of the cut heat tape over the same PRD vent opening on the outside of the mid ship tank shield as shown. Make sure the tape is centered and covers the opening completely.

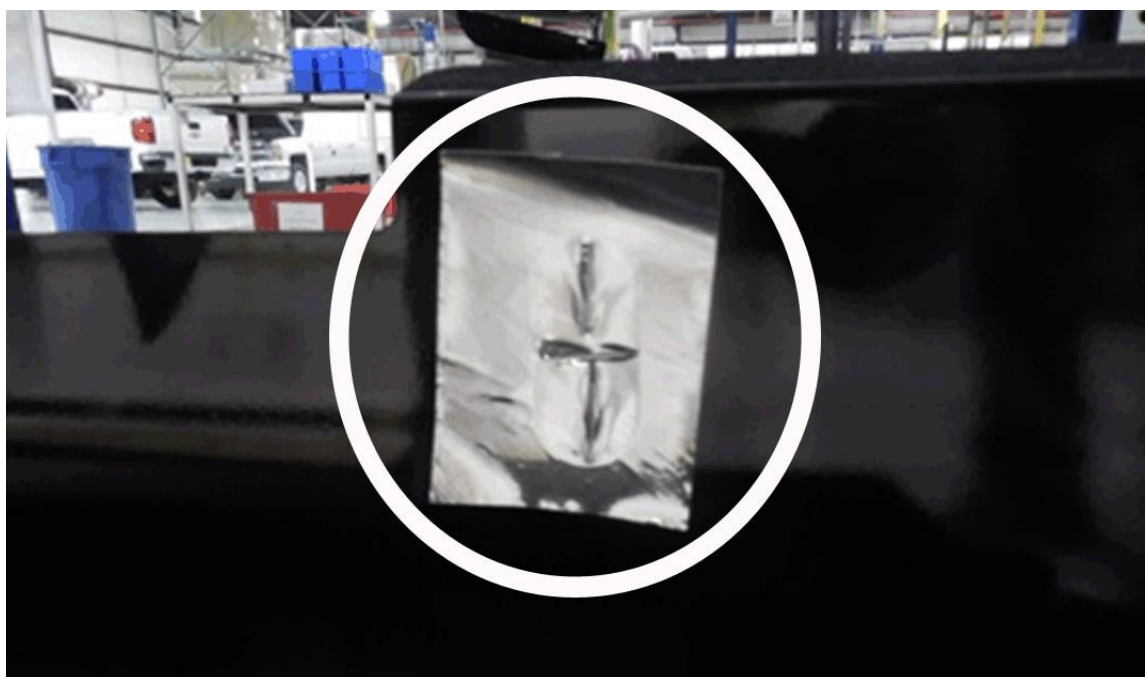
4068009

- 47.4 Cut slits in both the length and width of the PRD opening in the heat tape as shown. This is to allow the PRD to vent outside the shield.
48. Install the new midship tank cover. Refer to *CNG Tank Cover Replacement - Midship Tank* in SI.
49. Install the aft tank cover. Refer to *CNG Tank Cover Replacement - Aft Tank* in SI.
50. Lower the vehicle. Refer to *Lifting and Jacking the Vehicle* in SI.
51. FOR CALIFORNIA VEHICLES ONLY: Install a Recall Identification Label and complete a "Proof of Correction" certificate upon recall completion.
