INSTRUCTIONS TO PERFORM CAMPAIGN 131

Certain 2015 Winnebago® Vista models WFE26HE/WFE31KE and Itasca® Sunstar models IFE26HE/IFE31KE motorhomes.

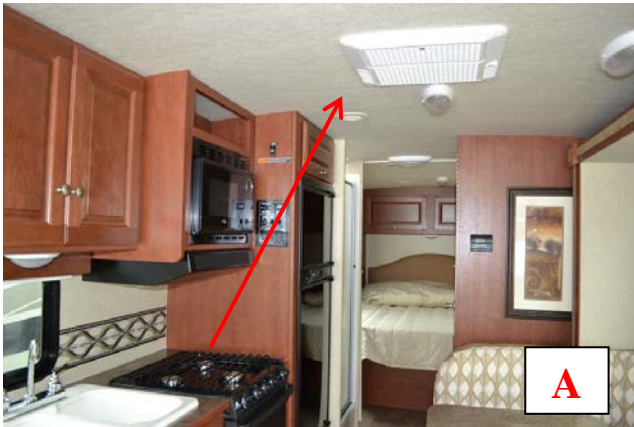
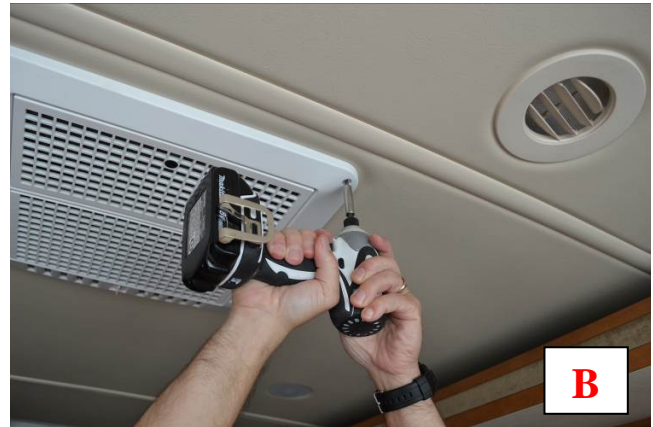
1. Remove (4) screws from perimeter of inside roof A/C assembly, (set aside). See figure A and B.

Figure (A) indicates diverter above cooktop that will be replaced with damper plate

6. Reinstall inside A/C shroud.
 - Install (3) screws under return air grate. *See figure D.*
 - Install (4) screws at perimeter of inside assembly. *See figure B.*
 - Install return air grate. *See figure C.*

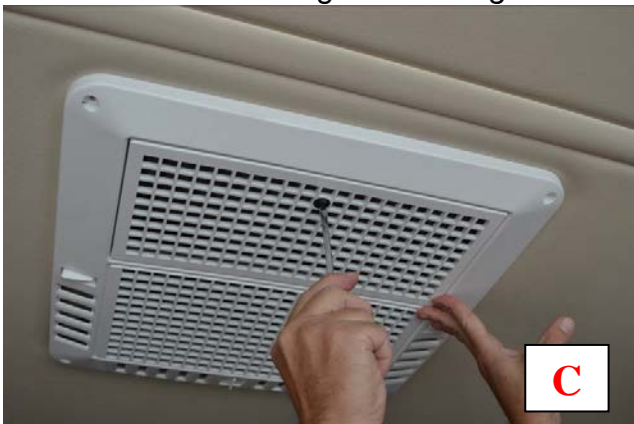
2. Remove return air grate. See figure C.

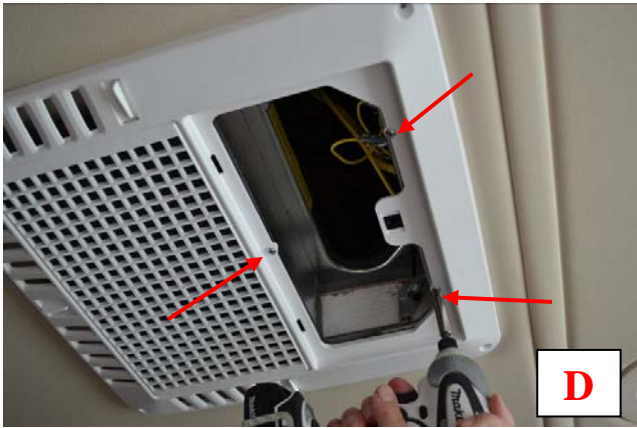
3. Remove (3) screws located behind return air grate, (set aside). See *figure D*. This will release inside A/C shroud from the ceiling.

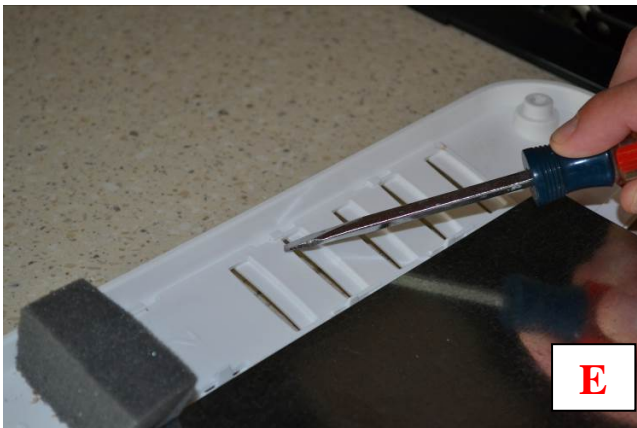
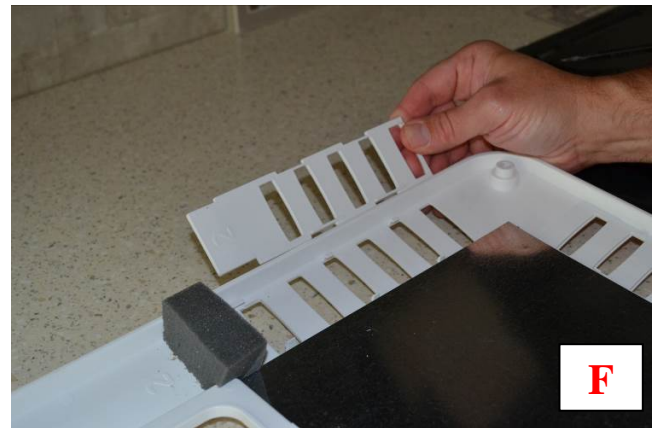
4. Place inside shroud on a solid surface. Using caution not to damage the retaining tabs, remove the right hand (passenger side) diverter. See *figure E and F*.

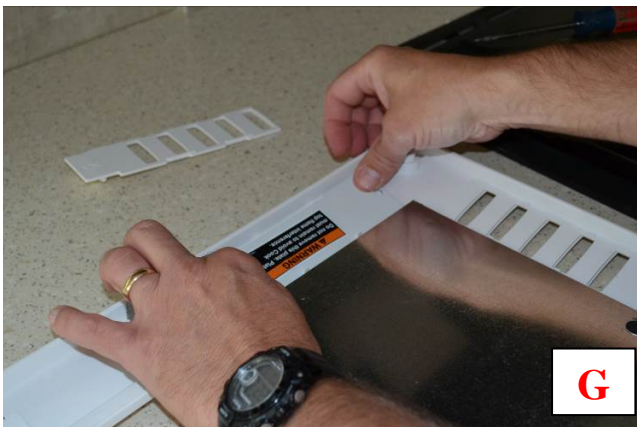
5. Using caution not to damage retaining tabs, install damper plate in place of diverter (label side up). See *figure G*.

7. When installation is completed, light the range, then turn on the roof air conditioner. Verify that the range flame remains constant, (even with a low flame).
