ITB14-050

## VOLUNTARY SAFETY RECALL CAMPAIGN 2014 Q50 HYBRID AND Q70 HYBRID; TRANSMISSION CASE INSPECTION

**CAMPAIGN ID #:** R1411**APPLIED VEHICLES:** 2014 Q50 Hybrid 2WD (V37)  
2014 Q50 Hybrid AWD (V37)  
2014 Q70 Hybrid (Y51)**Check Service COMM to confirm campaign eligibility.**

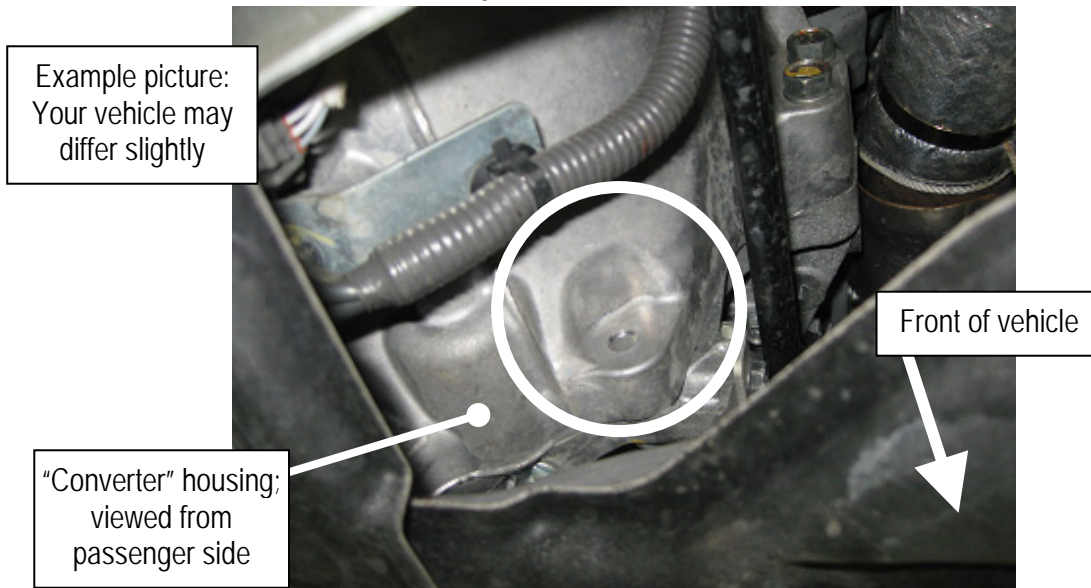
1. Raise the vehicle on a shop hoist.
2. Locate, and then clean the area circled in Figure 1 with C-NF Cleaner from the detection kit.

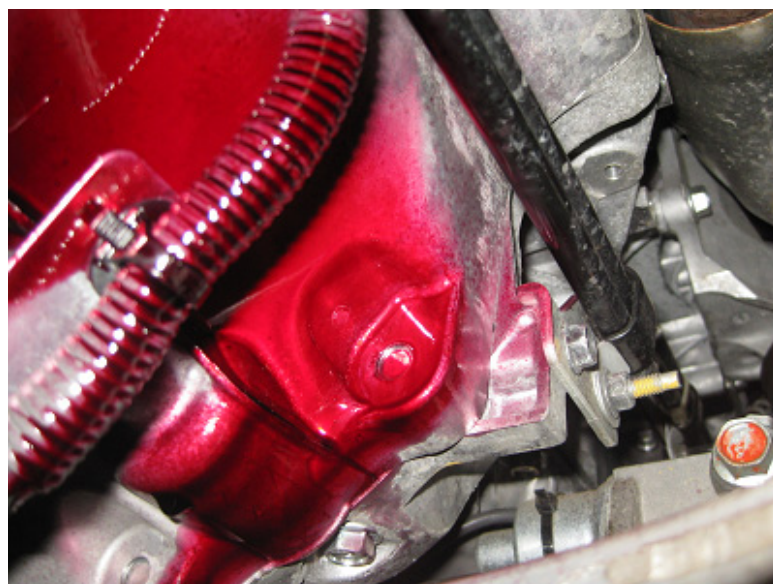
Figure 2

3. After C-NF Cleaner dries, spray PHF Penetrant (from the detection kit), and then leave the area momentarily. See Figure 2.
  - Leave the area for at least one (1) minute.

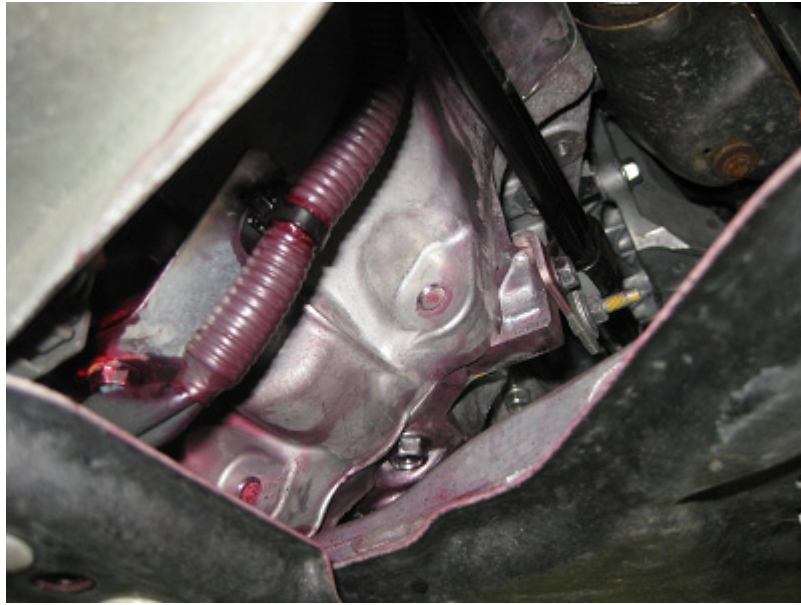
4. Wipe off the penetrant as shown in Figure 3 with a clean cloth pre-moistened with C-NF Cleaner.

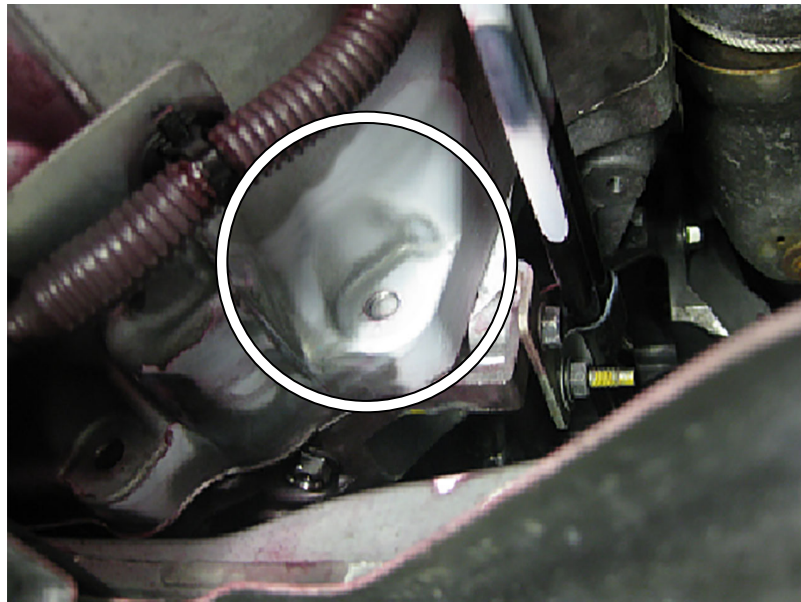
Figure 4

5. Apply D-NF Developer (from the detection kit) where shown in Figure 4.
