## Recall Information Bulletin

**No:** C1007010 **Issued:** 10/16/2014

**Re:** ATF Oil Cooler Hose

Safety Recall C1007010 – ATF Oil Cooler Hose

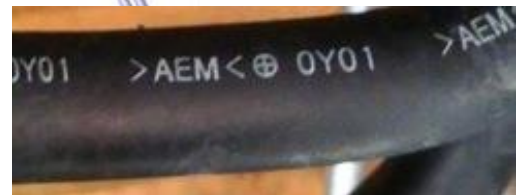
(Example)  
Lot No.: OY01 and white lettering **Affected**

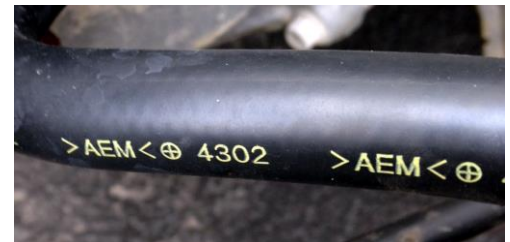
(Example)  
Lot No.: 4302 and yellow lettering **OK**

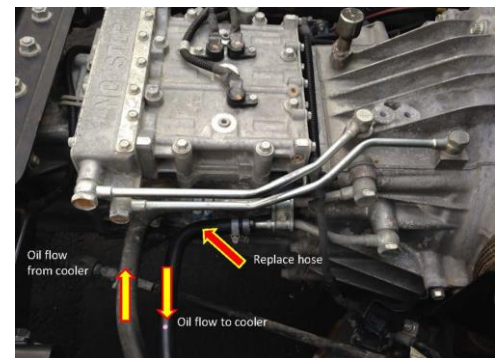
## 2. Remove defective feed side ATF oil cooler hose

Remove the oil cooler hose from the transmission side first. Raise the hose to drain fluid into the cooler line. This will reduce the volume of fluid lost. Remove the hose from the cooler line.

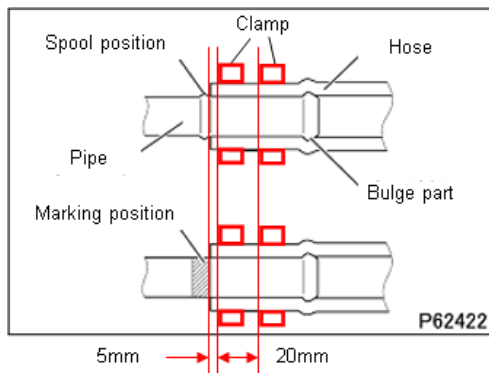
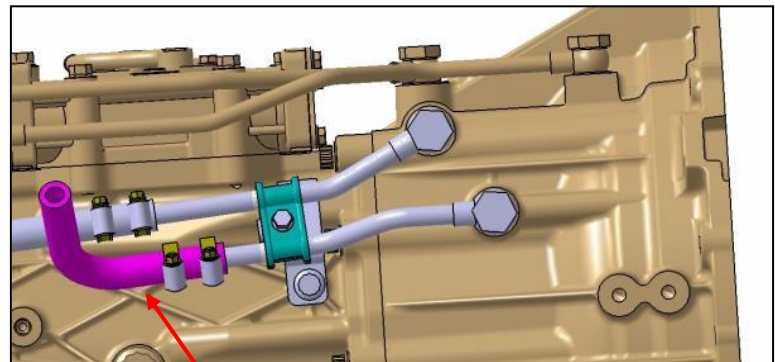
**LOWER HOSE**

Install the replacement hose. Tighten the clamps as shown below to a tightening torque of 2 ft.lbs. (3.0 Nm).
