Revised March 2015

Dealer Service Instructions for:

Safety Recall P61 / NHTSA 14V-631 Heated Power Side View Mirror Wire Harness

2011 - 2013 (JK) Jeep_® Wrangler

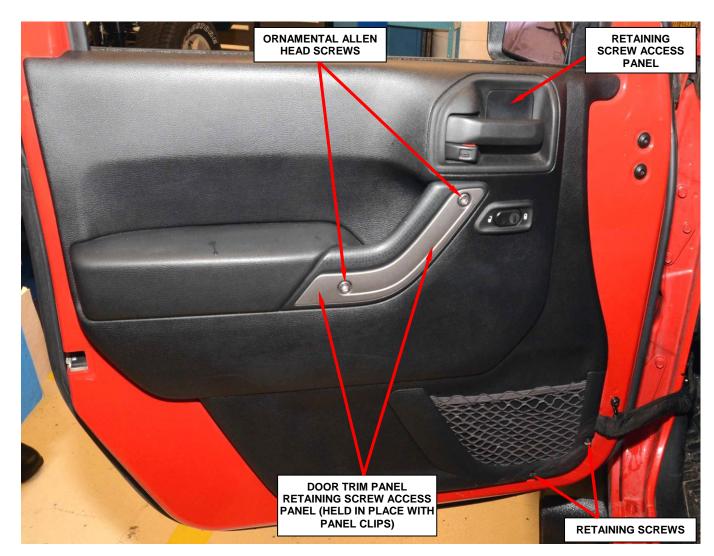
Figure 1 - Interior Door Trim Panel

- 1. Place both front windows in the full up position.
- 2. Open the hood.
- 3. Disconnect and isolate the negative battery cable.
- 4. Remove and save the interior door trim panel (Figure 1).
