**SAFETY ADVISORY # 14-218****Rubicon Generator Fuel Line Clamp**

Keystone RV Company is conducting a voluntary RECALL notification campaign in accordance with the National Traffic and Motor Vehicle Safety Act. It has been decided the vehicles subject to this recall campaign may not have the clamp installed correctly at the generator fuel filter and fuel tank. If the fuel line becomes disconnected it increases the risk of a fuel leak leading to an increased risk of fire, personal injury and property damage. This advisory explains how to correct the problem.

2015 Rubicon Travel Trailers

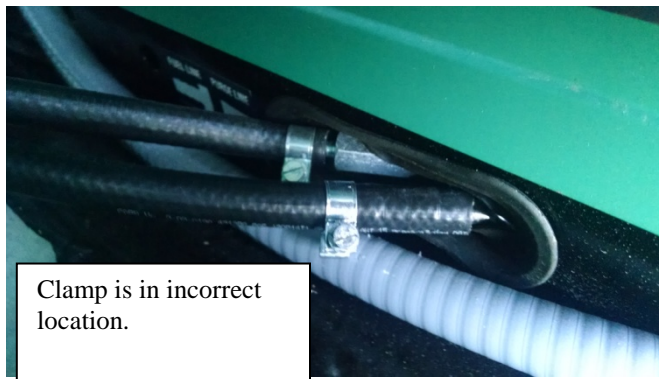
**Parts Required per Unit:** None**Tools Required:** Slotted Screwdriver**ONE      INSPECTION and REPAIR****Step 1**      Locate the trailer on a level, flat and hard surface. Chock the wheels.**Step 2**      Look under the generator and inspect the incoming fuel line and clamp to the generator where the line attaches to the fuel filter. Verify the fuel line is fully engaged on the barb fitting and the clamp is in the proper position and it is tight. See Figure 1 & 2.

**Figure 1 - Incorrect**

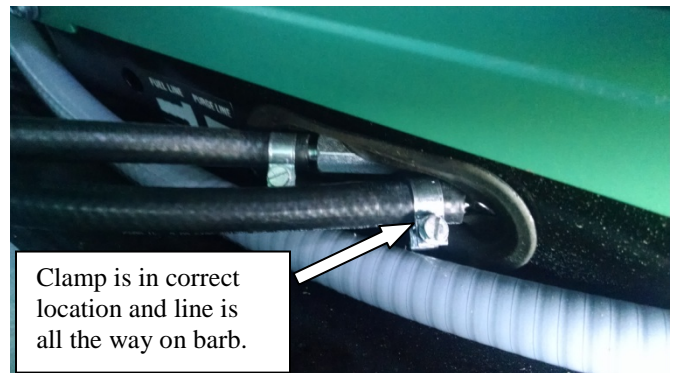
**Figure 2 – Correct****Step 3**      Look at the fuel pickup line on the fuel tank. Verify the fuel line is fully engaged on the barb fitting and the clamp is in the proper position and it is tight. See Figure 3 & 4.

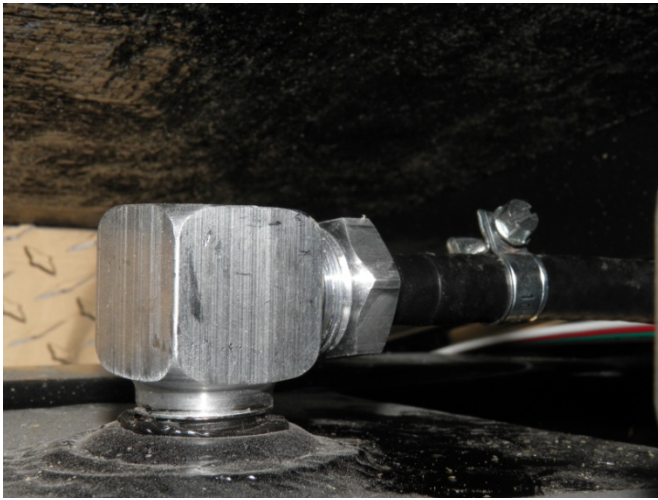
Figure 3 - Incorrect

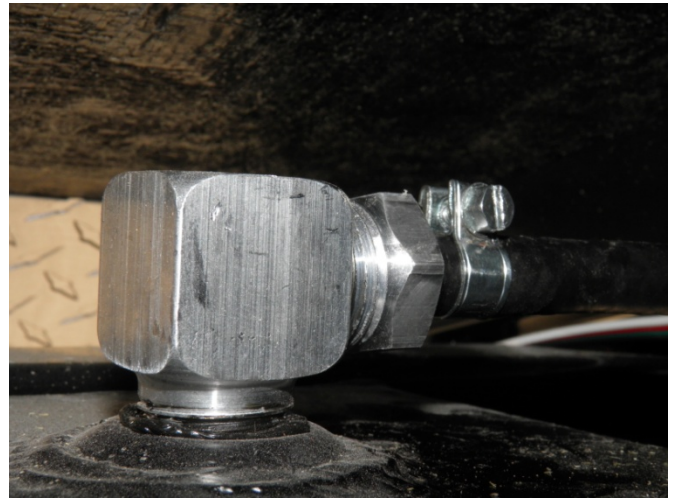
Figure 4 – Correct
