# Safety Recall

Code: 42G8

**Subject: 2011-2013 MY Jetta and 2012-2013 MY Beetle  
Rear Axle Trailing Arm Inlay Installation**

April 07, 2015

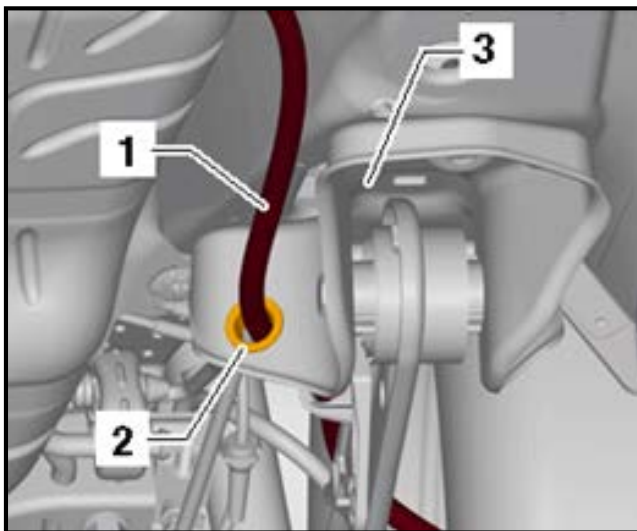
⇐ Disengage the parking brake cable <1> from the mounting hook <2> and pull it from the guide tube <3>.

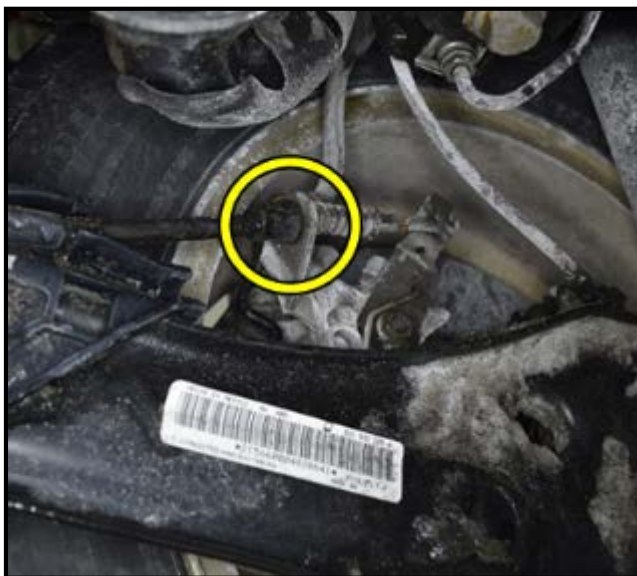
⇐ Slide the parking brake cable <1> rearward, out of the grommet <2> on the bracket mounted to the rear axle <3>.

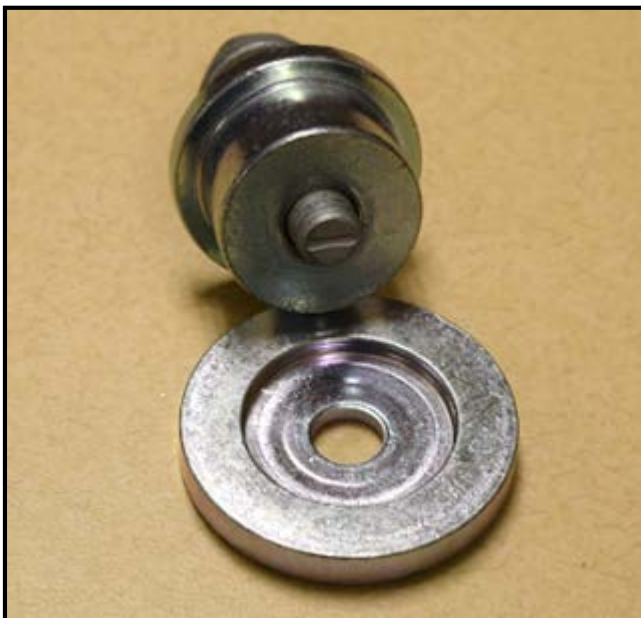
⇐ The mounting hardware is assembled as shown, with the trailing arm located between the bushing and the washer <arrows>.

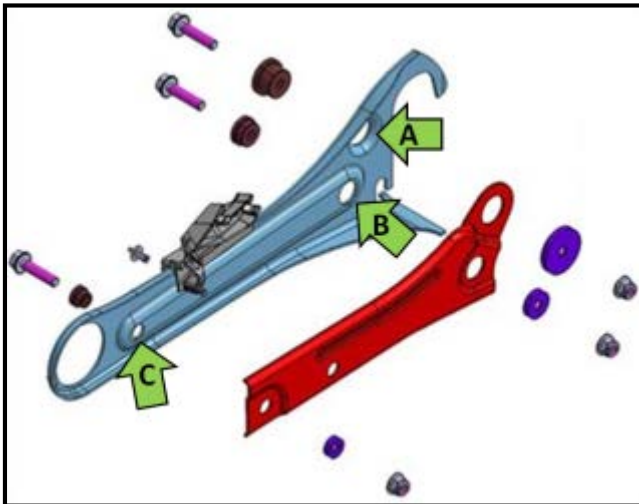
During assembly, the flat side of the washer must face the mounting nut. The inside edge of the washer is machined to fit over the end of the bushing <as shown>.

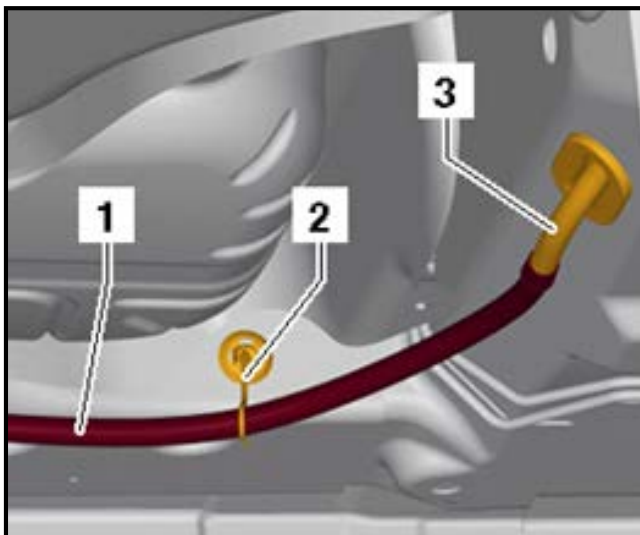
- ⇐ Reinstall the parking brake cable <1> into the grommet <2> on the bracket mounted to the rear axle <3>.

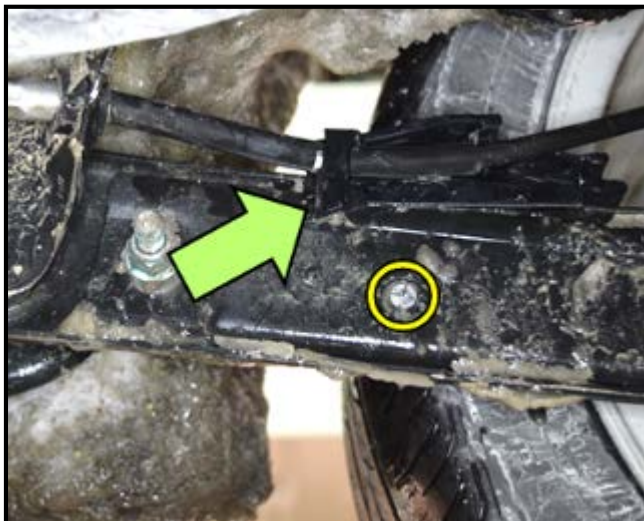
- ⇐ Reinstall the parking brake cable <1> into the guide tube <3>, and then into the mounting hook <2>.

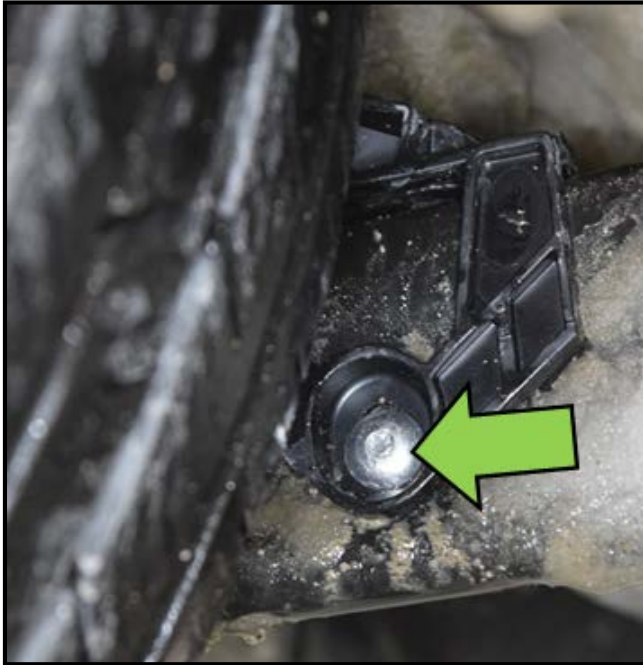
- ⇐ Position the parking brake cable bracket over-top the trailing arm as shown <arrow>.
- ⇐ Insert the rivet from the outboard side, through the mounting bracket, and into the trailing arm <circle>.
