Safety Recall

Code: 60B9

**Subject: 2013-2015 MY Beetle with Factory-Installed Panoramic Sunroof
Panoramic Sliding Sunroof Glass**

November 26, 2014

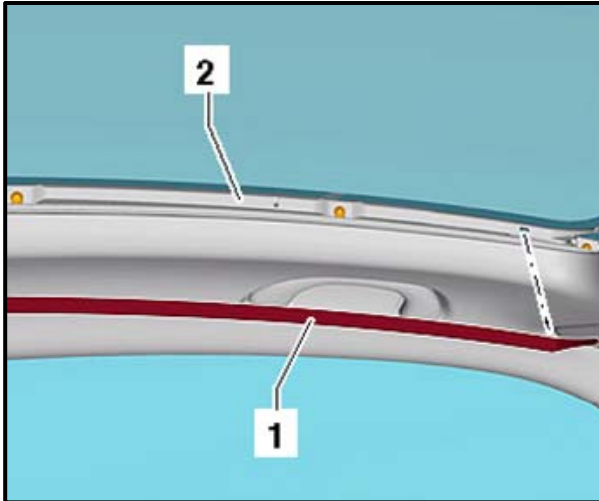
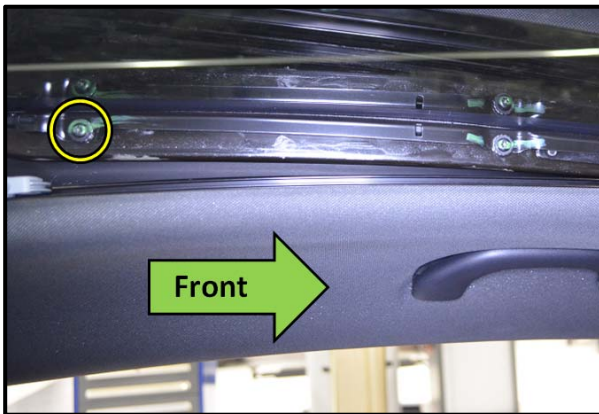
- Open the sunroof shade completely.
- Open the sunroof to the “tilt” position.
- ⇐ Remove the molding <1> from the sunroof mounting bracket <2> on each side of the sunroof.

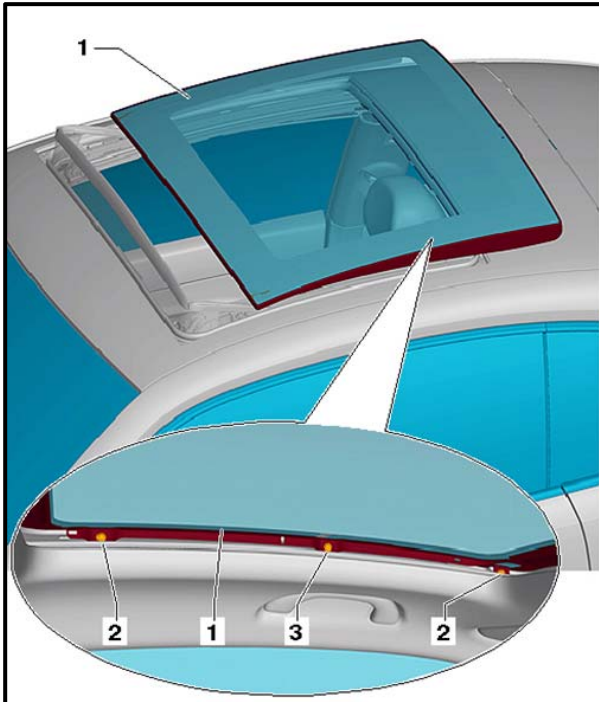
- ⇐ Remove and discard the center mounting screw from the left and right sides <3>.
- ⇐ Install a replacement screw from kit, P/N 5C5 017 737, in the center location <3> of the sunroof tilting mechanism on the left and right sides.

Note: DO NOT tighten the center mounting screws at this time. Only insert them by hand, as the sunroof glass must slide onto the center screws during reinstallation.

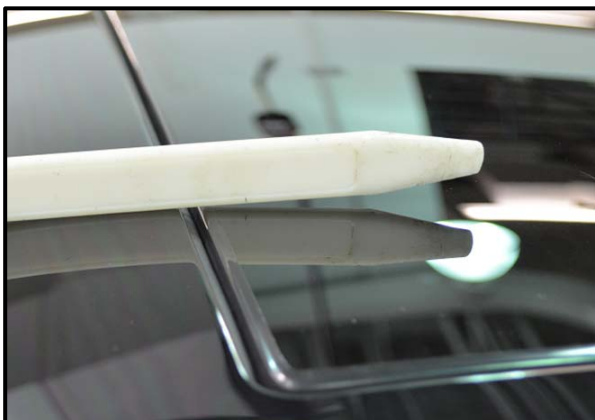
- ⇐ Position the replacement sunroof glass panel <1>, P/N: 5C5 877 071B, onto the center mounting screws <3> and carefully set it onto the tilting mechanism.
- ⇐ Install the new left and right mounting bolts <2> by hand.
- Move the sunroof the fully closed position.

- Adjust the sunroof glass height one corner at a time and gently tighten the associated mounting bolt.

Note: When adjusted correctly, the front edge of the sunroof glass should be roughly 1mm below the roof of the vehicle, and the rear edge of the sunroof glass should be roughly 1mm above the roof of the vehicle.

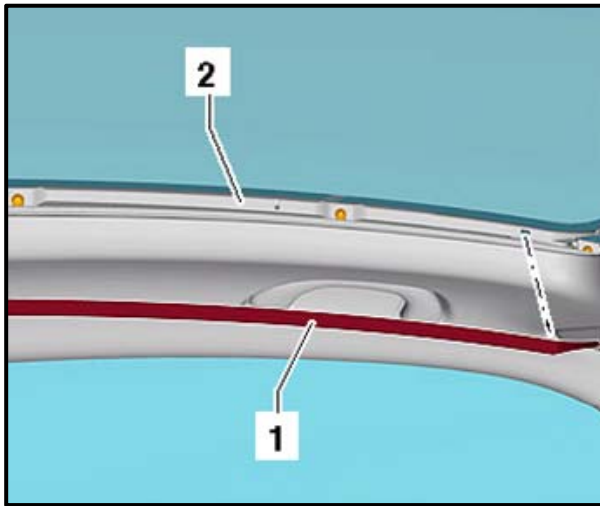
- ⇐ Use a trim stick (or equivalent) to inspect the sunroof glass to roof alignment <as shown> to verify it is positioned correctly.
- Torque all 6 mounting screws to 6 Nm using the VAG1783 – 2-10Nm Torque Wrench (or equivalent).

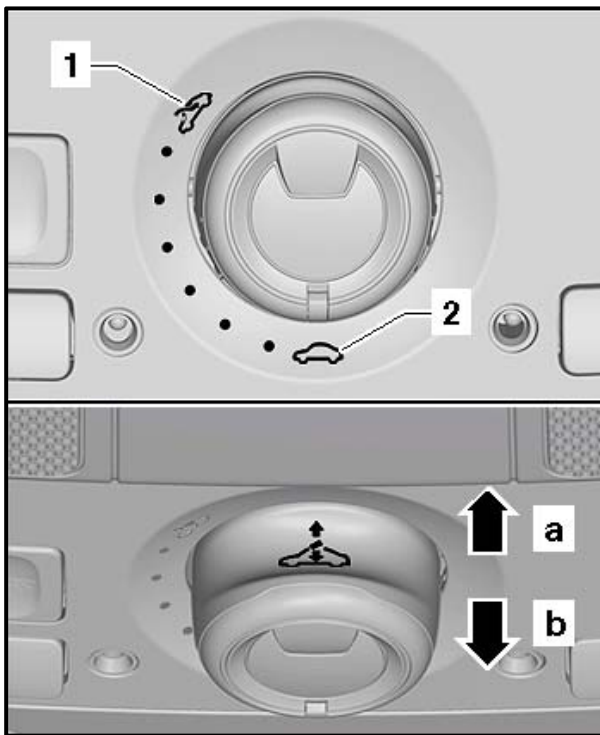
⚠ Note: Basic settings must be performed any time the glass panel is removed, adjusted, or altered in any way.

- Switch the ignition ON.
- Close the rear lid and both doors
- ⇐ Turn the sunroof knob to the “Closed” position <2>.
- ⇐ Pull the sunroof knob downward <arrow b> and hold it in this position for the entire basic settings procedure.
