Safety Recall

Code: 72F1

**Subject: 2015 MY Passat and Jetta with Manual Front Seatback Recliner(s)
Seatback Recliner**

October 24, 2014

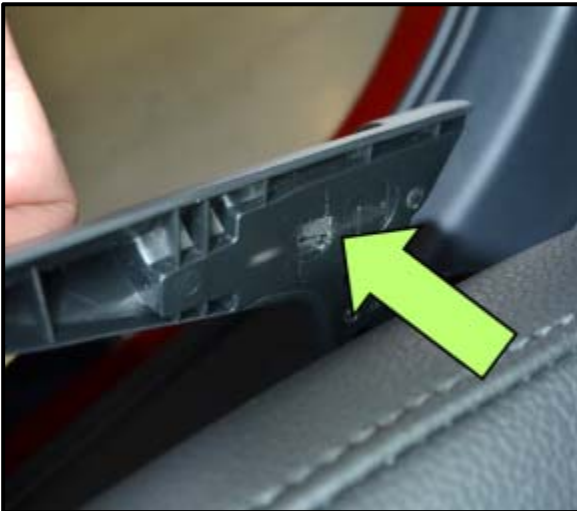
- Adjust the seat to full-forward position.
- Position the seatback in a partially reclined position (i.e. not fully forward, or fully reclined).
- Pull up on the height adjustment handle repeatedly until the seat is in the fully-raised position.
- ⇐ Using a 90° pick tool (or equivalent) disengage the locking tab <arrow> from the seat height adjustment lever.
- Slide the handle forward to remove it.
- Repeat this procedure to remove the seat recliner handle.

Note: To prevent damage to the trim panel, wrap each seat adjustment lever with masking tape (or equivalent) after removing the plastic handles and prior to removing the side trim panel. Damage to the seat trim panel is NOT covered under this action.

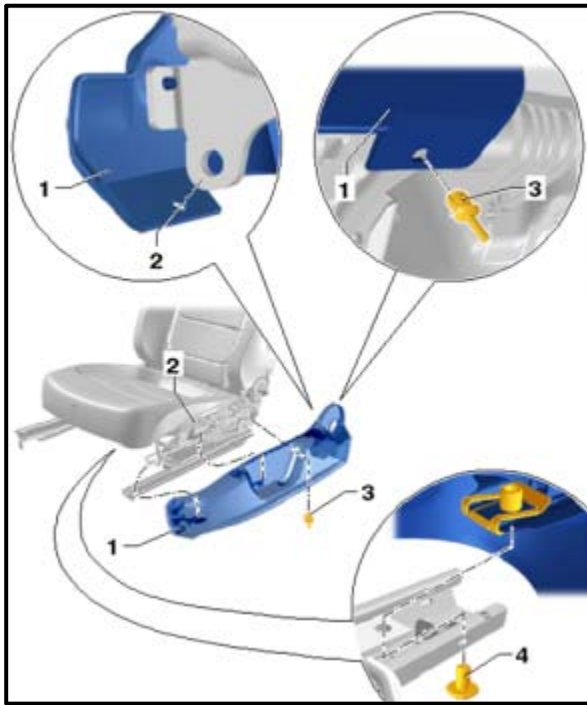
- ⇐ Remove the screw <4> from the trim <1>.
- ⇐ Remove the plastic rivet <3> from the trim <1>.

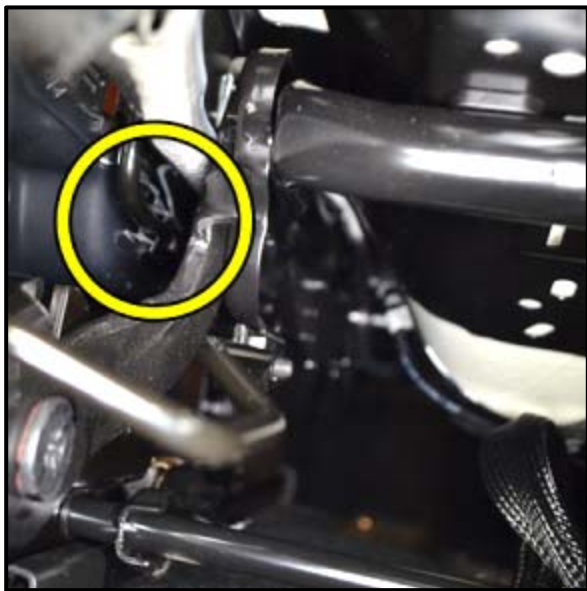
- ⇐ Release the locking tab on the inside of the seat trim panel <circle> and disengage the trim panel from the seat frame.
- ⇐ Carefully remove the trim panel from the seat.

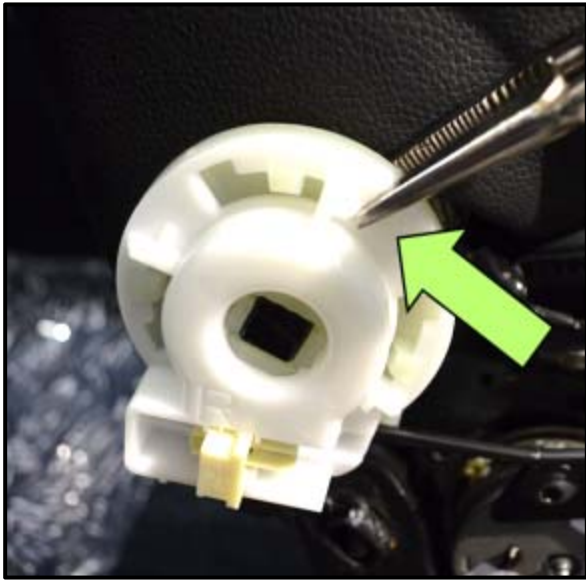
⇐ Lightly clamp a pair of needle nosed locking pliers (or equivalent) onto the outboard seat recliner mechanism as shown <arrow>.

i Tip: The clamping force on the pliers should be adjusted so that it is just strong enough for the pliers to stay in place without holding them, but relaxed enough so as not to leave imprints in the plastic seat recliner mechanism.

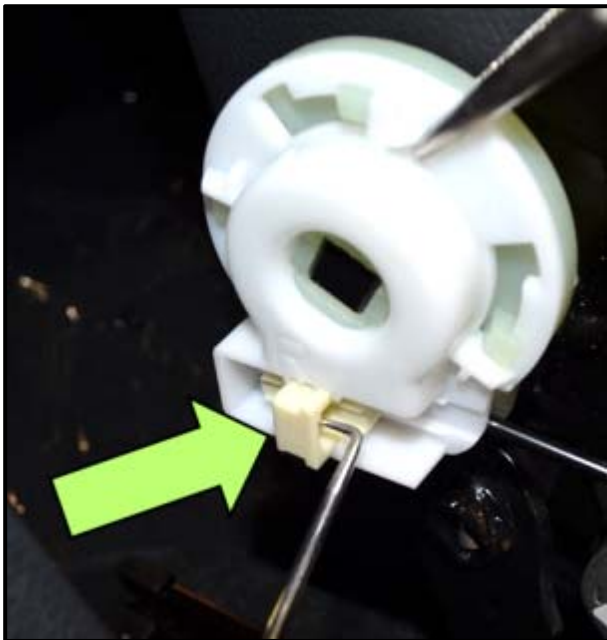
⇐ Use a 90° pick tool (or equivalent) to partially remove the clip <arrow>.

! Note: It is not necessary to fully remove the locking clip. Only pull the clip out 3-4 mm until it reaches the first detent.

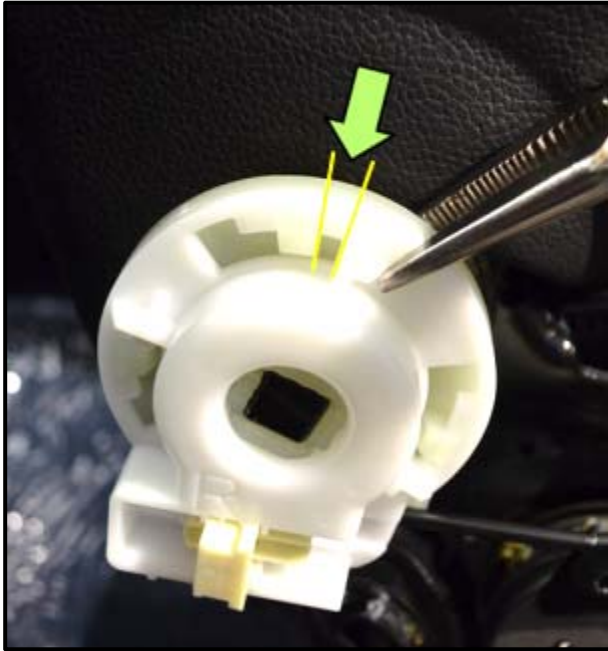
- ⇐ If a gap is present between the locking ears of the rotating plate, and the hard stop on the ground plate as shown <arrow>, release the locking pliers, turn the rotating plate in the appropriate direction to close the gap completely, then reattach the locking pliers.

Note: The locking pliers **MUST** be released prior to adjusting the rotating plate.

Tip: To perform this adjustment on the driver seat, turn the rotating ring in a clockwise direction.
To adjust the passenger seat, turn the rotating ring in a counter-clockwise position.

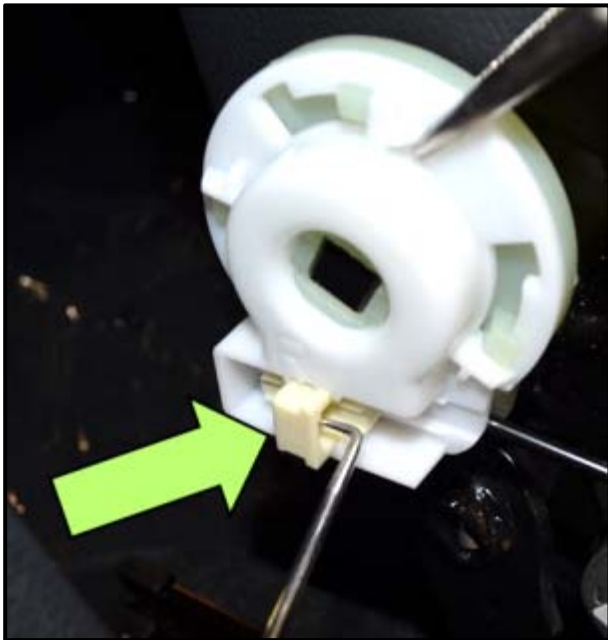
- ⇐ Reinstall the clip <arrow>.
- Remove the locking pliers.
 - Reinstall the outboard seat trim panel and all fasteners.
