Eldorado National - California

INSTRUCTION FOR INSPECTION AND REPLACEMENT:

Subject: Safety Recall
NHTSA Recall No. #14V685

Model year 2008 & 2009 Axess, XHF, E-Z Rider, Escort RE-A & Transmark RE.

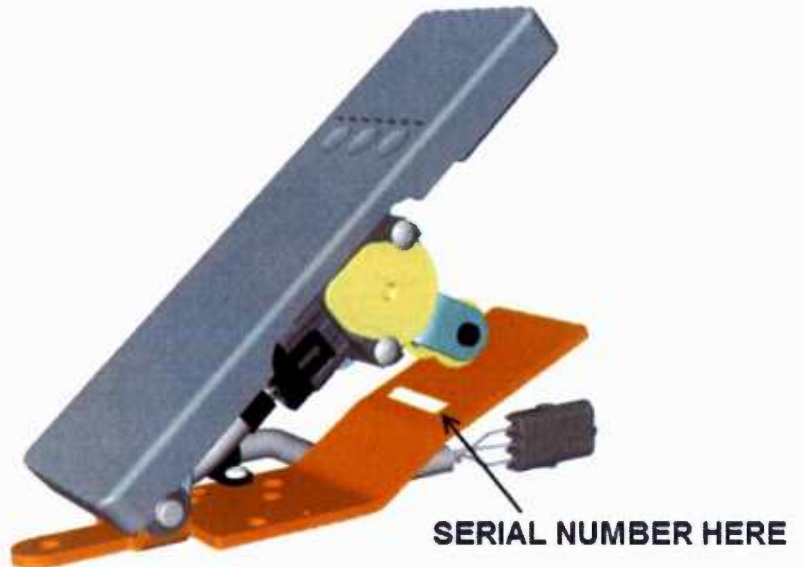
1. Check the serial number on the accelerator pedal assembly.
2. If the accelerator pedal serial number matches with a serial number found in the following list, a replacement of the accelerator pedal is needed. To do so, perform Part 2 of this campaign.
3. If your accelerator pedal serial number is not within the range of affected accelerator pedal, no replacement is needed. No other verification or repair is necessary.
