14516

SUBJECT: SAFETY RECALL

No Idle HVAC Module Harness on certain LoneStar® and ProStar® models built 16 December 2008 thru 20 June 2014 with feature code 16UZL: No Idle Heating, Ventilation, and Air Conditioning (HVAC) module.

VEHICLE RECALL 14516

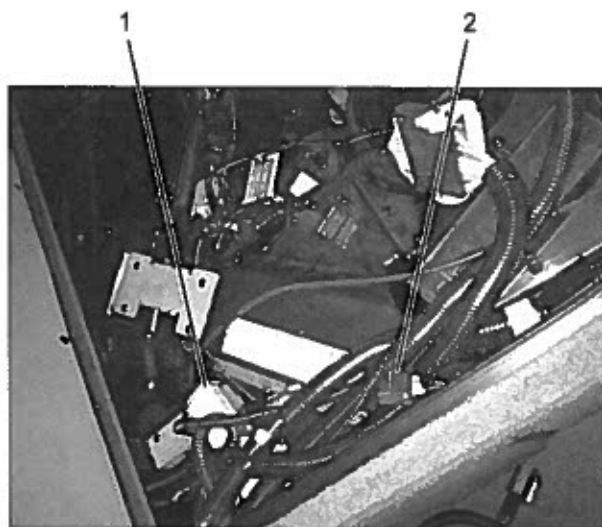
Figure 2. Control Center Harness.

1. Control center
 2. Control center harness 4-way connector
7. Disconnect control center harness 4-way connector (Figure 2, Item 2) from harness connector near control center (Figure 2, Item 1).
 8. Remove battery cable from vehicle. Discard battery cable.

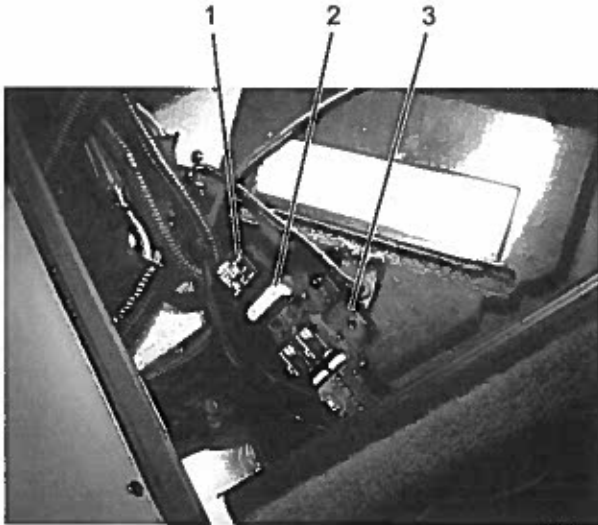
Figure 5. 70 Amp Relay and 60 Amp Compressor Fuse.

1. 70 amp relay
2. 60 amp compressor fuse
3. Control center

11. Remove 70 amp relay (Figure 5, Item 1) and 60 amp compressor fuse (Figure 5, Item 2) from control center (Figure 5, Item 3). Discard relay and fuse.
