SAFETY ADVISORY # 14-219

Laredo Mini Breaker Relocation

Models Included: 2015 Laredo Travel Trailers

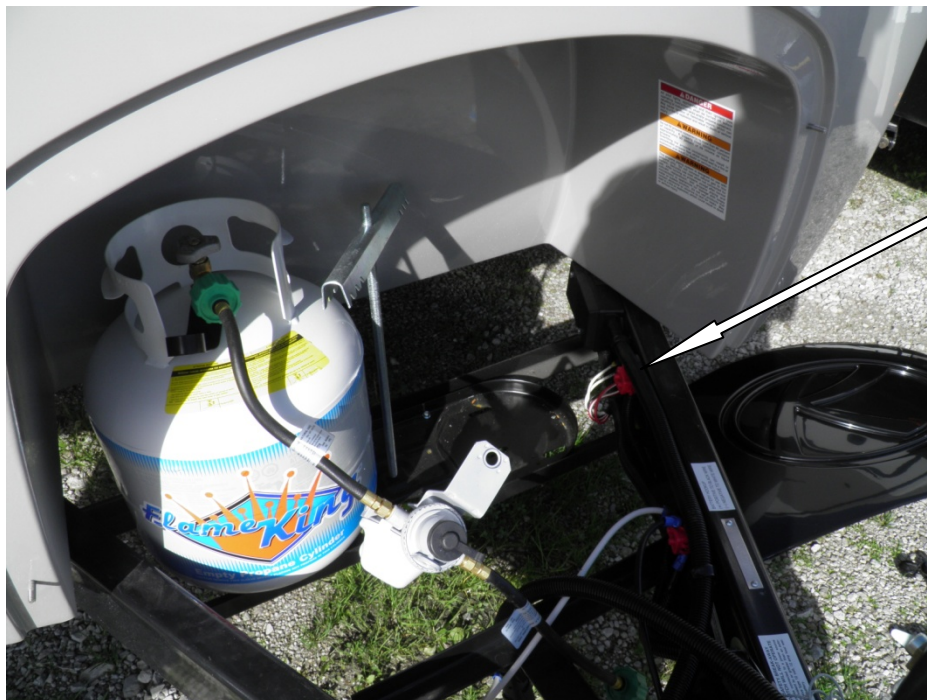
Fig. 1

Keystone RV Company is conducting a voluntary RECALL notification campaign in accordance with the National Traffic and Motor Vehicle Safety Act. It has been decided a 12V mini breaker is located too close to the propane cylinder. If the propane bottle rubs against the rubber boot it may wear through and cause a short leading to an increased risk of fire and personal injury. This safety advisory explains how to correct the installation.

Relocate
rear breaker
forward

Step 1 Locate the propane cylinders at the front of the unit. Remove the cover, and right side propane cylinder. See figure 1.
