00407-01886 Version 8

Safety Recall: Front Passenger's Airbag Inflator May Produce Excessive Pressure After Long-Term Exposure To High Absolute Humidity

AFFECTED VEHICLES

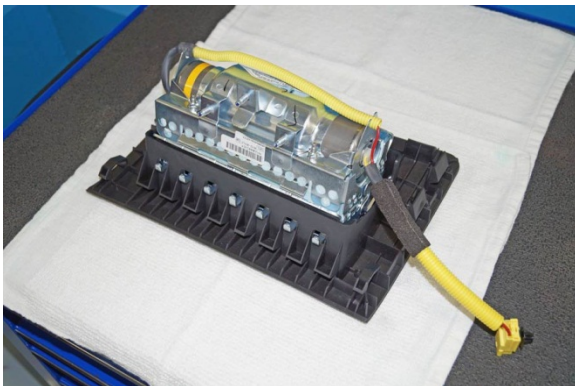
3. Remove the front passenger's airbag by referring to the applicable electronic service manual.
 4. Place the airbag, face-down, on a clean shop towel.

- The orientation of the airbag is critical because if the inflator is installed incorrectly, the harness will be too short when you reinstall the airbag.
- The brackets between the various models are similar but may differ from the example shown.

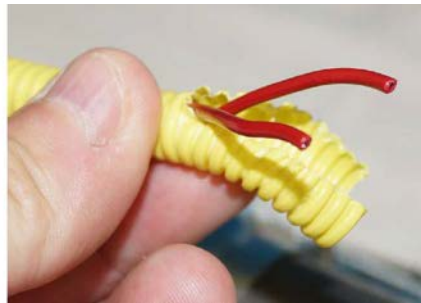
- Cut about 2 inches of the corrugated tube, then pull out the two red wires.

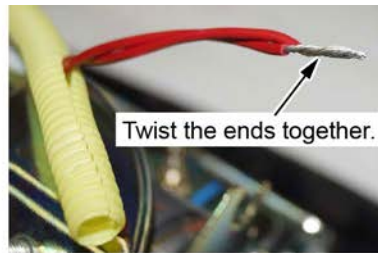
- Strip away about 1 inch of the wire insulation, then twist the wires together.

- Tape the twisted ends with electrical tape.

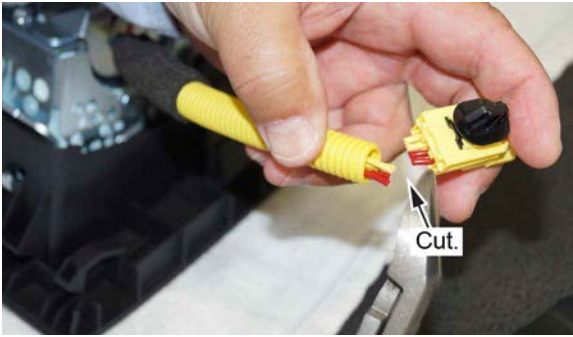
9. Cut off the connector and short the yellow wires.

You must cut and short the wires as indicated to prevent accidental deployment.

- Cut all four wires to remove the connector.

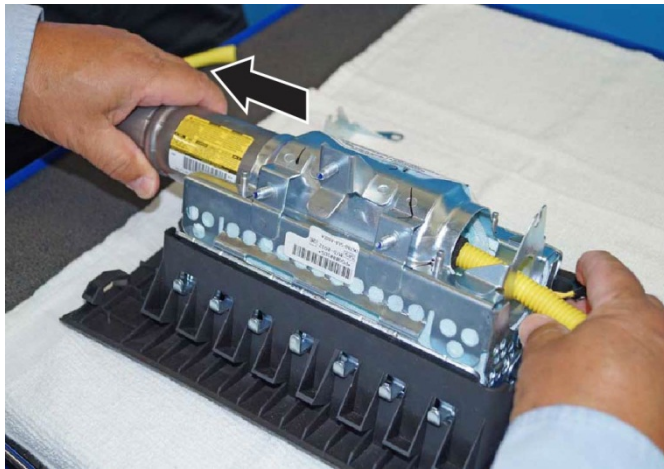
12. Remove the inflator by pushing it out.

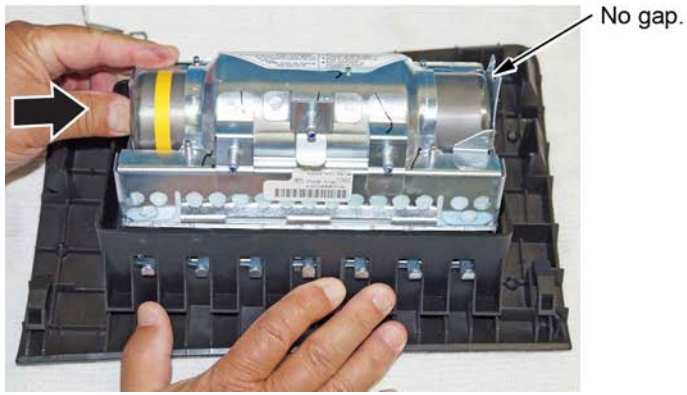
- Slide the inflator in until the “D” aligns with the tab on the inflator bracket. There should be no space or gap between the inflator and bracket.

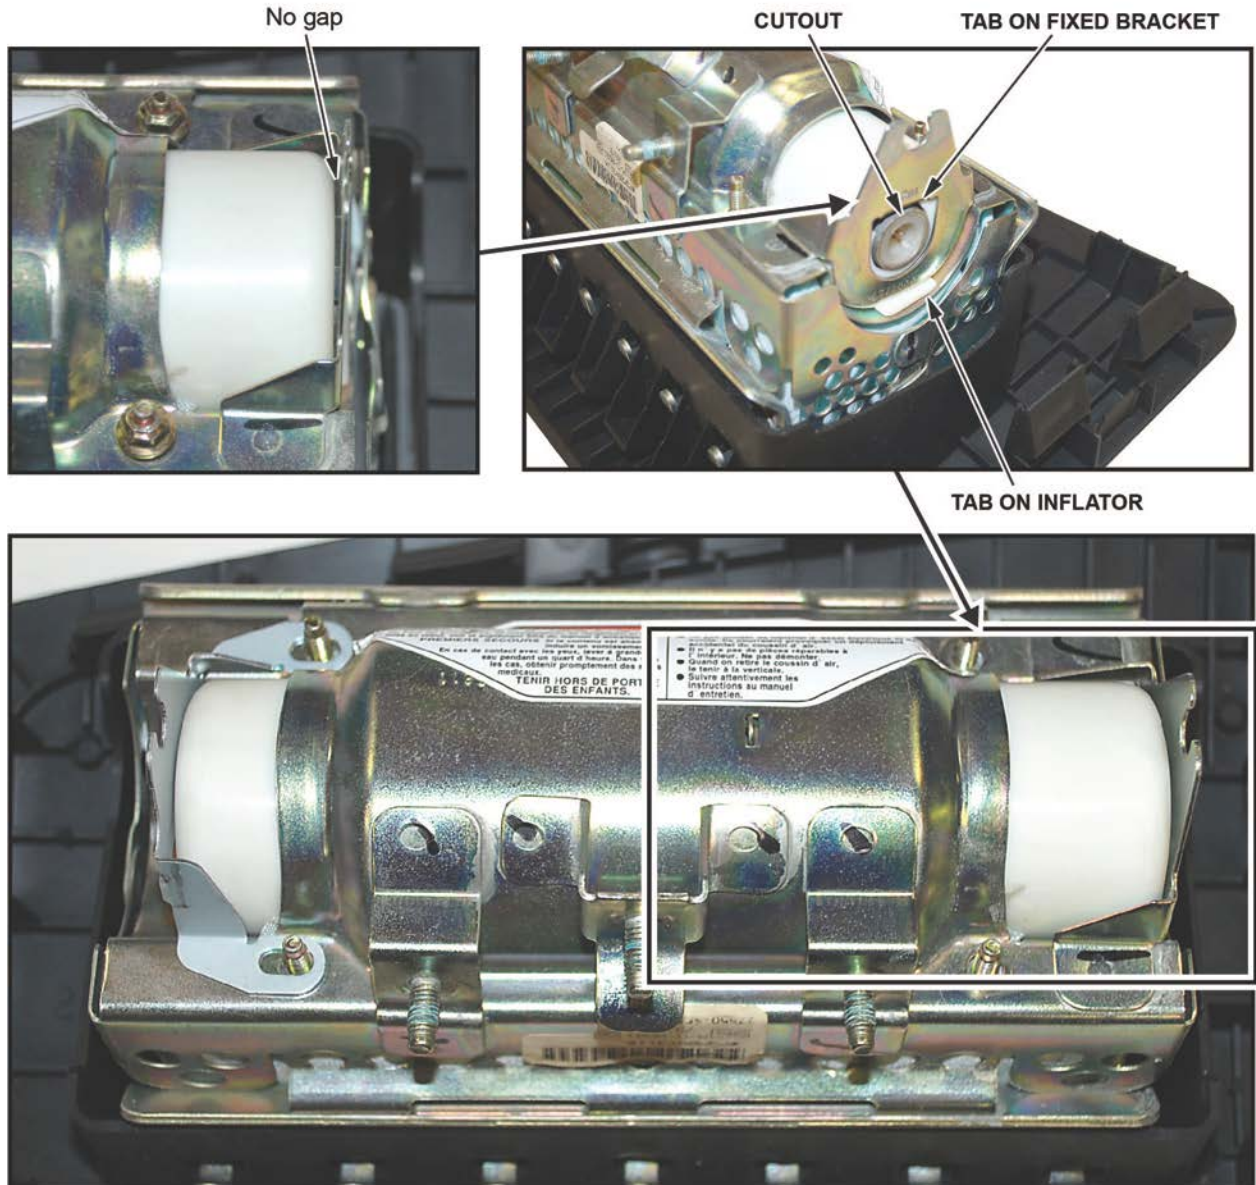
FIXED BRACKET END

- Slide the inflator in until the plastic cutout and the small flat spot align with the tab on the bracket. There should be no space or gap between the inflator and bracket.

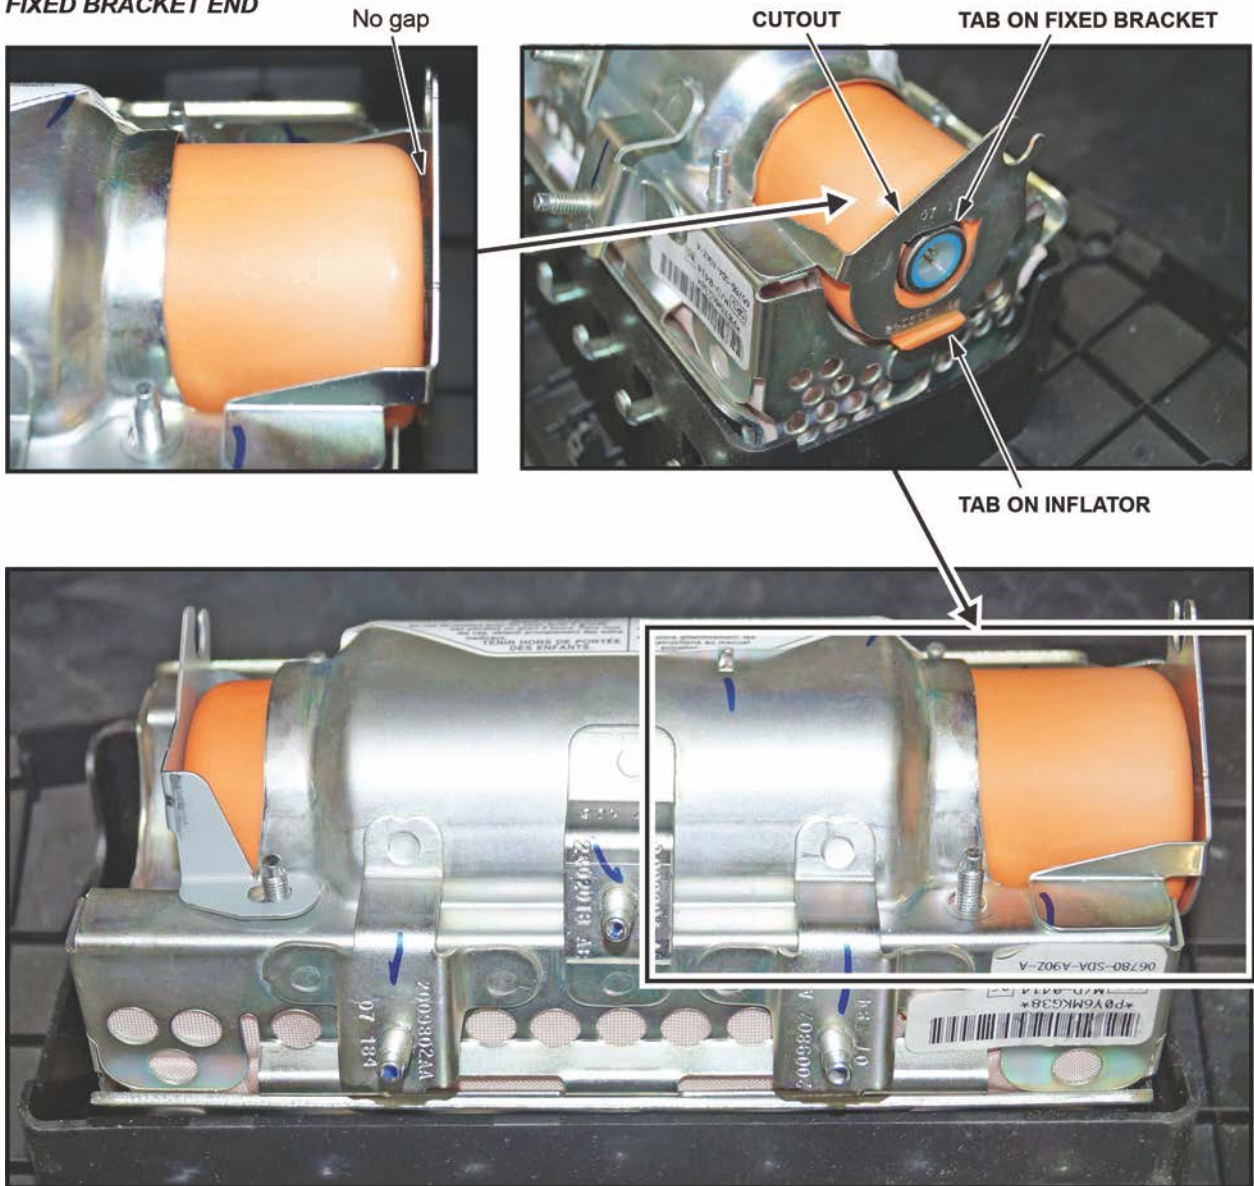
FIXED BRACKET END

- Slide the inflator in until the plastic cutout and the small flat spot align with the tab on the bracket. There should be no space or gap between the inflator and bracket.

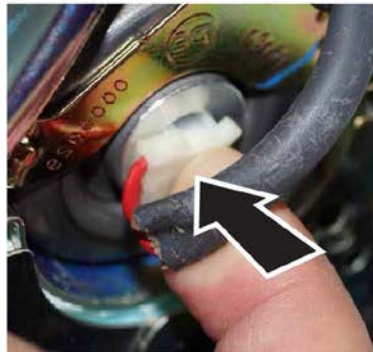
② Press the connector into place until it clicks.
