December 22, 2015

00406-01910 Version 5

Safety Recall: Front Passenger's Airbag Inflator May Produce Excessive Pressure After Long-Term Exposure To High Absolute Humidity

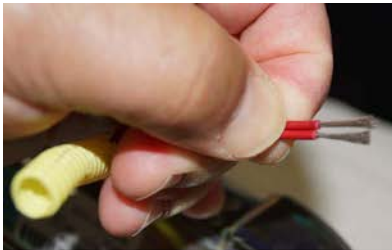
- Strip away about 1 inch of the wire insulation, then twist the wires together.
